# Notification of Water Quality Monitoring Exceedance

## Incident Report on Action/ Limit Level Exceedance

Reference No.:	IR20220823_M2_SS						
Project:	Contract No. SPW 07/2020 Environmental Team for Construction of Yuen Long Effluent Polishing Plant Stage 1						
Date:	2022/08/23						
Time: (hh:mm)	<b>(Flood Tide)</b> M1: M2: <u>19:03</u> M3:						
Action level / Limit level: <b>(For Flood Tide)</b>		<b>DO (mg/L)</b>		<b>Turbidity (NTU)</b>		<b>SS (mg/L)</b>	
		<b>AL</b>	<b>LL</b>	<b>AL</b>	<b>LL</b>	<b>AL</b>	<b>LL</b>
	<b>M2</b>	1.88	1.79	43.0	52.4	81	112
	<b>M3</b>	3.28	3.14	74.3	78.0	104	167
Measured level of exceeded parameter: (fill in / circle as appropriate)	<b>M1</b>	DO (AL / LL) : _____		<b>M3</b>	DO (AL / LL) : _____		
		NTU (AL / LL) : _____			NTU (AL / LL) : _____		
		SS (AL / LL) : _____			SS (AL / LL) : _____		
	<b>M2</b>	DO (AL / LL) : _____					
		NTU (AL / LL) : _____					
		SS (AL / LL) : <u>94</u>					
Action taken / to be taken: (tick / circle / fill in as appropriate)	Inspection : <input checked="" type="checkbox"/> ER / IEC / Contractor is/are informed. <input checked="" type="checkbox"/> Monitoring equipment & monitoring data are checked and confirmed

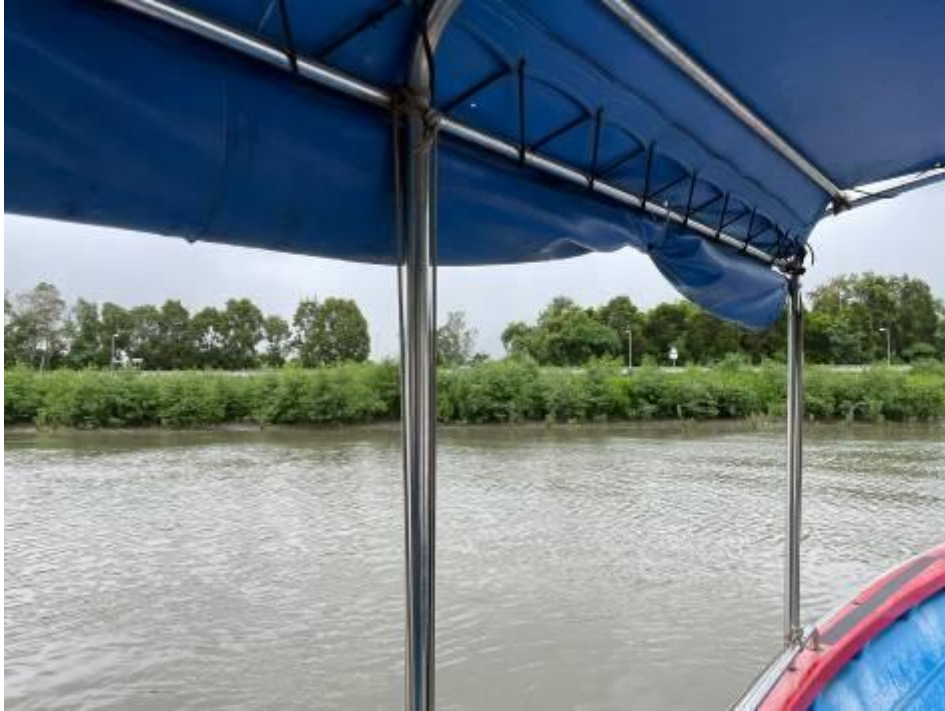
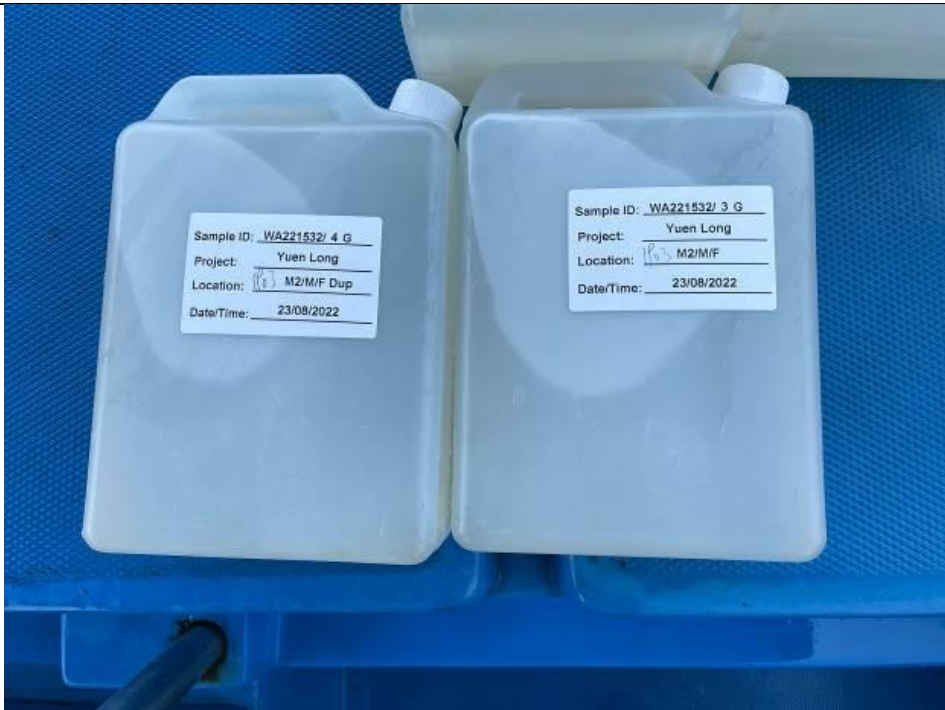
Monitoring Station: M2

_____ _____						
Possible reason for action or Limit level Non-compliance: (tick / fill in as appropriate)				<b>DO</b>	<b>Turbidity</b>	<b>SS</b>	
	Finding / Evidences						
	<input type="checkbox"/> Upstream Control Station exceeded AL/LL						
	<input type="checkbox"/> Station was polluted by the inflow of other construction site						
	<input type="checkbox"/> Station was polluted by the inflow of residential discharge						
	<input type="checkbox"/> Station was polluted by the inflow of surface runoff from rainstorm and storm water drainage						
	<input checked="" type="checkbox"/> No construction activities were carried out in the vicinity of station					M2	
<input type="checkbox"/> Other

Date of investigation: 23 August 2022 (**Flood Tide**)

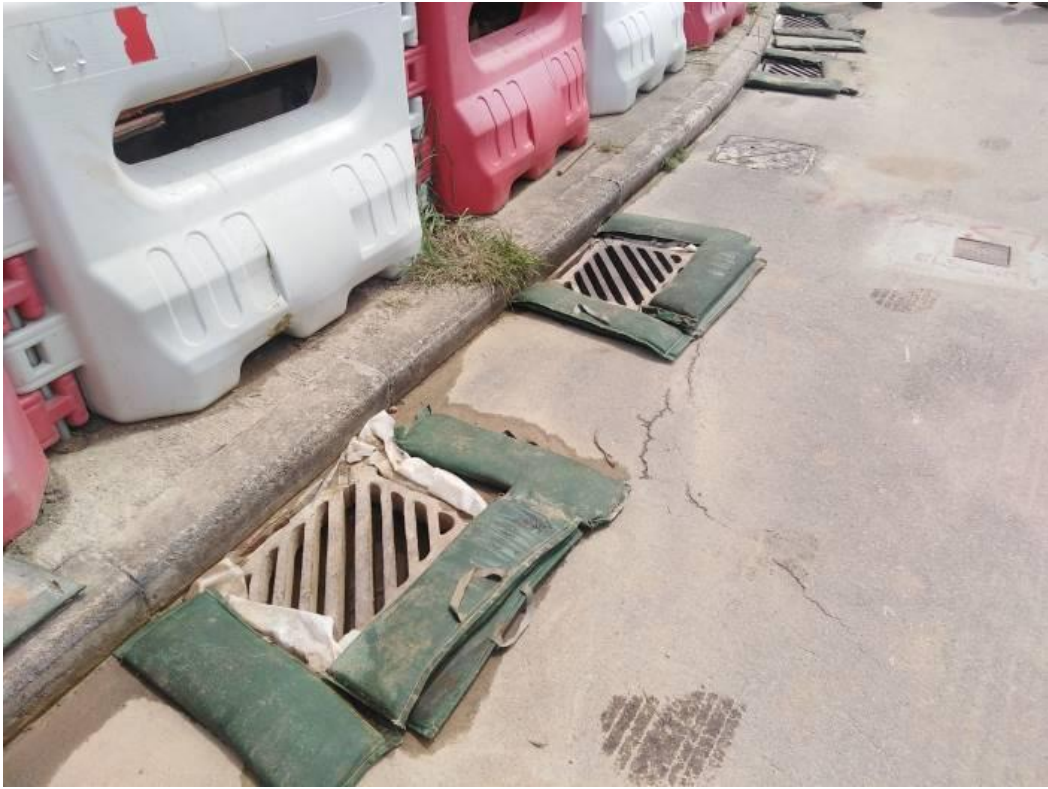
Date of site inspection: 24 August 2022  
Gullies were bunded by sand bags to prevent surface runoff.
