Monthly EM&A Report (March 2022)

0120/20/ED/0455 02

Contract No. SPW 07/2020 Environmental Team for Construction of Yuen Long Effluent Polishing Plant Stage 1

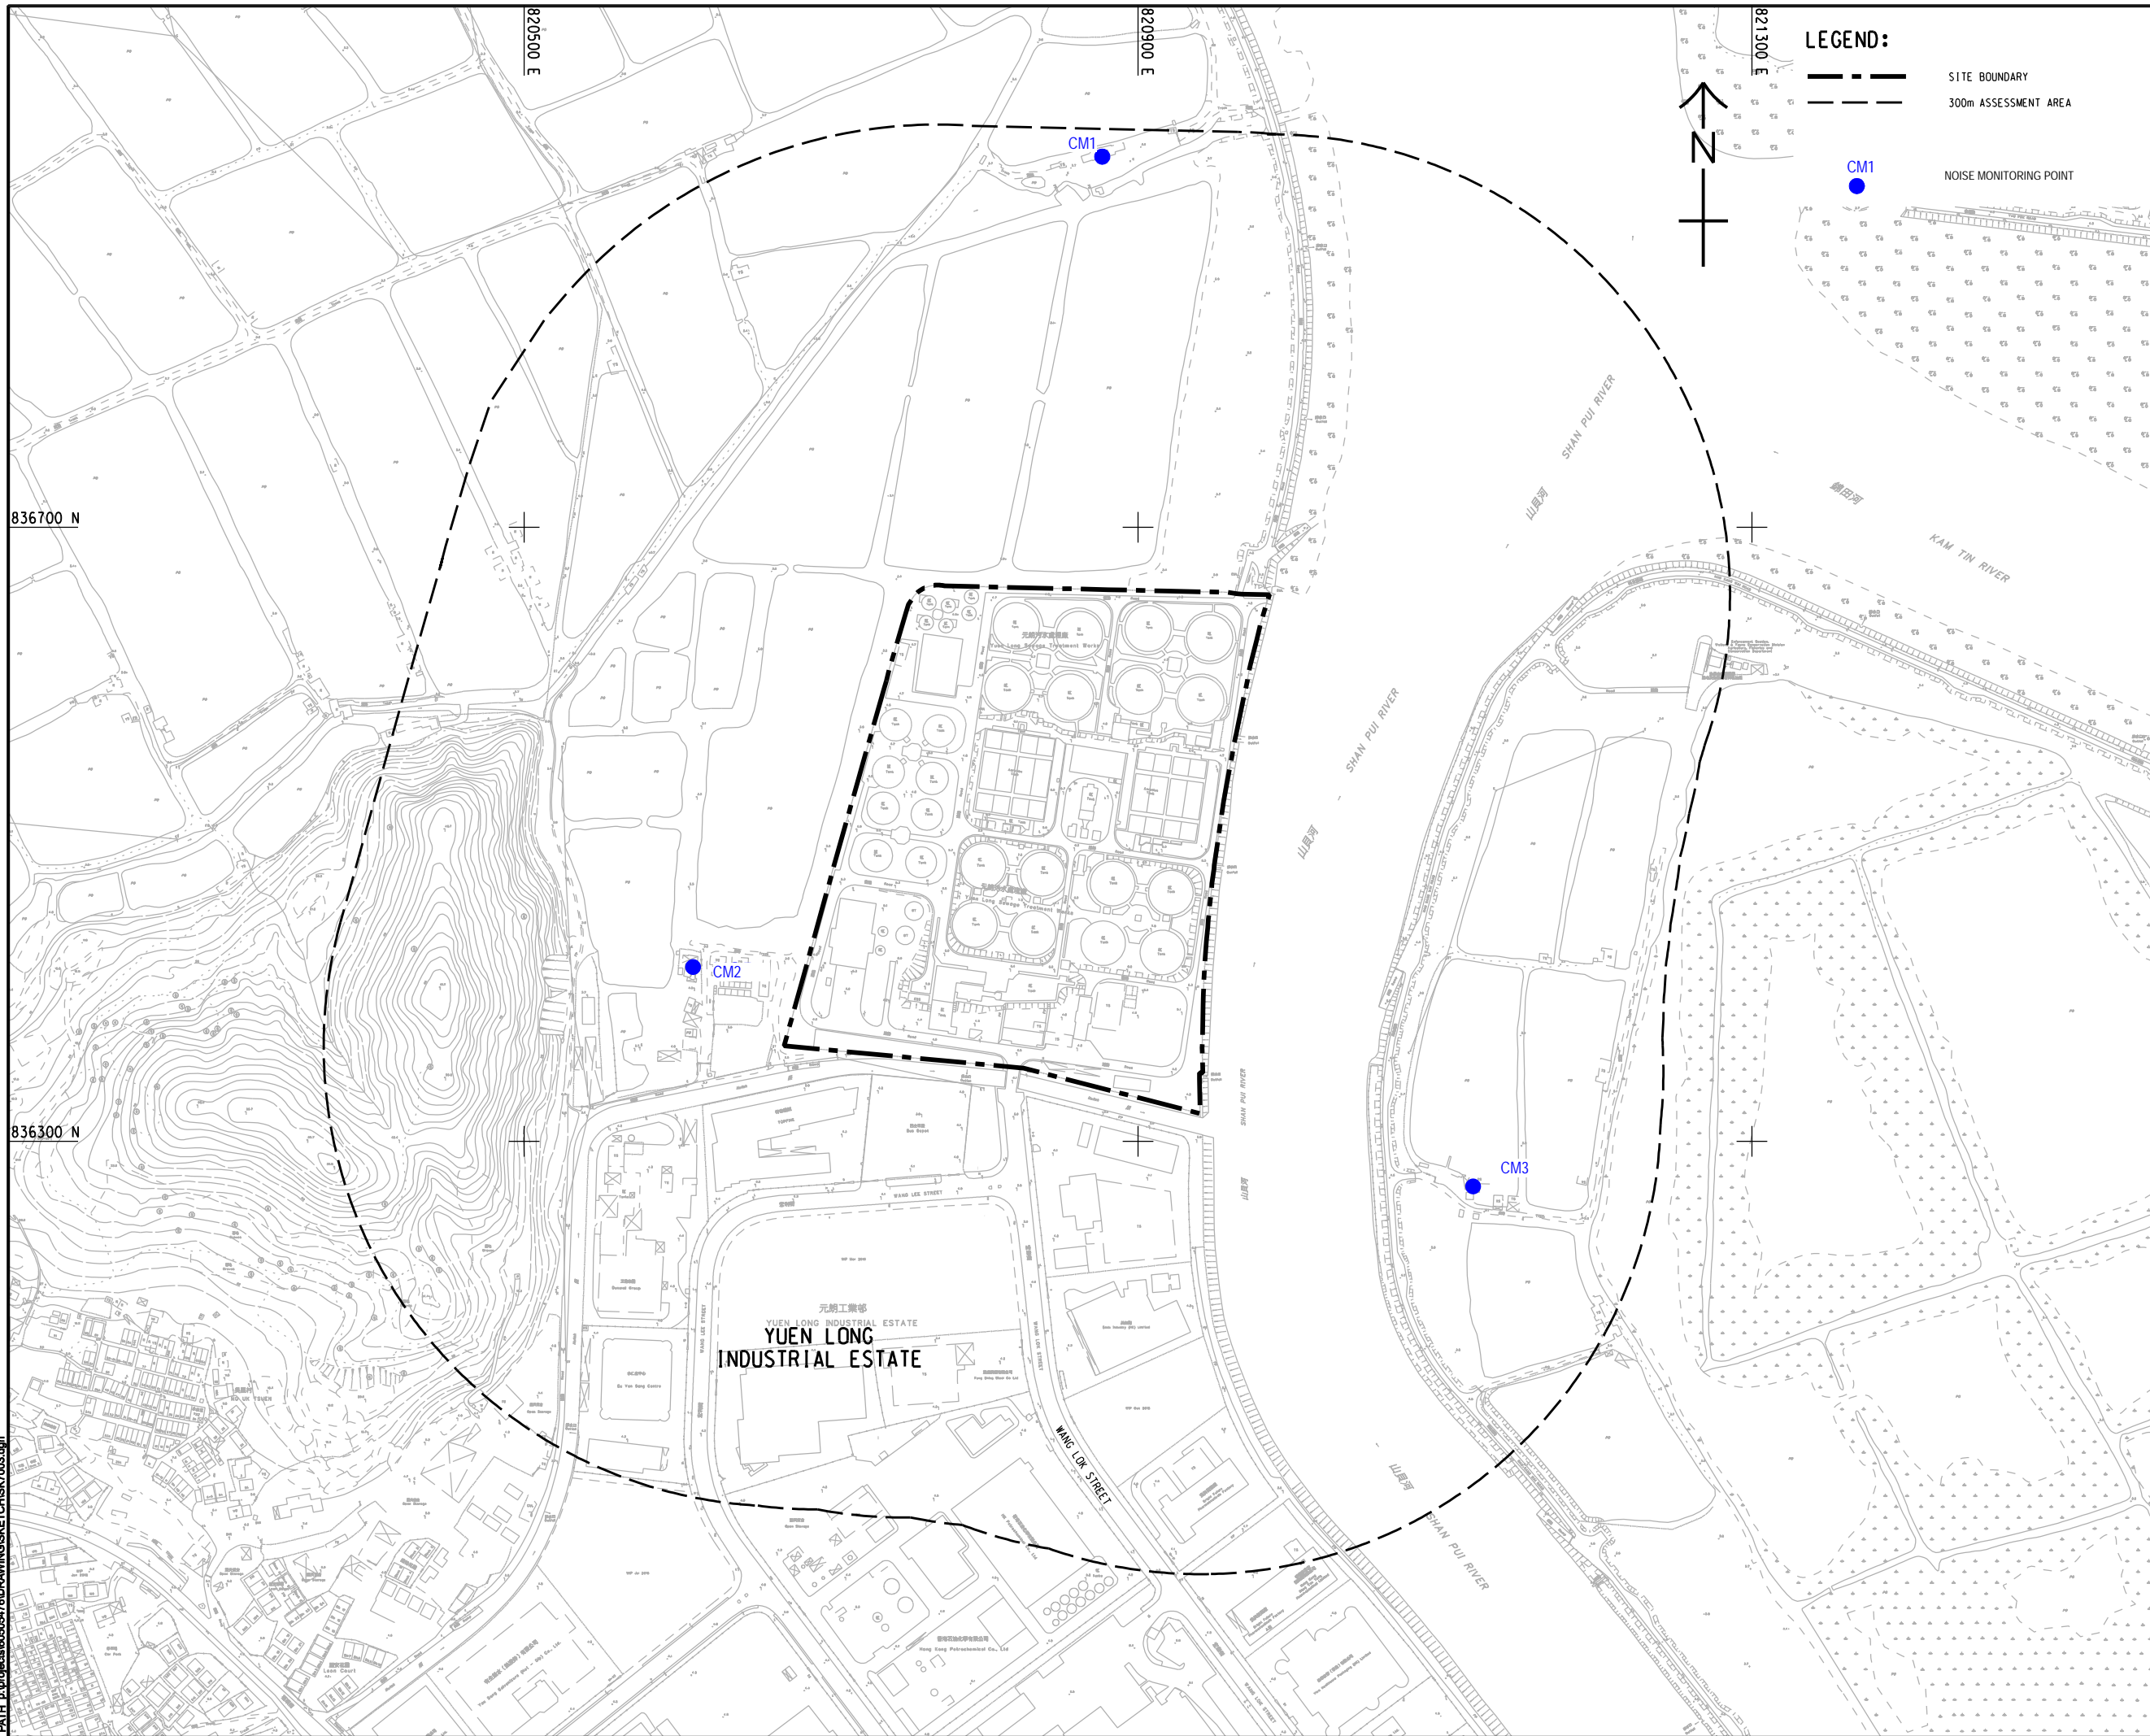
Figure 3

Noise Monitoring Locations

- SITE BOUNDARY
- 300m ASSESSMENT AREA
- NOISE MONITORING POINT

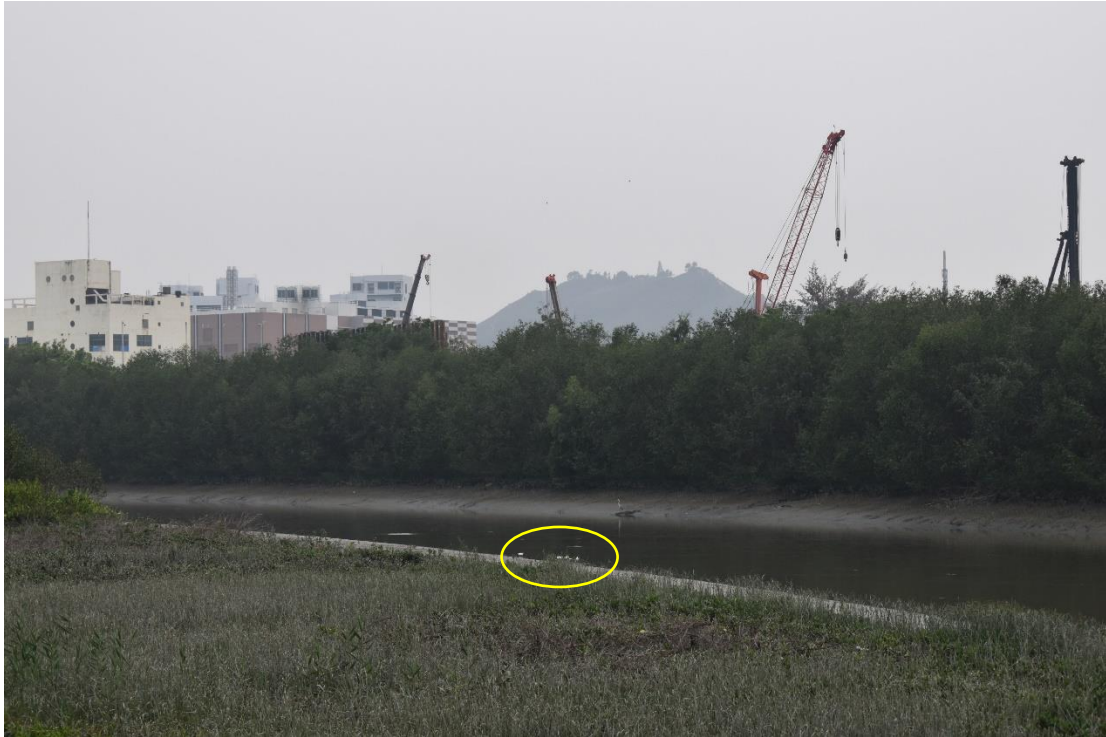
Appendix O.2.1a: Pre-roost aggregate of Chinese Pond Heron *Ardeola bacchus* and Intermediate Egret *Egretta intermedia* in the mudflat area east of the Project boundary observed on 18 March 2022 around 17:35

The monitoring activity was conducted on 18 March 2022 and started around 17:34 (one hour before sunset) on a low tide condition. During the pre-roost period (PRP), the period when avian individuals gather first before flying into a night roost, Chinese Pond Heron *Ardeola bacchus* (2 individuals) and Intermediate Egret *Egretta intermedia* (3 individuals) were observed in pre-roost aggregate (PRA) around 17:35 at the mudflat east side (ANR1) of the Project boundary while Intermediate Egret (4 individuals) and Little Egret *Egretta garzetta* (2 individuals) were concurrently noted at the mudflat northeast side (ANR2) of the Project boundary during the period (**Table 5.2**).

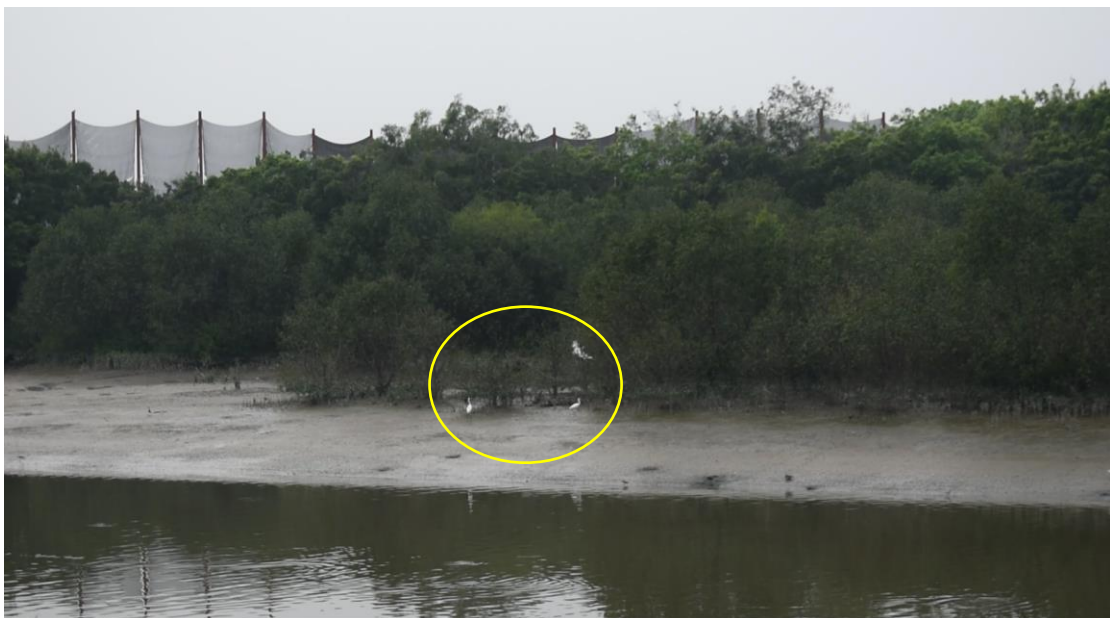
Appendix O.2.1b: Pre-roost aggregate of Intermediate Egret *Egretta intermedia* and Little Egret *Egretta garzetta* in the mudflat area northeast of the Project boundary observed on 18 March 2022 around 17:35

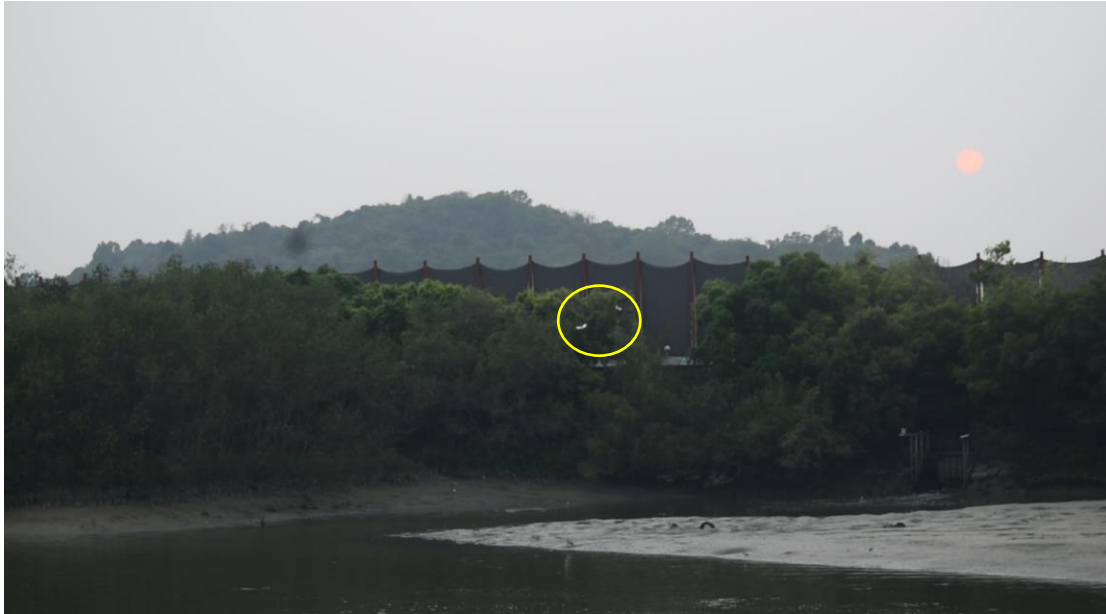
Appendix O.2.2a: Active night roost on *Sonneratia apetala* and *S. caseolaris* mangrove roosting substrate located east of the Project boundary observed on 18 March 2022 around 18:15

For the final night roost at around 18:15, Chinese Pond Heron individuals were observed at both the roosting areas ANR1 (6 individuals) and ANR2 (7 individuals) utilizing the inside portions of the understory to canopy layers of the roosting substrate *Sonneratia apetala* and *S. caseolaris*; while individuals of Great Egret (3 individuals), Intermediate Egret (6 individuals), and Little Egret (10 individuals) were only noted at ANR2 and utilized the canopy layer of the aforementioned roosting substrate.

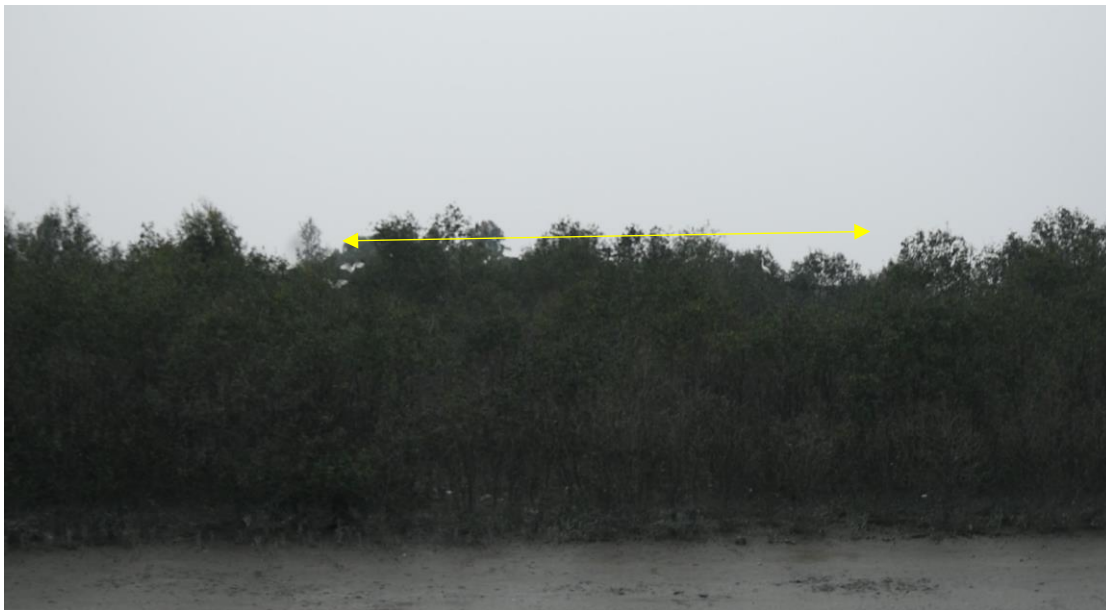
Appendix O.2.2b: Active night roost on *Sonneratia apetala* and *S. caseolaris* mangrove roosting substrate located northeast of the Project boundary observed on 18 March 2022 around 18:15
