Monthly EM&A Report (April 2022)

Contract No. SPW 07/2020 Environmental Team for Construction of Yuen Long Effluent Polishing Plant Stage 1

Verification of the Monthly EM&A Report (April 2022)

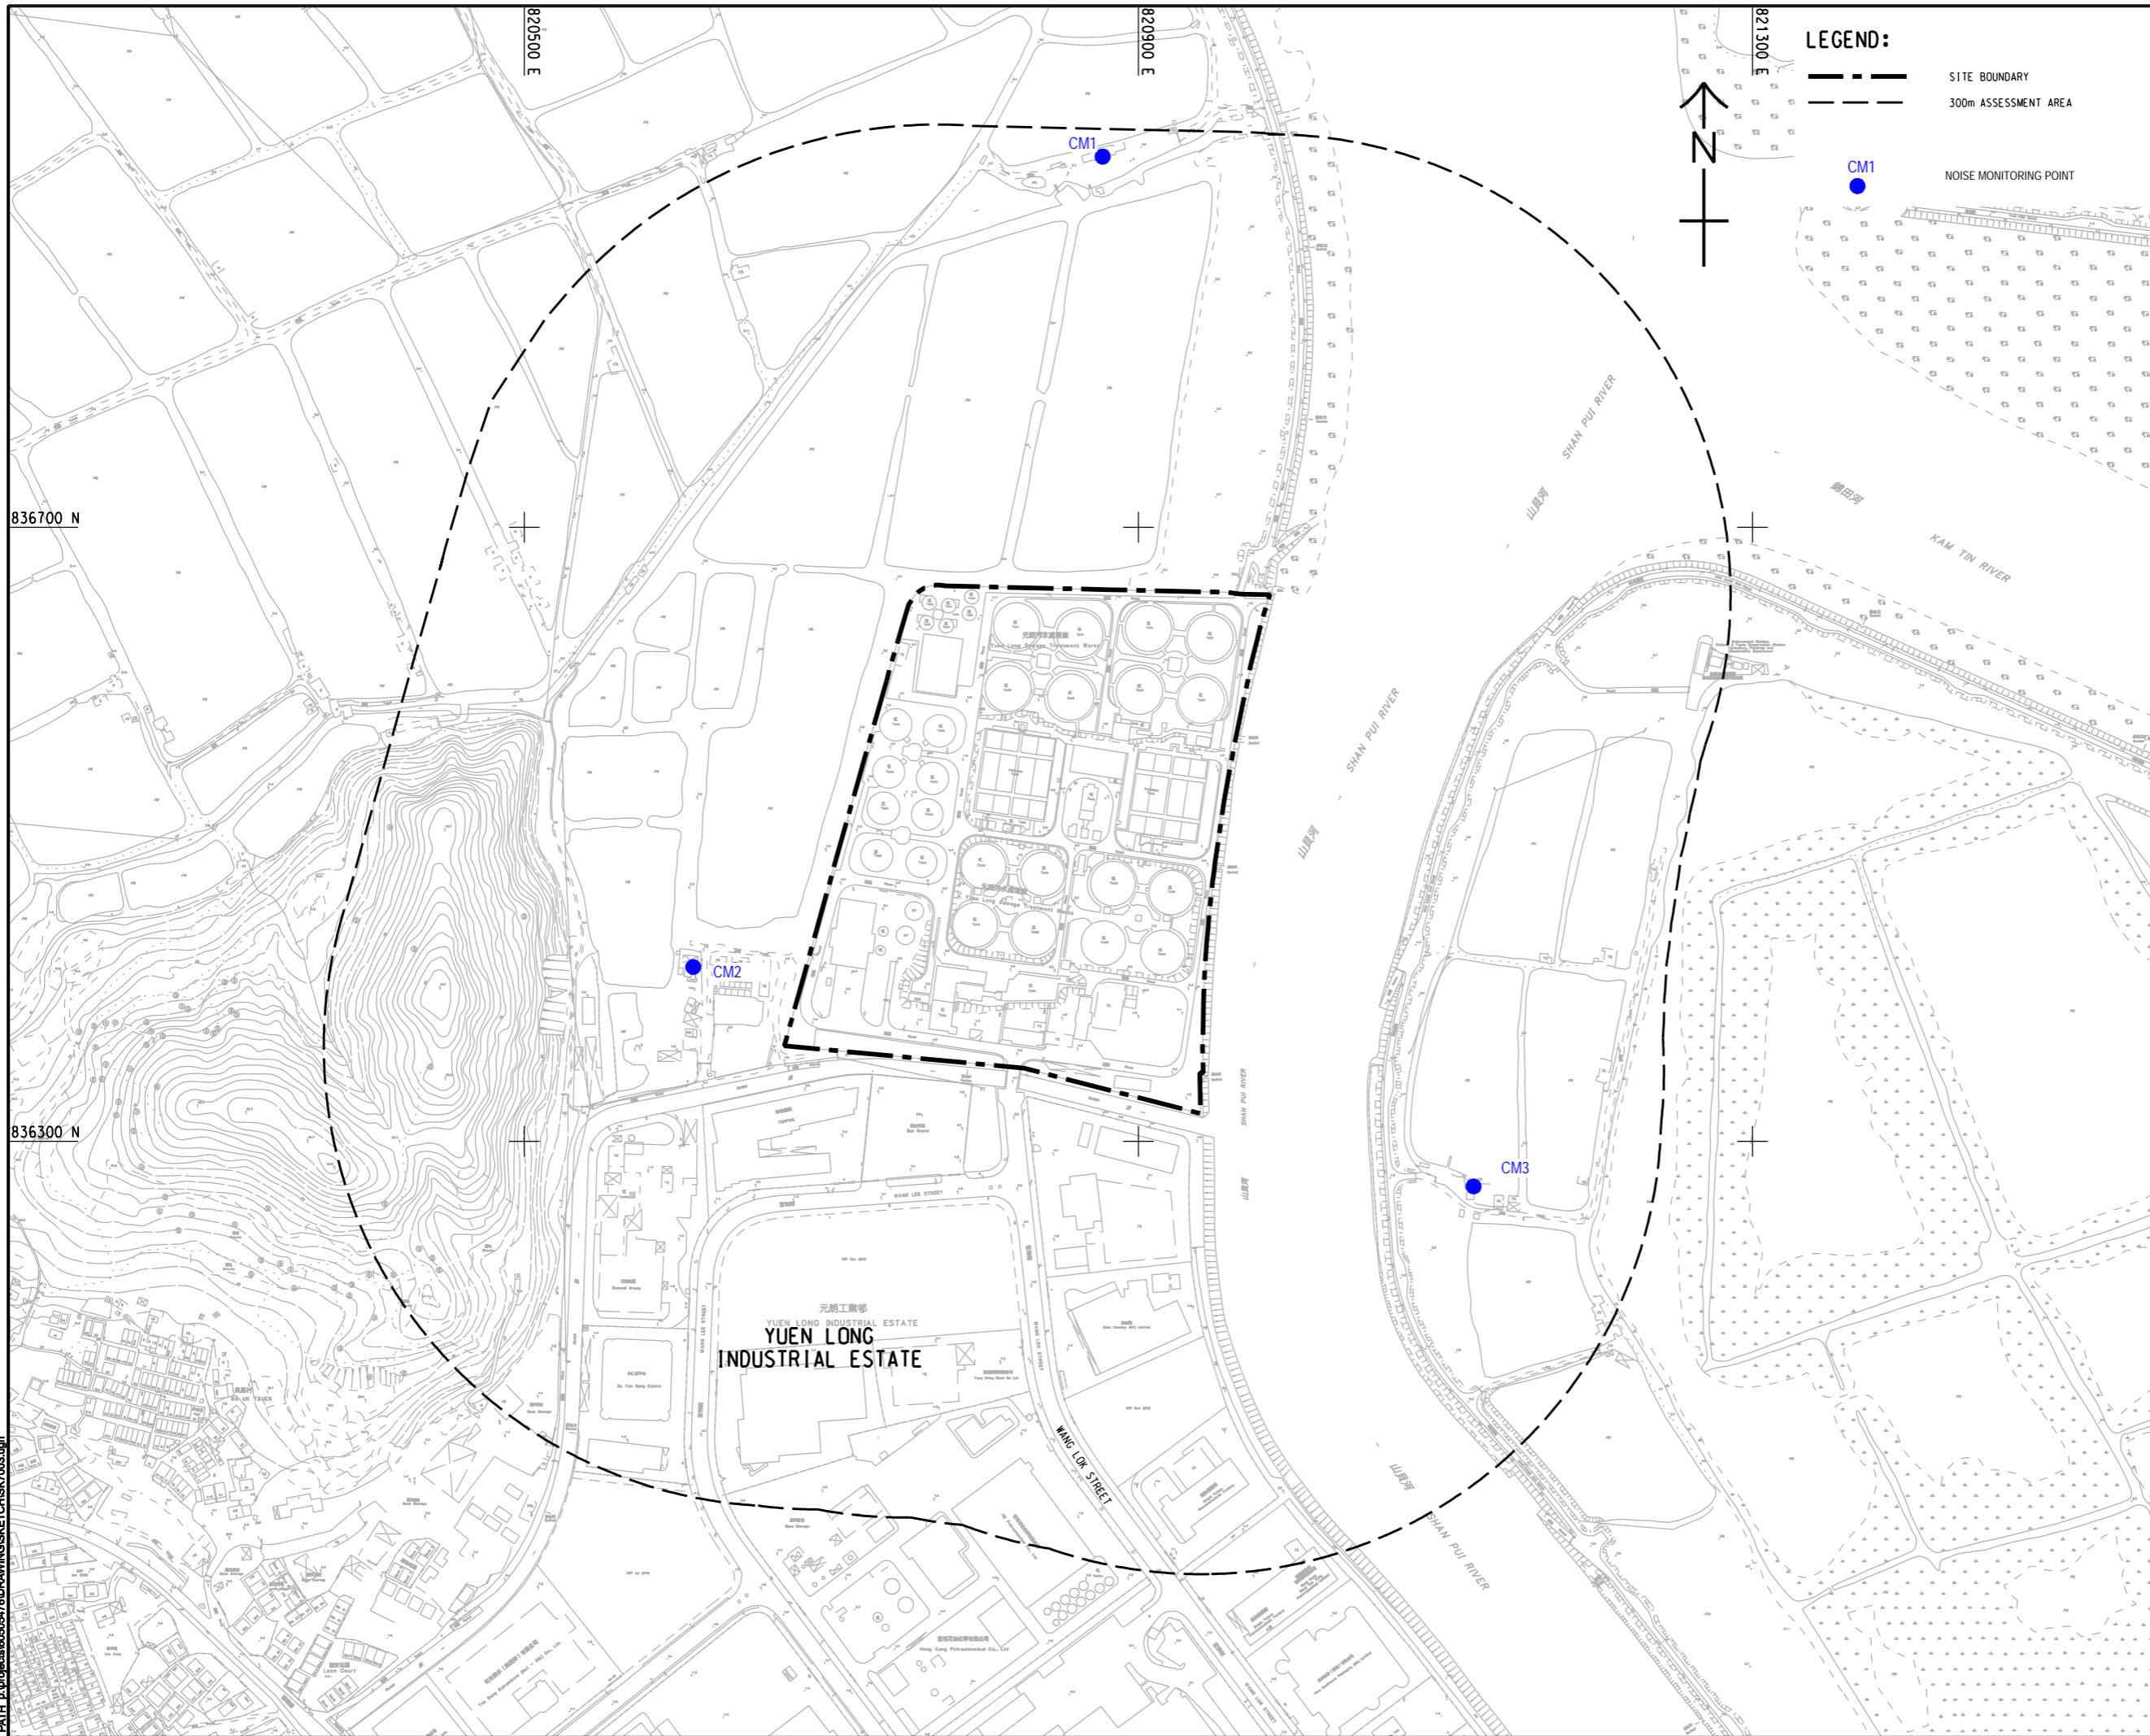
Figure 3

Noise Monitoring Locations

- SITE BOUNDARY
- 300m ASSESSMENT AREA
- NOISE MONITORING POINT

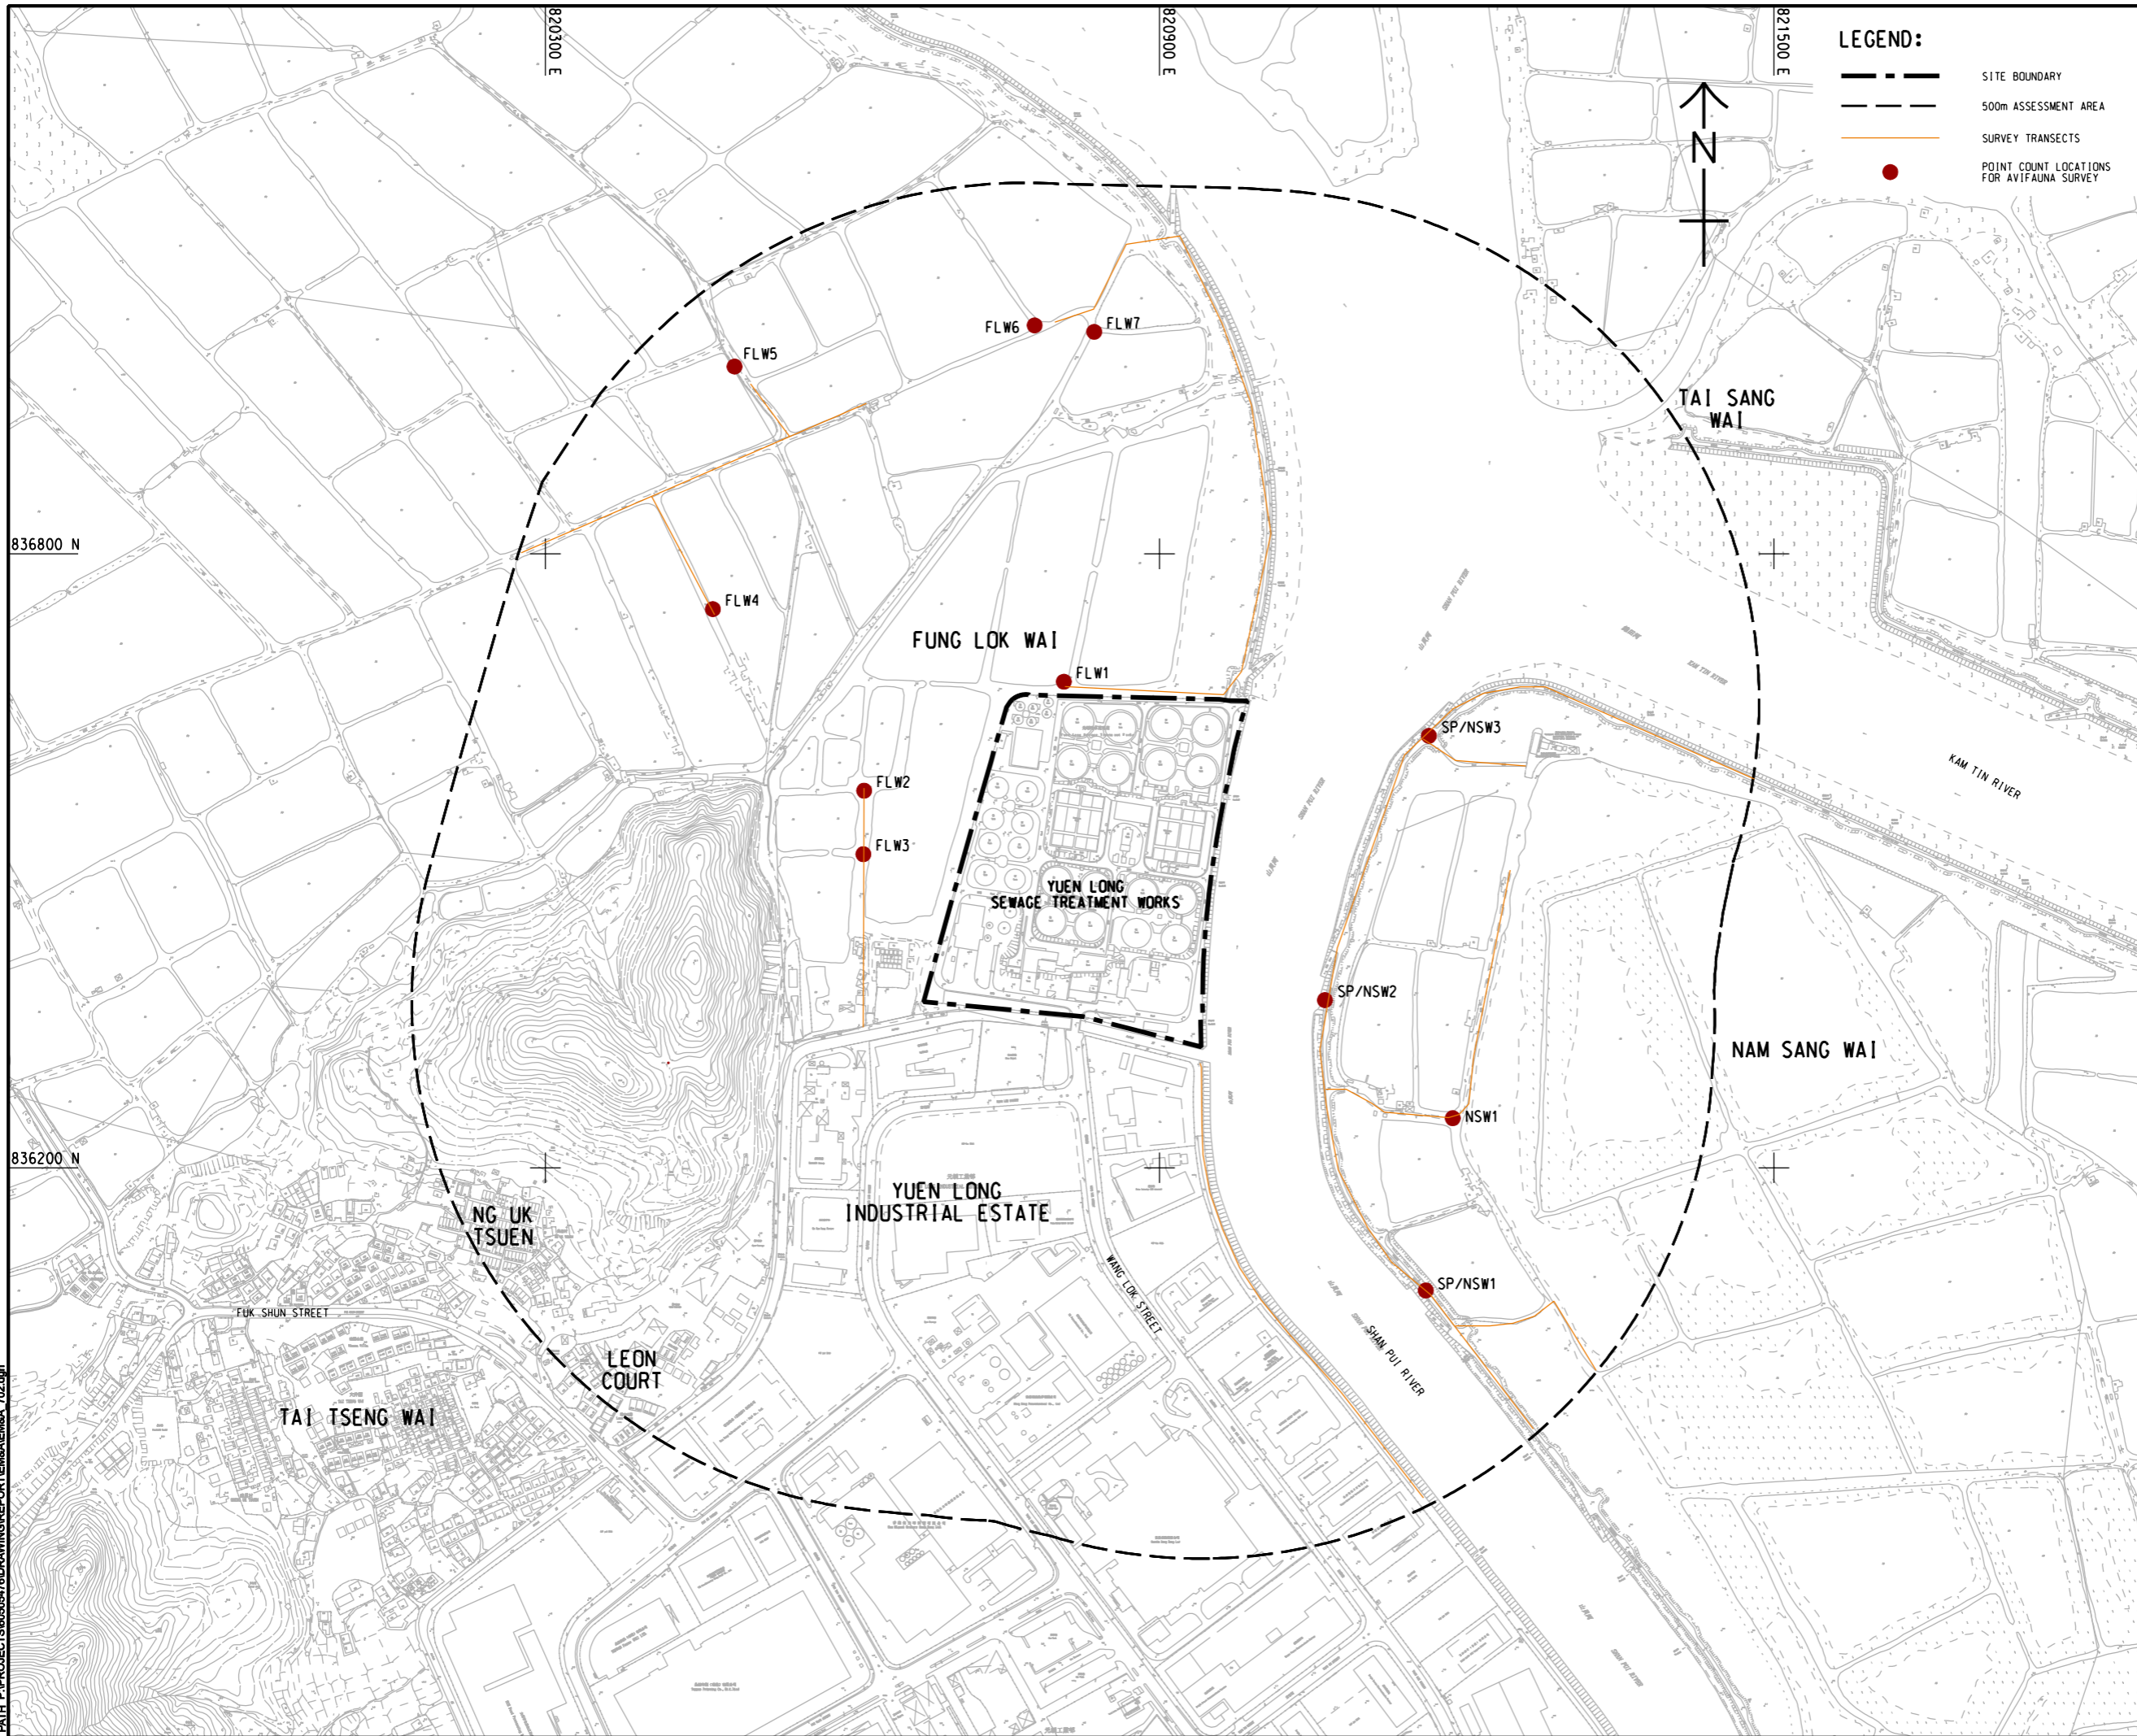
Ecology Monitoring Locations

- SITE BOUNDARY
- 500m ASSESSMENT AREA
- SURVEY TRANSECTS
- POINT COUNT LOCATIONS FOR AVIFAUNA SURVEY

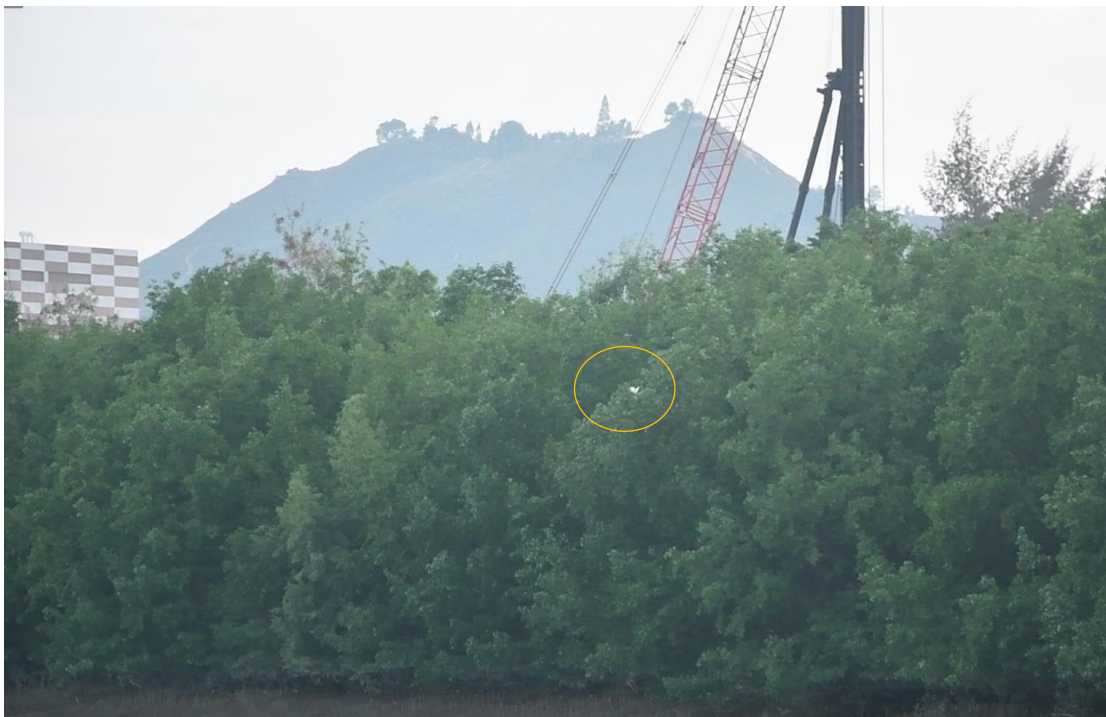
For the final night roost at around 18:59, Chinese Pond Heron (3 individuals) were observed at the roosting area ANR1 utilizing the inside portions of the understory to canopy layers of the roosting substrate *Sonneratia apetala* and *S. caseolaris*; while individuals of Little Egret (7 individuals) were noted at ANR2 and utilized the canopy layer of the aforementioned roosting substrate.

Appendix O.2.2a: Active night roost on *Sonneratia apetala* and *S. caseolaris* mangrove roosting substrate located east of the Project boundary observed on 21 April 2022 around 18:59

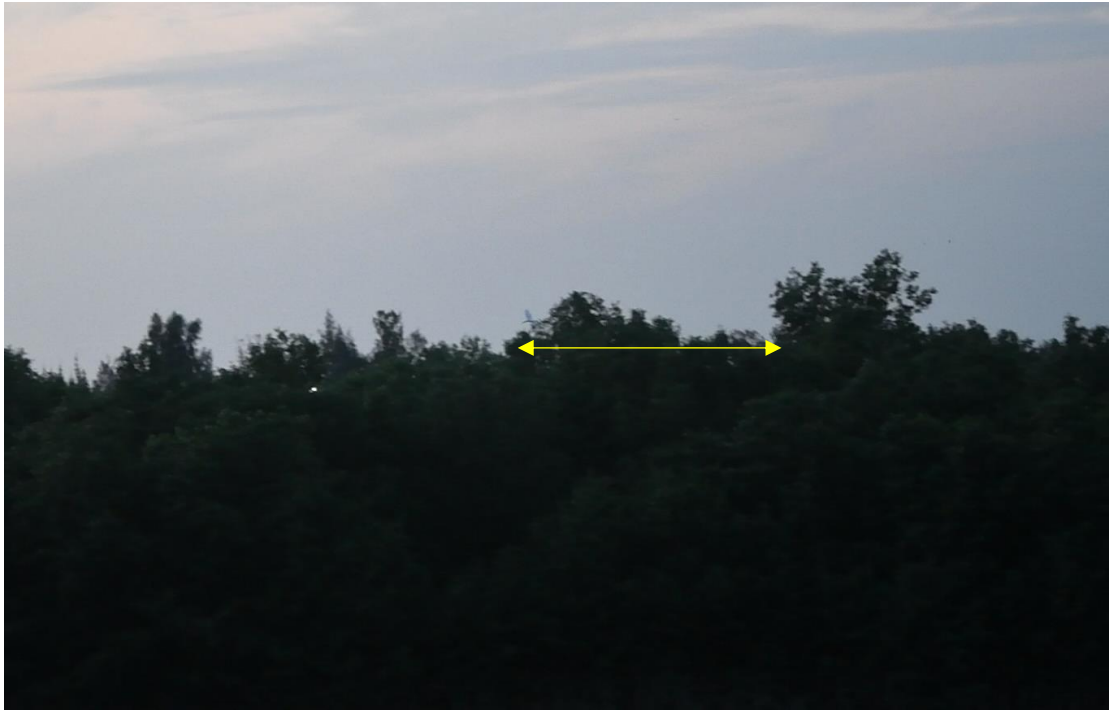
Appendix O.2.2b: Active night roost on *Sonneratia apetala* and *S. caseolaris* mangrove roosting substrate located northeast of the Project boundary observed on 21 April 2022 around 18:59
