# Monthly EM&A Report (October 2022)

**Contract No. SPW 07/2020 Environmental Team for Construction of Yuen Long Effluent Polishing Plant Stage 1**

**EP Condition 3.4 – Monthly EM&A Report for October 2022**

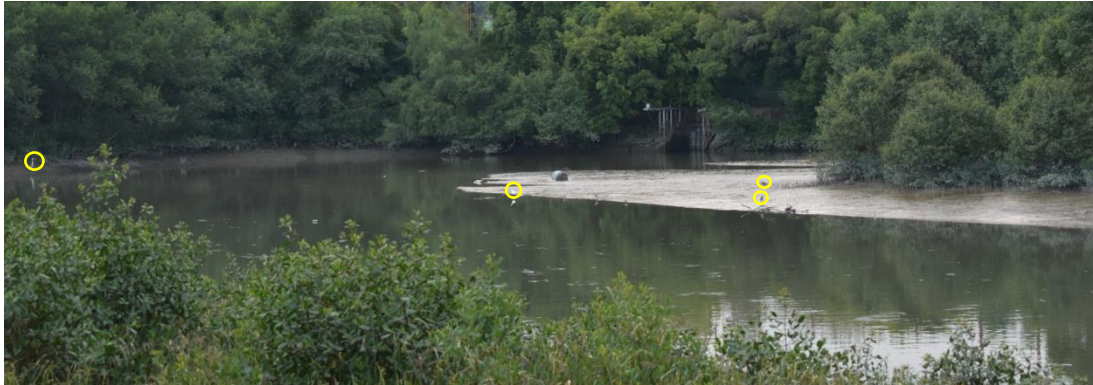
Appendix O.2.1a: Pre-roost aggregate of Chinese Pond Heron *Ardeola bacchus*, Little Egret *Egretta garzetta* and Grey Heron *Ardea cinerea* in the mudflat area east of the Project boundary observed on 13 October 2022 around 17:40

The monitoring activity was conducted on 13 October 2022 and started around 17:00 (one hour before sunset) on a low tide condition. During the pre-roost period (PRP), the period when avian individuals gather first before flying into a night roost, two Chinese Pond Heron *Ardeola bacchus*, one Little Egret *Egretta garzetta*, and one Grey Heron *Ardea cinerea* were observed in pre-roost aggregate (PRA) around 17:40 at the mudflat east side (ANR1) of the Project boundary while another one individual of Little Egret, four Great Egret *Ardea alba*, and two Grey Heron were concurrently noted at the mudflat northeast side (ANR2) of the Project boundary during the period (**Table 5.2**).

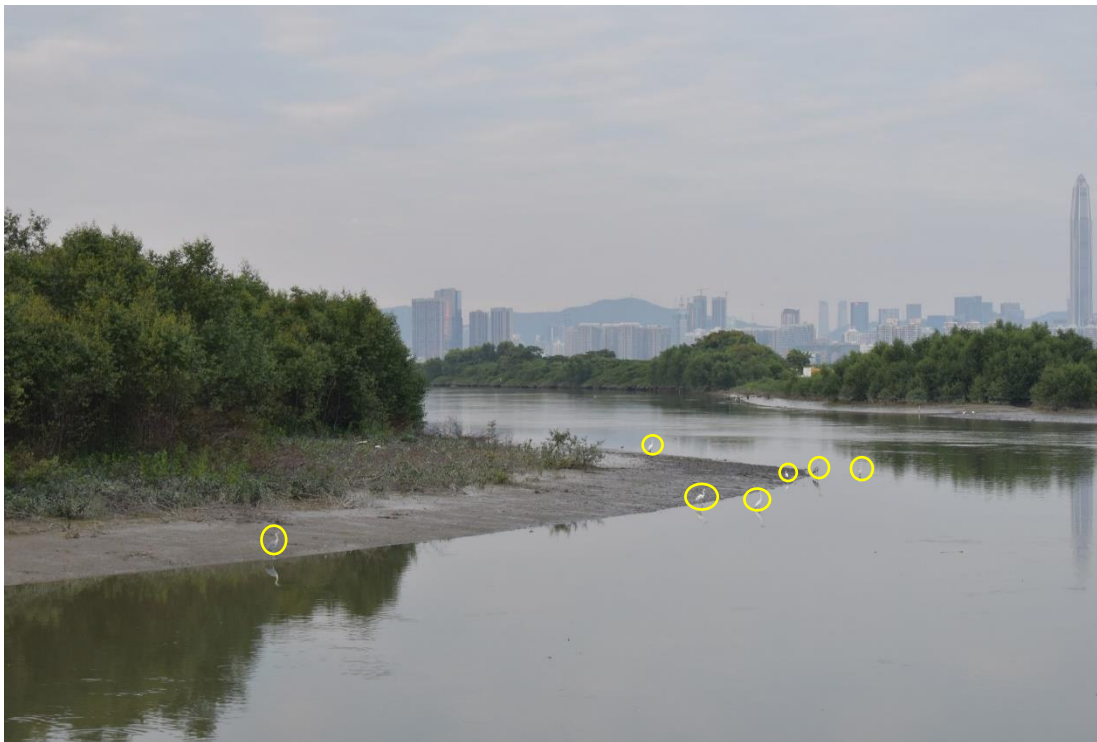
Appendix O.2.1b: Pre-roost aggregate of Great Egret *Ardea alba*, Little Egret *Egretta garzetta* and Grey Heron *Ardea cinerea* in the mudflat area northeast of the Project boundary observed on 13 October 2022 around 17:40

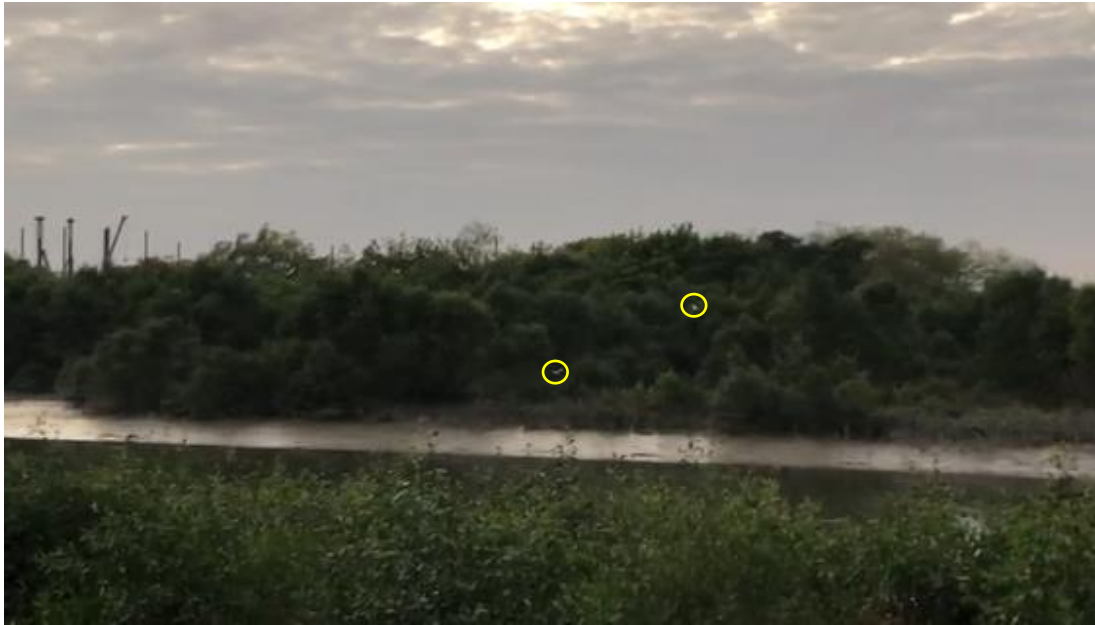
Appendix O.2.2: Active night roost on *Sonneratia apetala* and *S. caseolaris* mangrove roosting substrate located northeast of the Project boundary observed on 13 October 2022 around 18:20

For the final night roost at around 18:20, four individuals of Chinese Pond Heron *Ardeola bacchus* were observed at the roosting area ANR1 utilizing the understory to canopy layer of the roosting substrate *Sonneratia apetala* and *S. caseolaris*; while 12 individuals of Chinese Pond Heron, and four individuals of Little Egret were also noted at ANR2 that utilized the understory layer of the aforementioned roosting substrate.

No disturbance (construction related and/or otherwise) to the active night roost areas was observed during the period. Bird droppings were observed within the vicinity of the roosting area located east of the Project boundary.
