Monthly EM&A Report (June 2023)

Contract No. SPW 07/2020 Environmental Team for Construction of Yuen Long Effluent Polishing Plant Stage 1

Environmental Permit No. EP-565/2019

EP Condition 3.4 – Monthly EM&A Report for June 2023

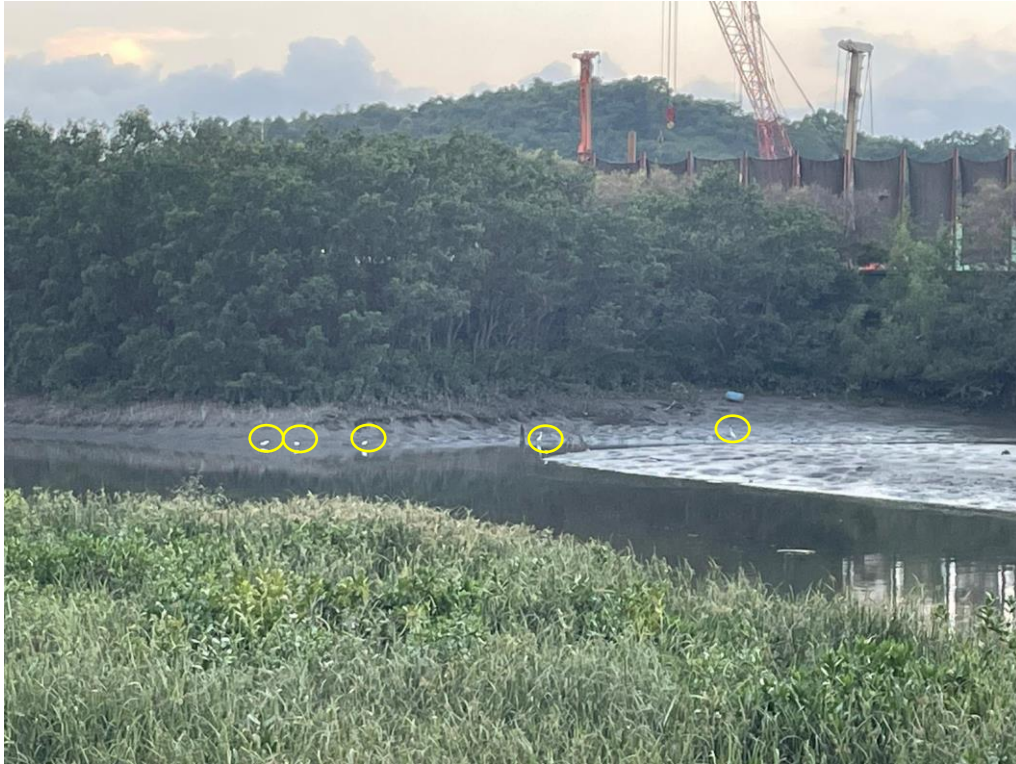
Appendix O.2.1a: Pre-roost aggregate of Little Egret *Egretta garzetta* northeast of the Project boundary observed on 5 June 2023 around 18:30.

The monitoring activity was conducted on 5 June 2023 and started around 18:05 (one hour before sunset) on a low tide condition. During the pre-roost period (PRP), the period when avian individuals gather first before flying into a night roost, individuals of Great Egret *Ardea alba* (2), Little Egret *Egretta garzetta* (6) and Chinese Pond Heron *Ardeola bacchus* (1) were noted in the east side (ANR1) of the Project boundary while individuals of Chinese Pond Heron *Ardeola bacchus* (1), Great Egret *Ardea alba* (1) and Little Egret *Egretta garzetta* (6) were noted at the northeast side of the Project boundary (**Table 5.2**).

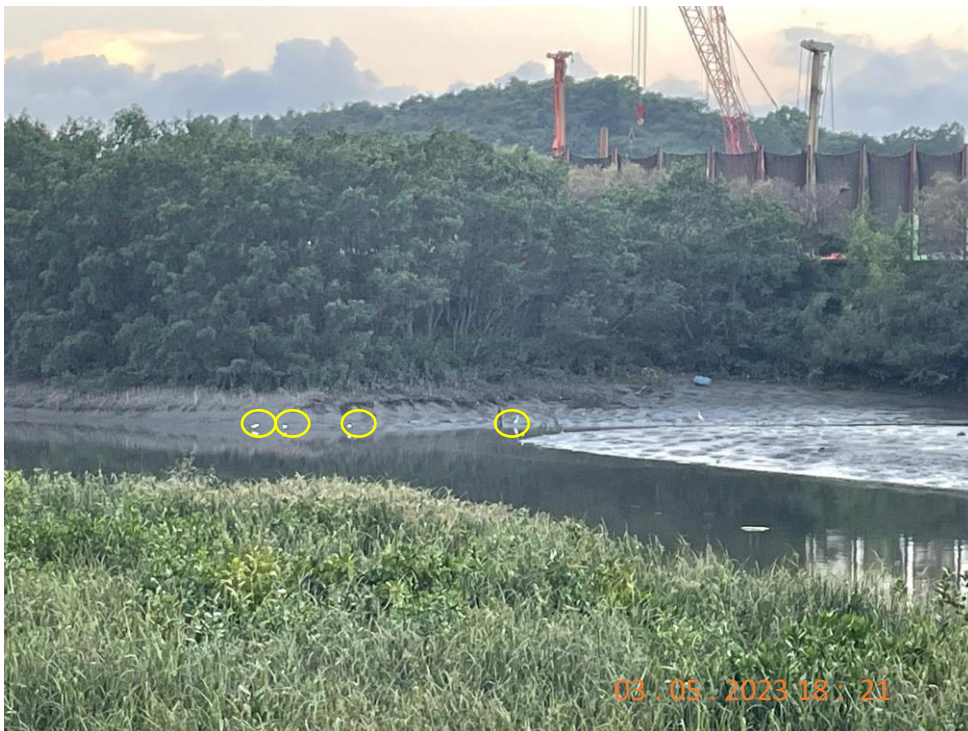
Appendix O.2.1b: Pre-roost aggregate of Little Egret *Egretta garzetta* northeast of the Project boundary observed on 5 June 2023 around 18:30.

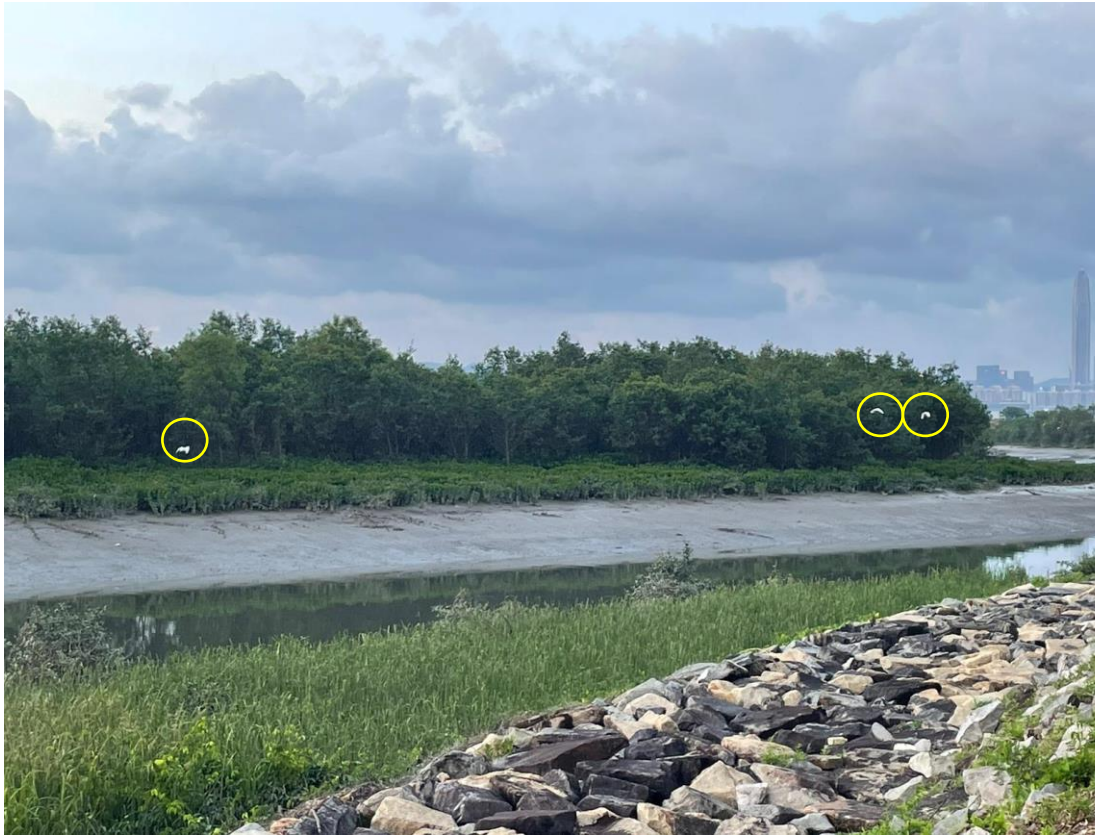
Appendix O.2.2a: Active night roost on *Sonneratia apetala* and *S. caseolaris* mangrove roosting substrate located northeast of the Project boundary observed on 5 June 2023 around 19:05.

For the final night roost at around 19:05, individuals of Little Egret *Egretta garzetta* (1) and Chinese Pond Heron (1) were observed at the roosting area ANR1 utilizing the understory to canopy layer of the roosting substrate *Sonneratia apetala* and *S. caseolaris*; while Chinese Pond Heron (10), Little Egret *Egretta garzetta* (11) and Great Egret (3) were noted at ANR2 that utilized the understory to canopy layer of the aforementioned roosting substrate.
