Monthly EM&A Report (January 2023)

Contract No. SPW 07/2020 Environmental Team for Construction of Yuen Long Effluent Polishing Plant Stage 1

Independent Environmental Checker for Construction of Yuen Long Effluent Polishing Plant Stage 1 (2022-2023)

EP Condition 3.4 – Monthly EM&A Report for January 2023

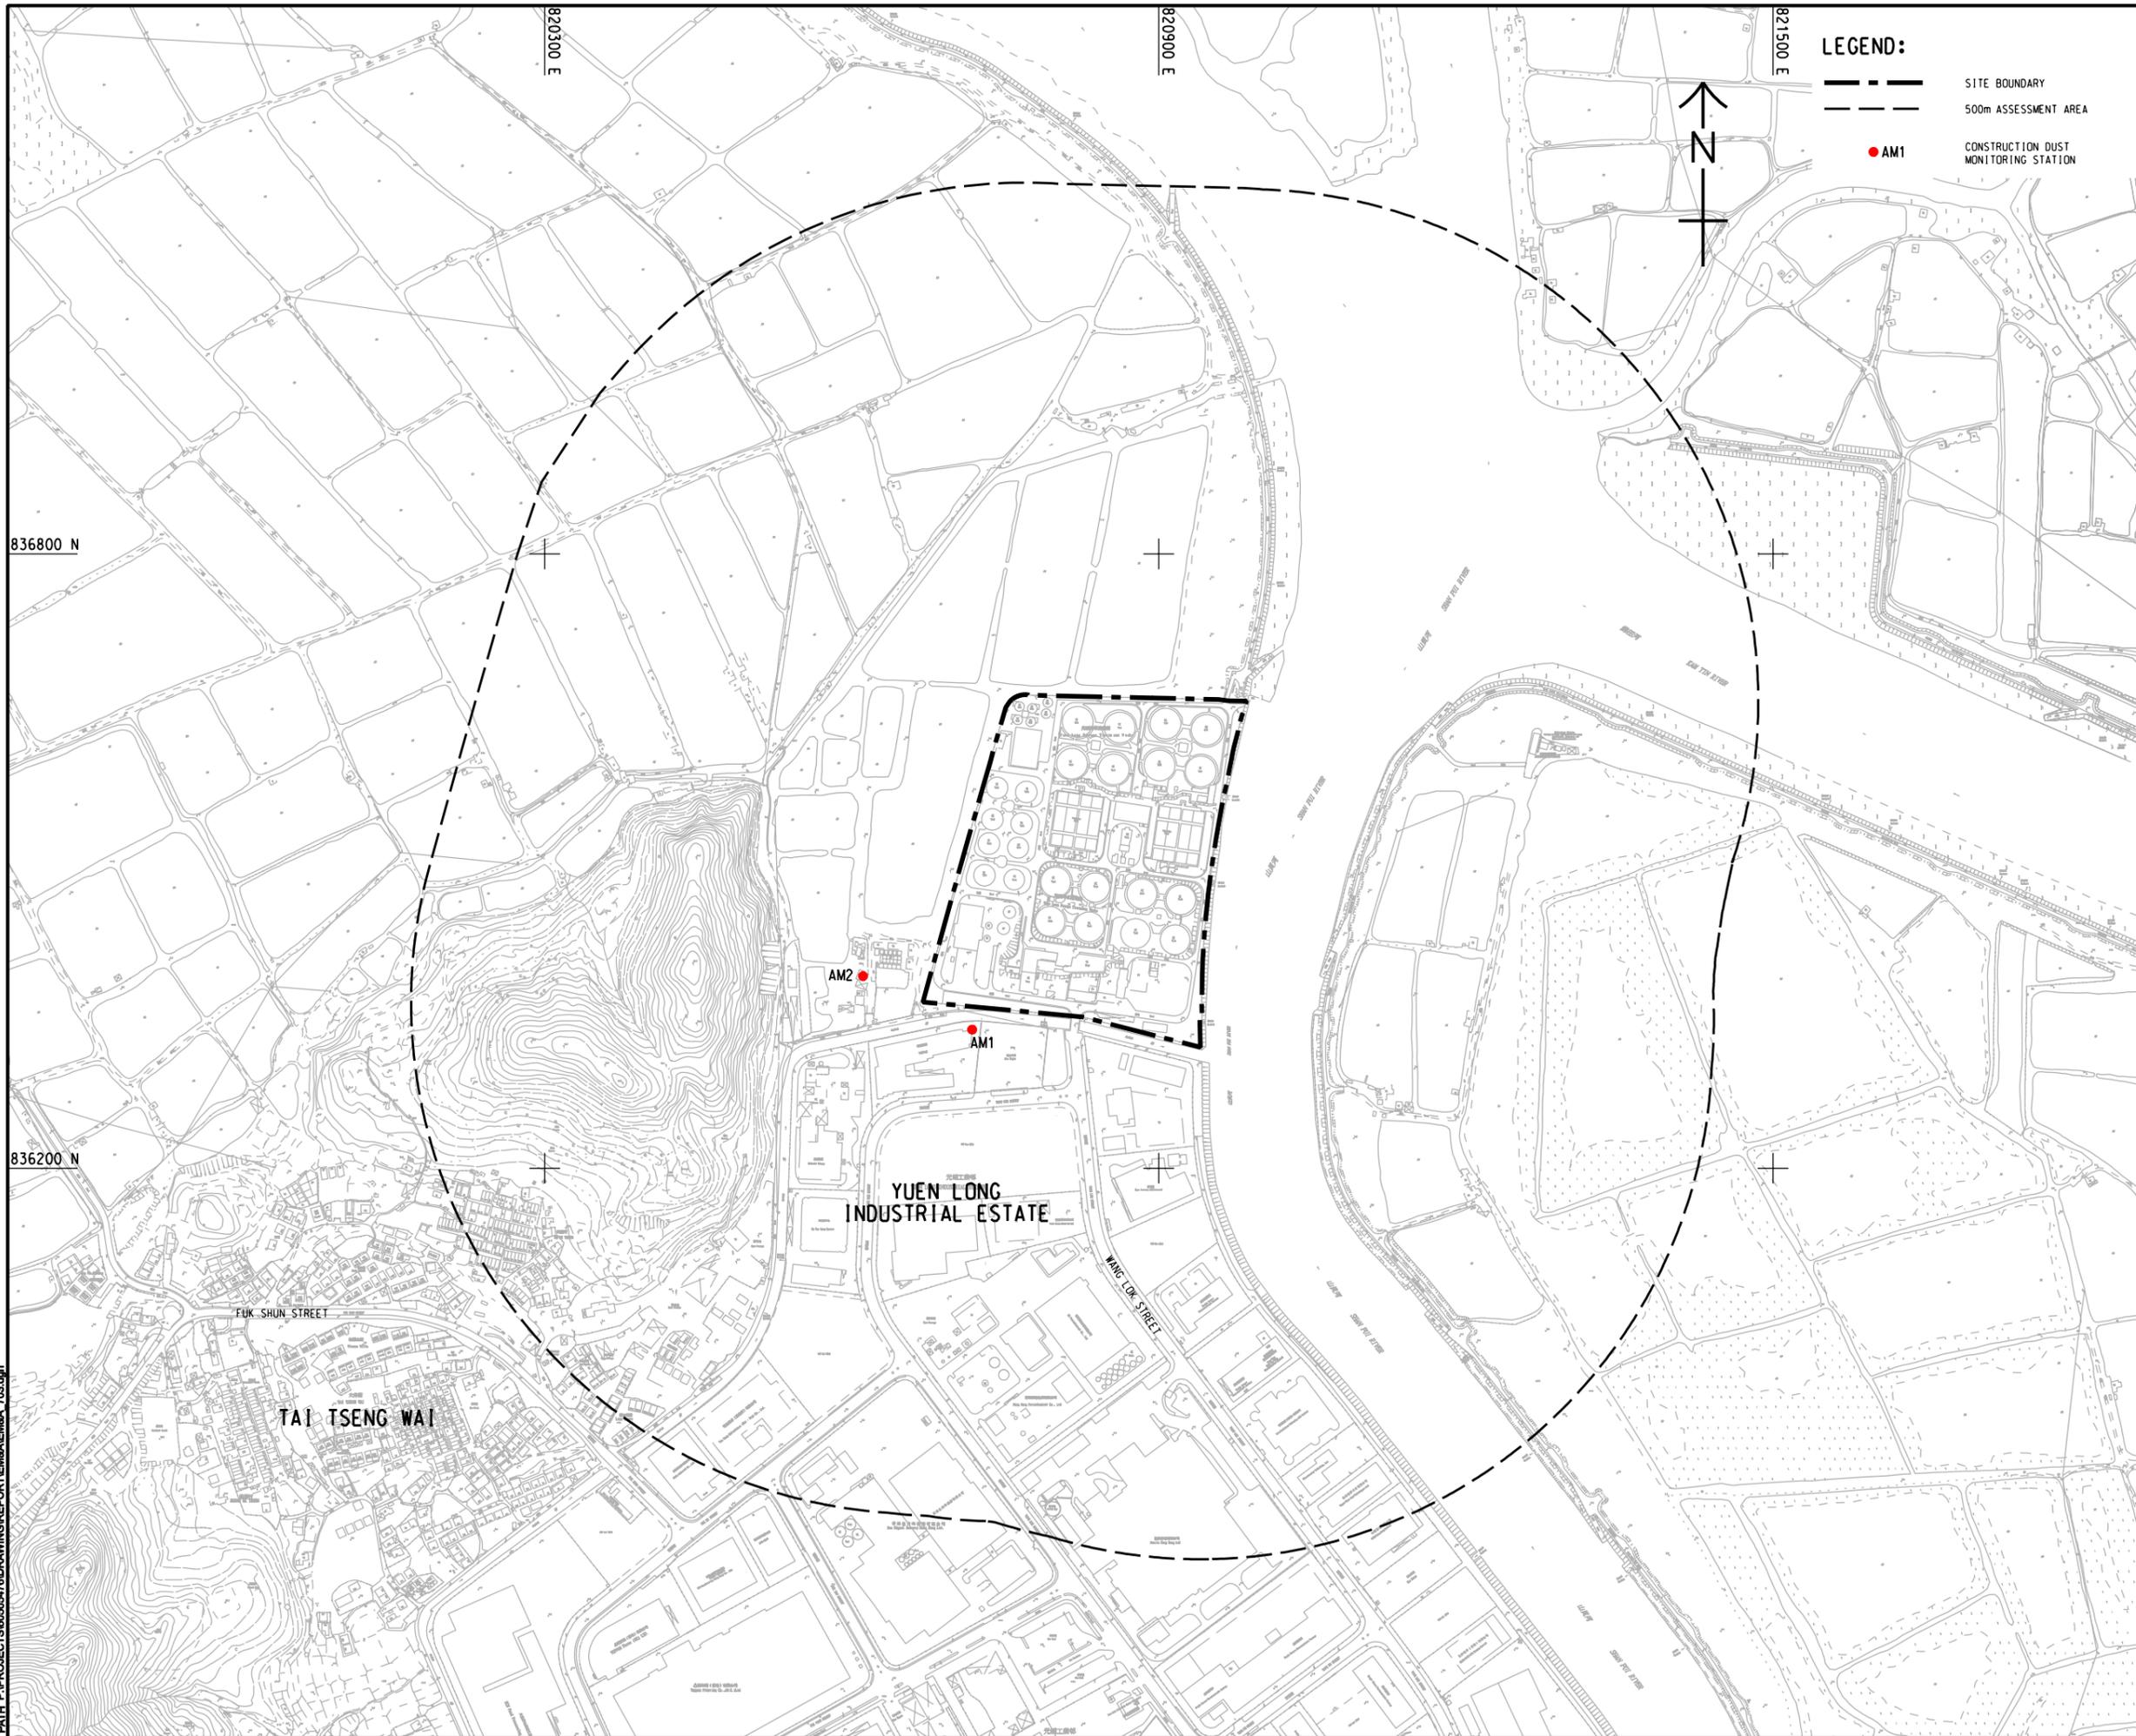
Location of Construction Dust
Monitoring Stations

- SITE BOUNDARY
- 500m ASSESSMENT AREA
- AM1 CONSTRUCTION DUST MONITORING STATION

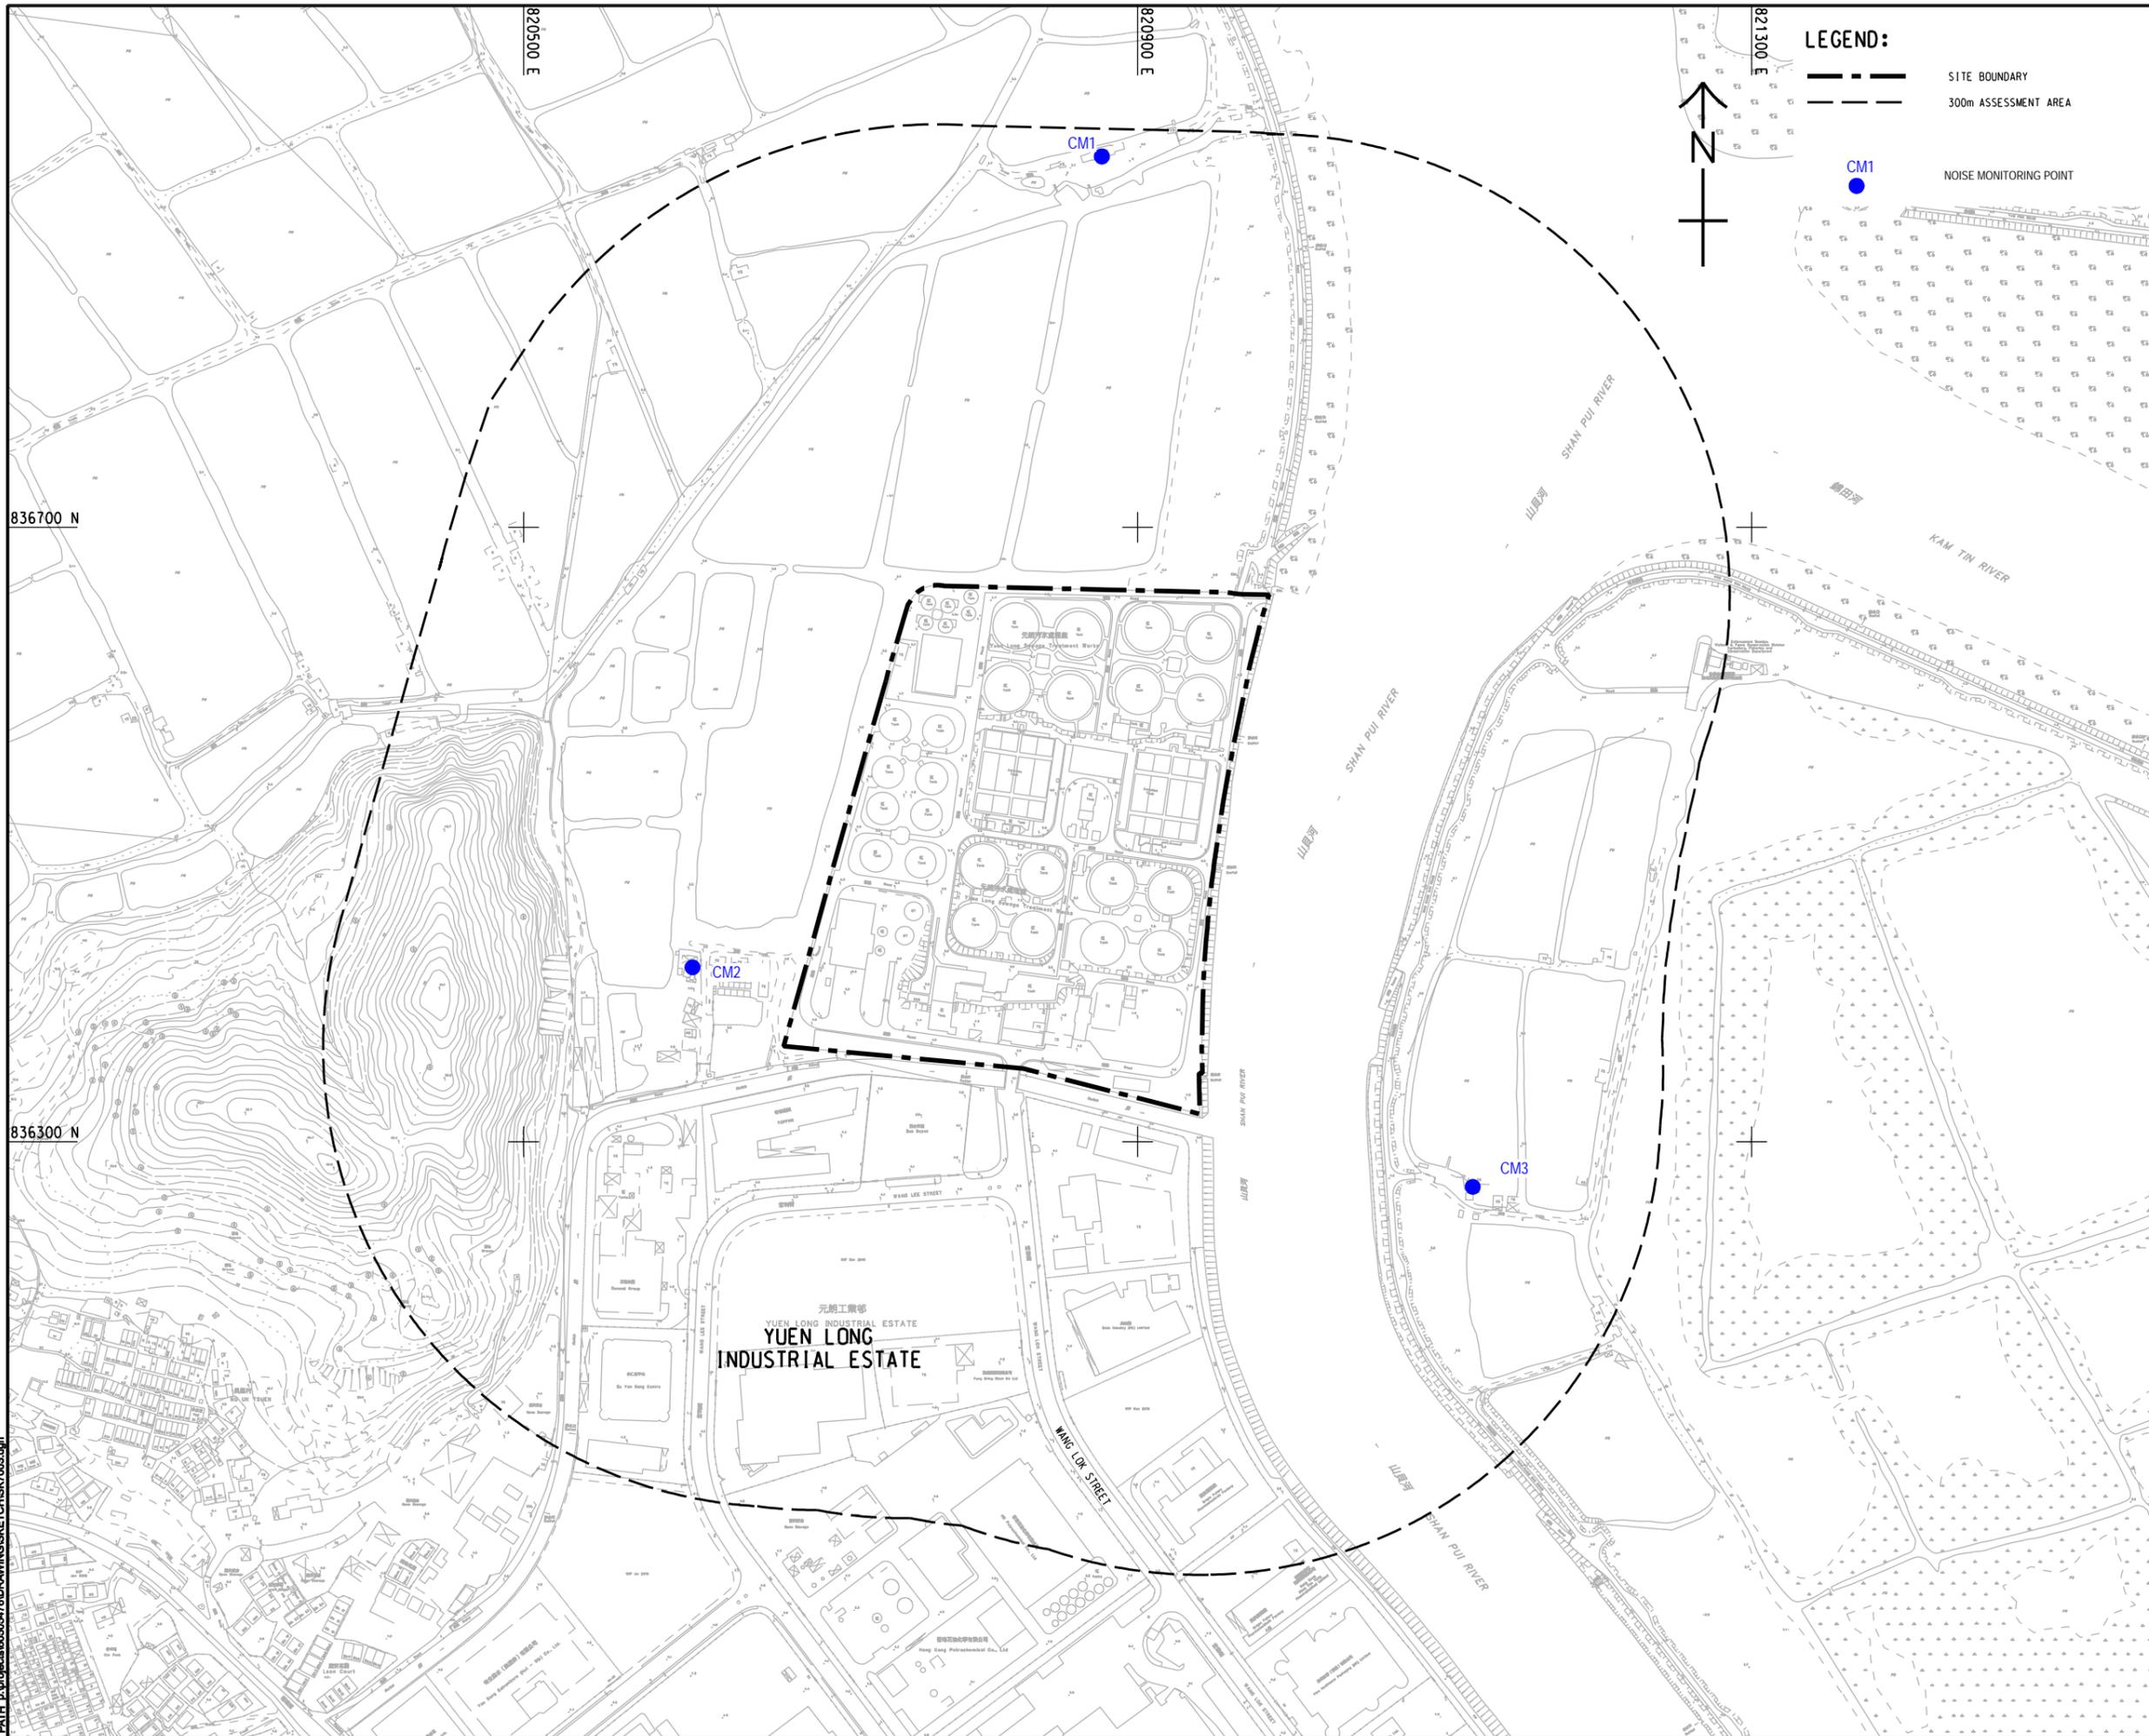
Figure 3

- SITE BOUNDARY
- 300m ASSESSMENT AREA
- NOISE MONITORING POINT

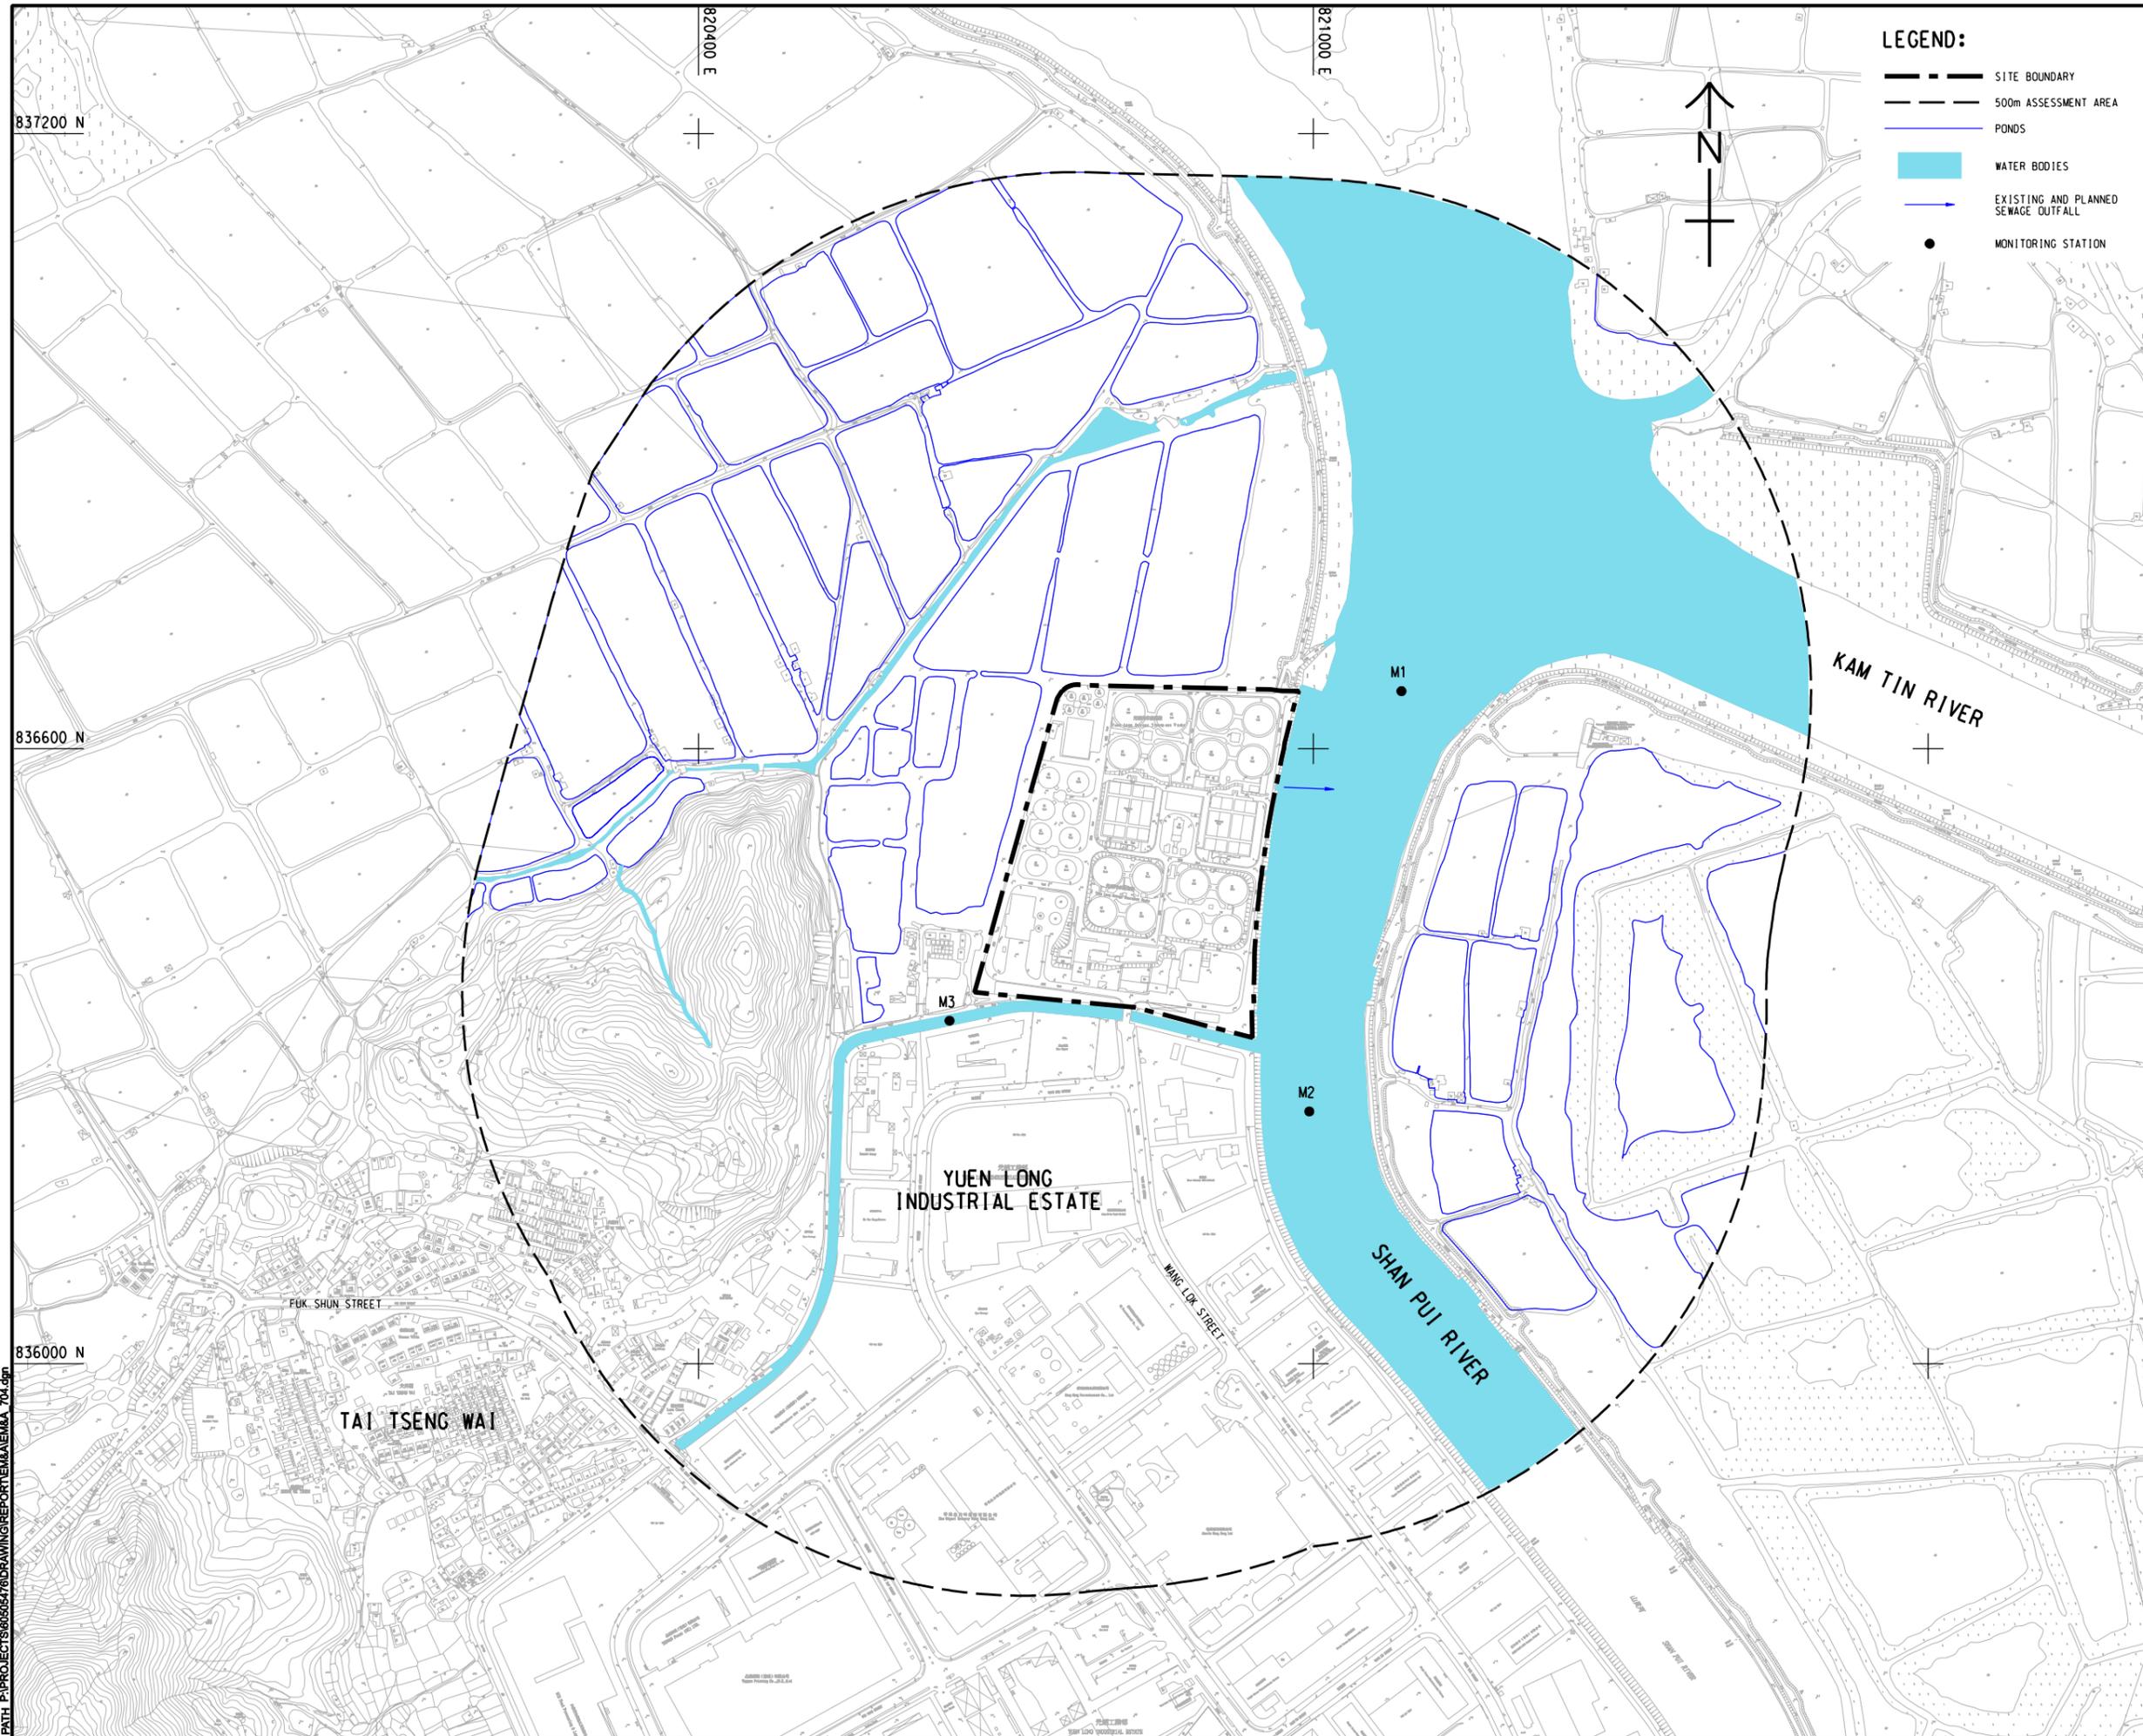
Water Quality Monitoring Locations

- SITE BOUNDARY
- 500m ASSESSMENT AREA
- PONDS
- WATER BODIES
- EXISTING AND PLANNED SEWAGE OUTFALL
- MONITORING STATION

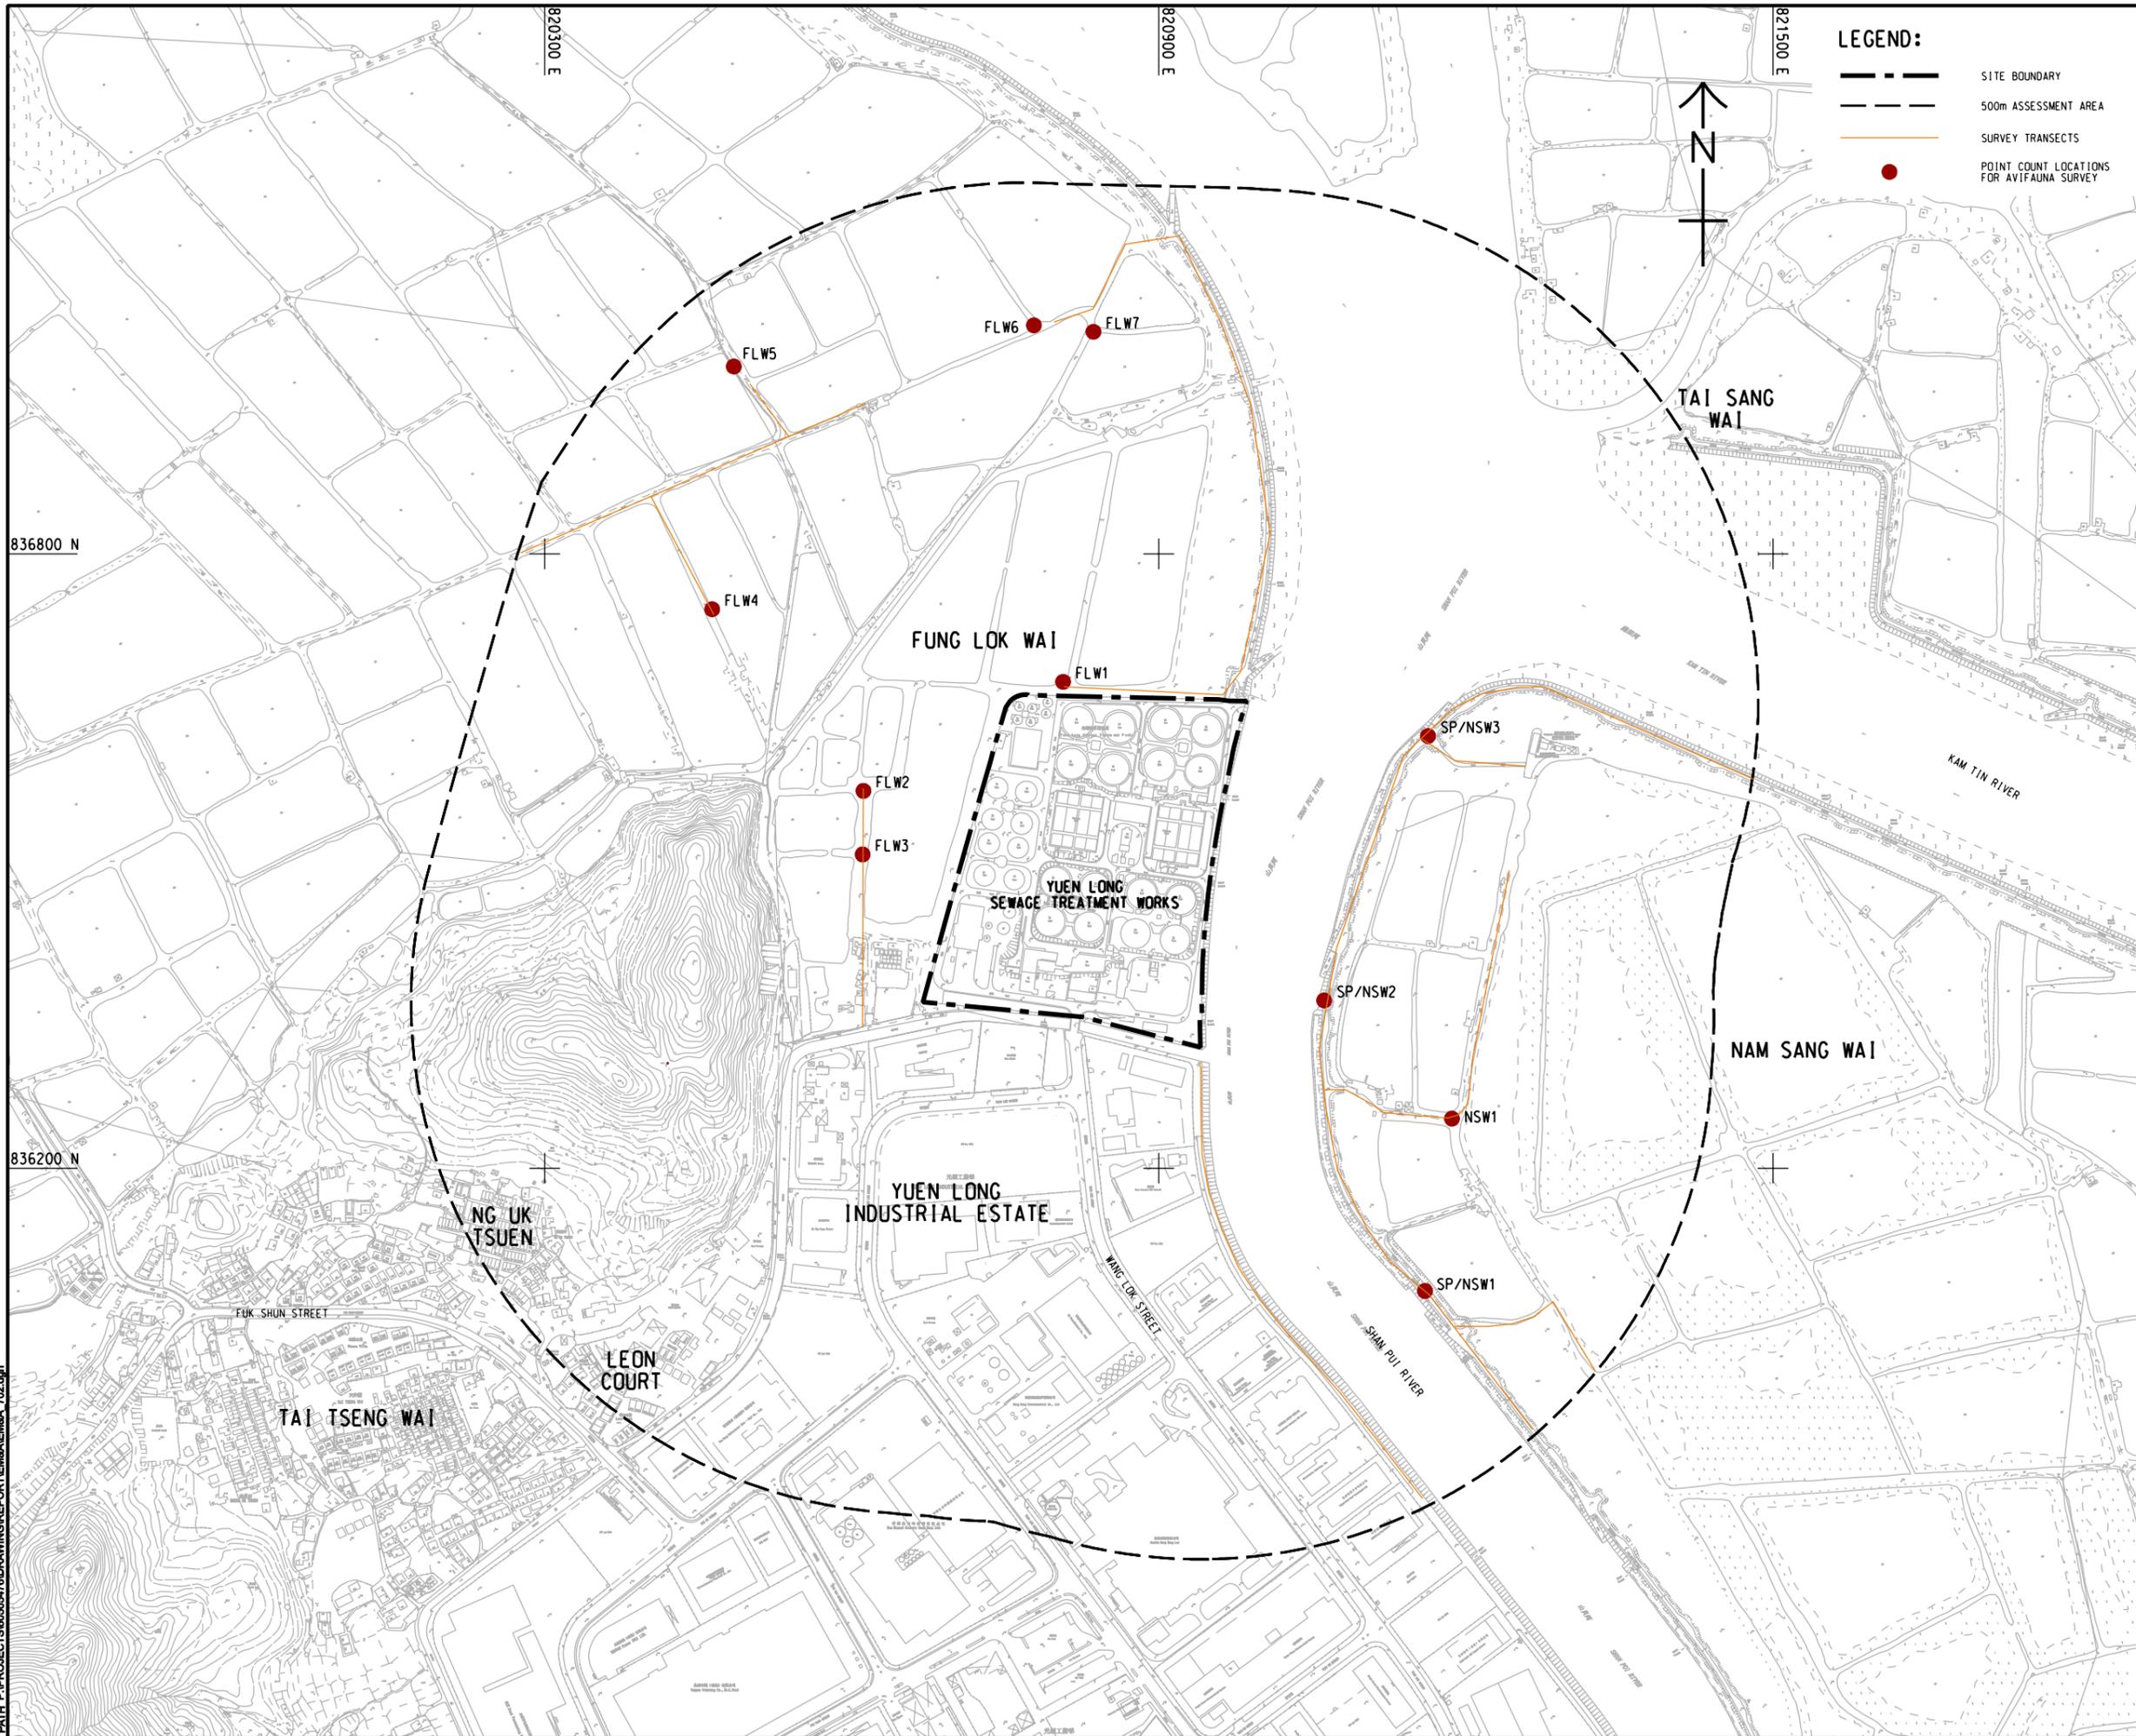
Ecology Monitoring Locations

- SITE BOUNDARY
- 500m ASSESSMENT AREA
- SURVEY TRANSECTS
- POINT COUNT LOCATIONS FOR AVIFAUNA SURVEY

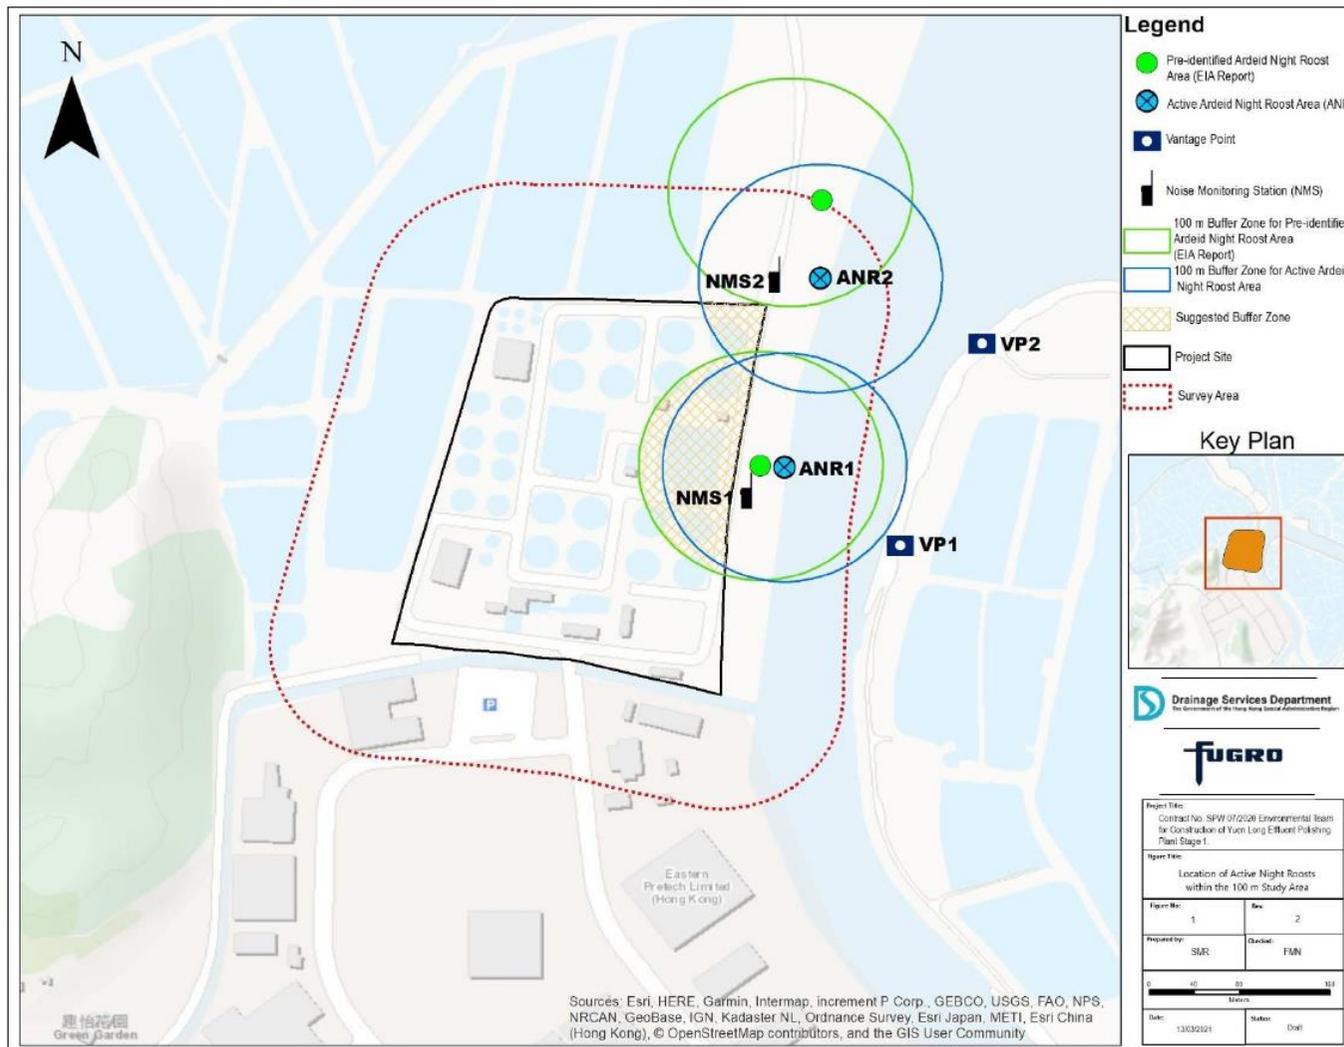
O.1 Map of the Monitoring Area, Vantage Points for Observation of Active Night Roosts and Noise Monitoring Stations

Appendix O.1: Monitoring Area, Vantage Points for Observation of Active Night Roosts and Noise Monitoring Stations

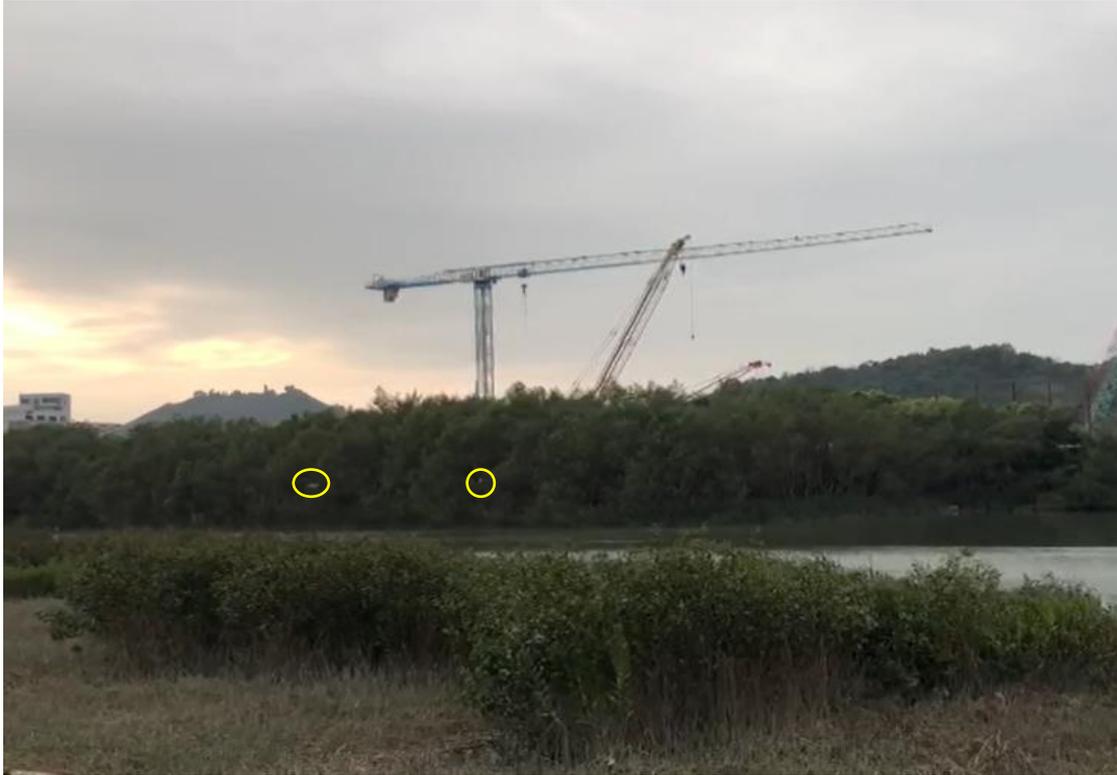
Appendix O.2.1a: Active night roost on *Sonneratia apetala* and *S. caseolaris* mangrove roosting substrate located east of the Project boundary observed on 17 January 2023 around 17:50

For the final night roost at around 17:50, individuals of Chinese Pond Heron *Ardeola bacchus* (9), and Grey Heron *Ardea cinerea* (1) were observed at the roosting area ANR1 utilizing the understory to canopy layer of the roosting substrate *Sonneratia apetala* and *S. caseolaris*; while, other individuals of similar species Chinese Pond Heron (11), and Grey Heron (1) were also noted at ANR2 that utilized the understory to canopy layer of the aforementioned roosting substrate in addition to Little Egret *Egretta garzetta* (8) and Great Egret *Ardea alba* (3) in this area.

No disturbance (construction related and/or otherwise) to the active night roost areas was observed during the period. Bird droppings were observed within the vicinity of the roosting area located east of the Project boundary.

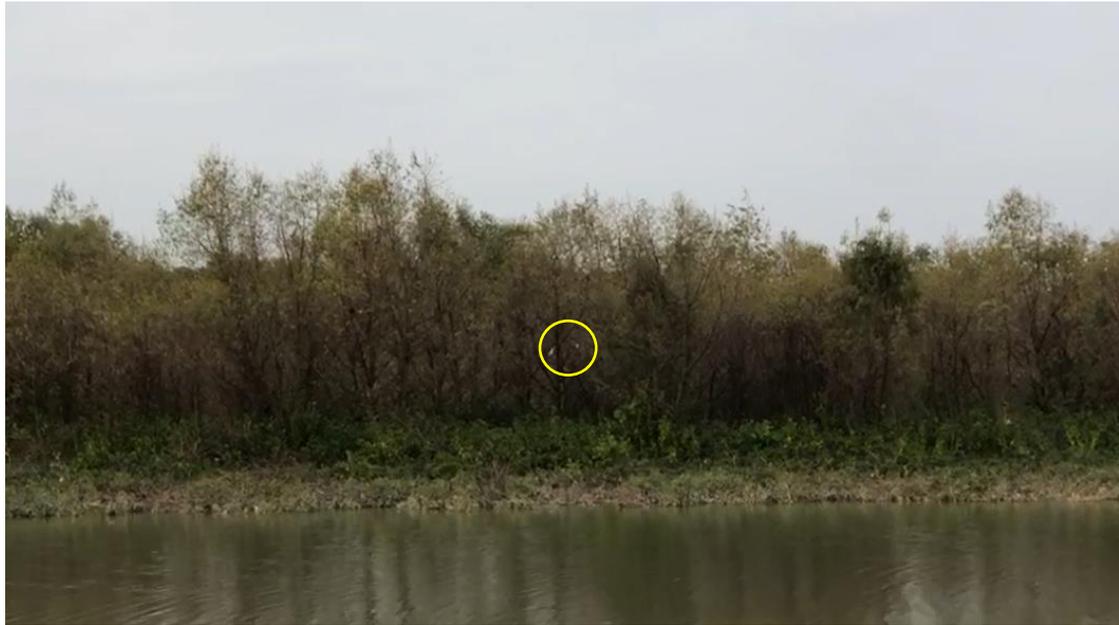
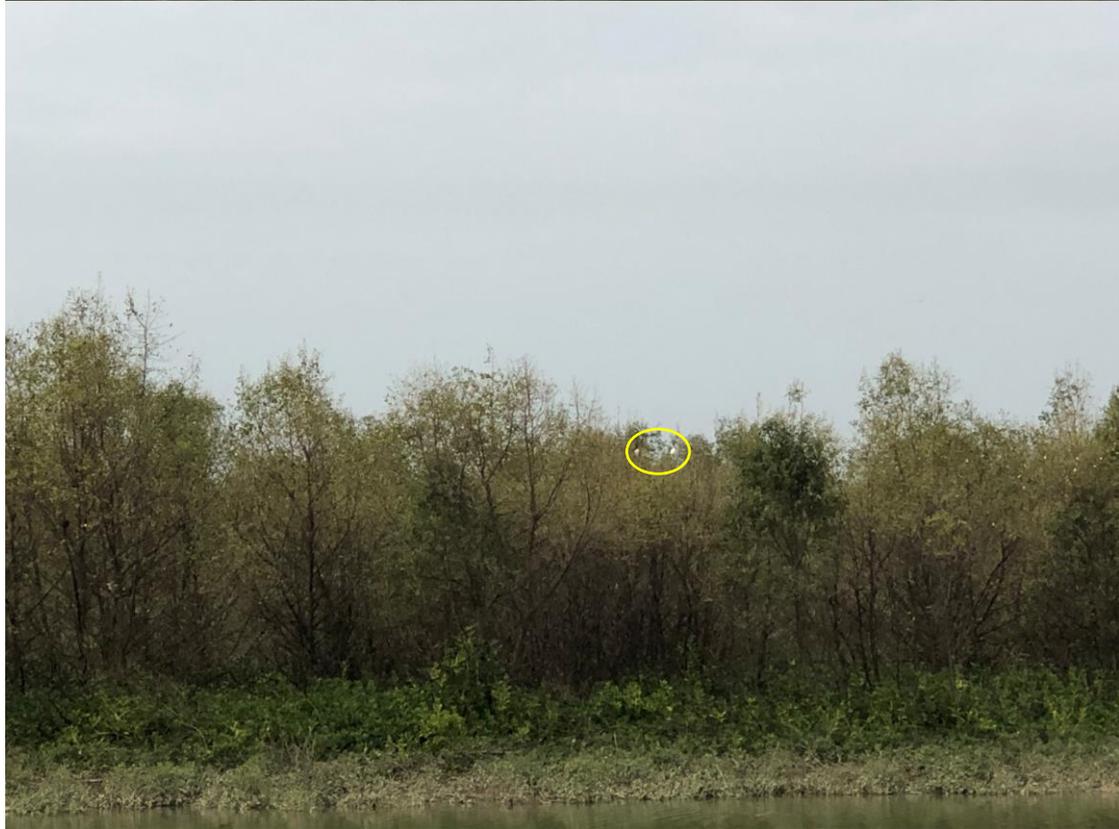
Appendix O.2.1b: Active night roost on *Sonneratia apetala* and *S. caseolaris* mangrove roosting substrate located northeast of the Project boundary observed on 17 January 2023 around 17:50

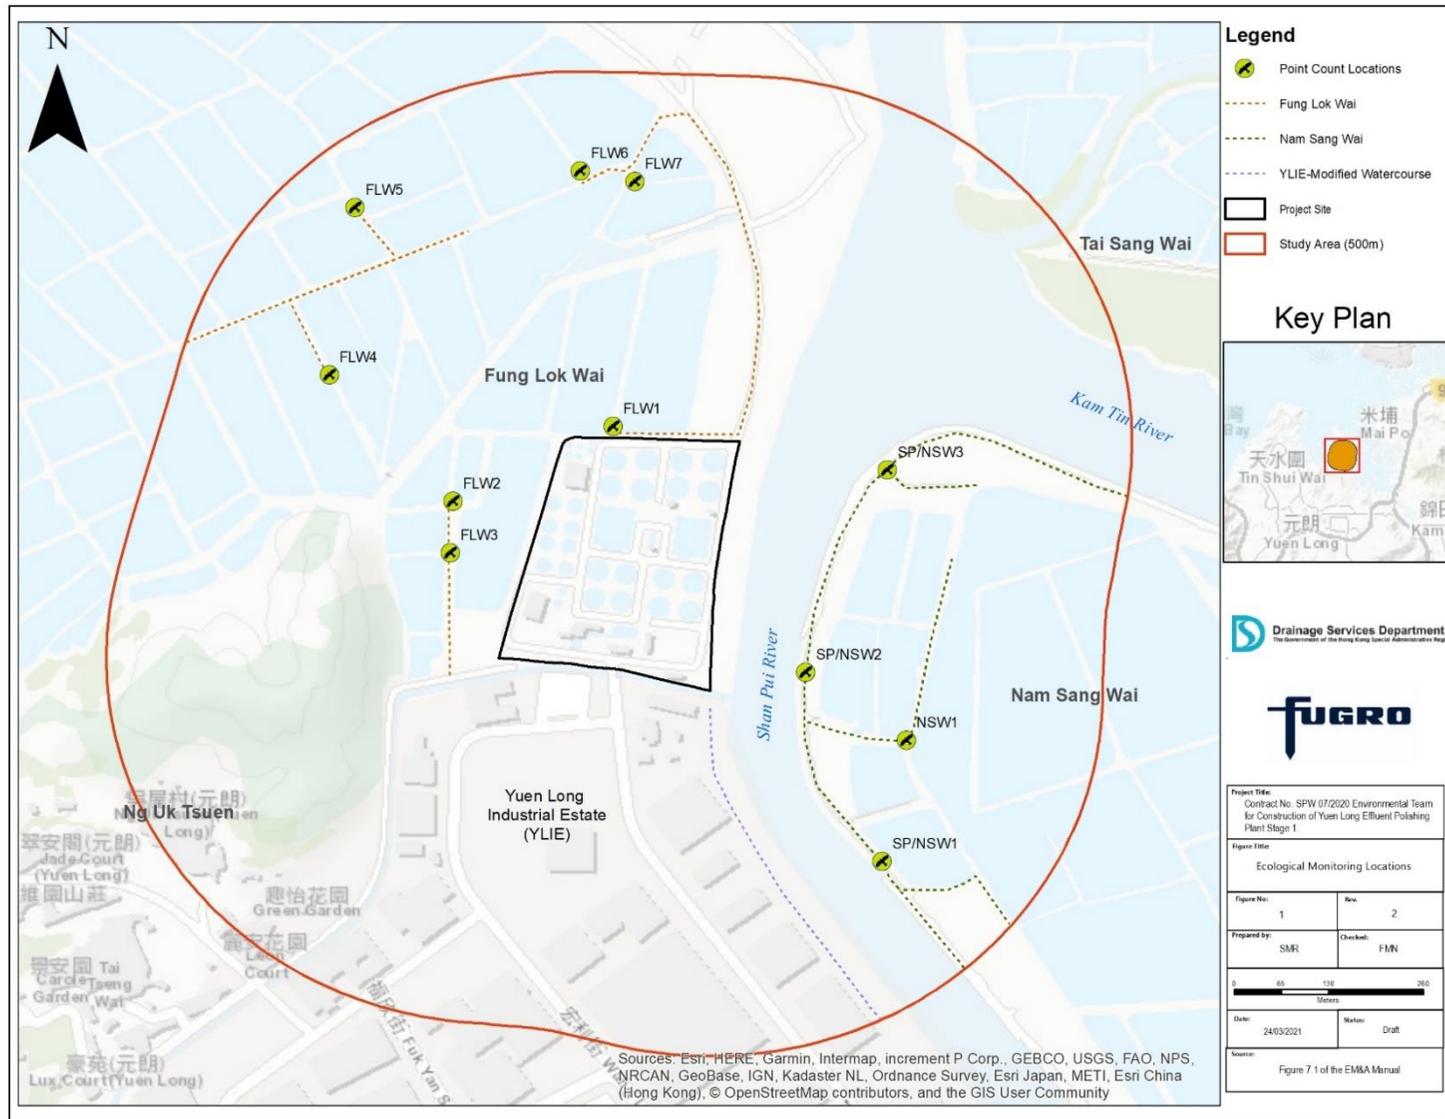
Appendix P: Ecological bird monitoring area with the locations of point count sites and transect routes

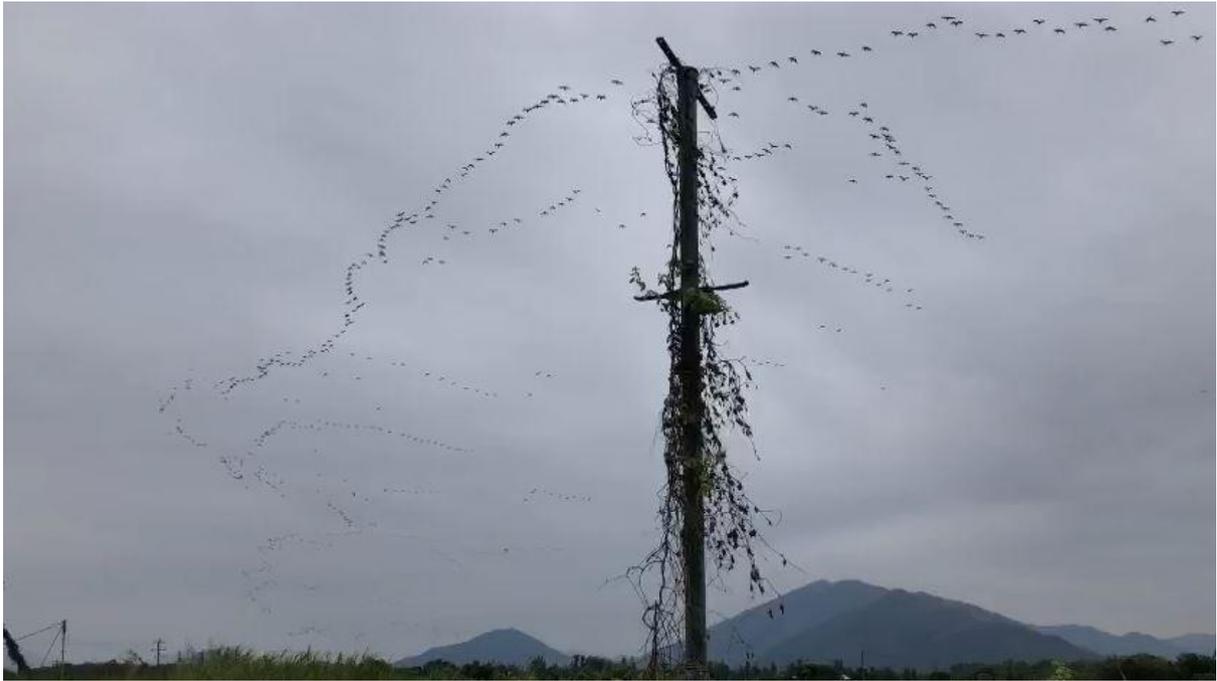
Annex G.1. Flock of Great Cormorants in Fung Lok Wai, far north of the Project Site.

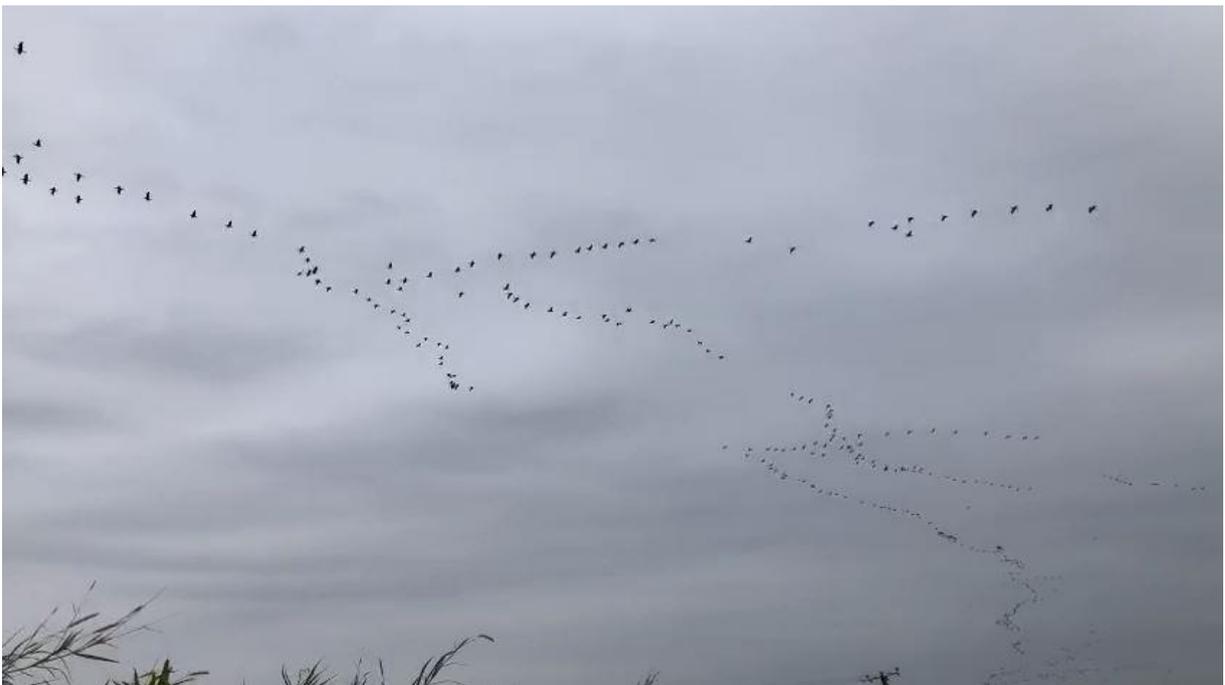
Annex G.2. Flock of Great Cormorants in Fung Lok Wai, far north of the Project Site.
