# Monthly EM&A Report (August 2022)

Contract No. SPW 07/2020 Environmental Team for Construction of Yuen Long Effluent Polishing Plant Stage 1

Independent Environmental Checker for Construction of Yuen Long Effluent Polishing Plant Stage 1 (2022-2023)

**Environmental Permit No. EP-565/2019**

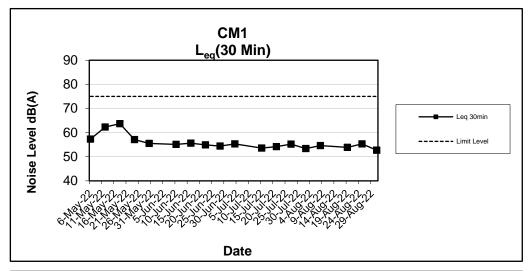
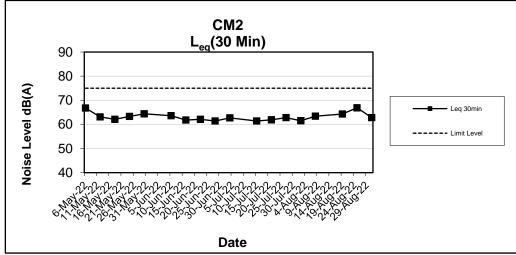
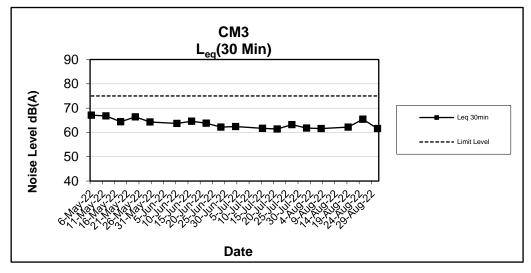
**Noise Monitoring Results**

CM1, CM2 and CM3: Free-field measurement (+3dB(A) correction has been applied).

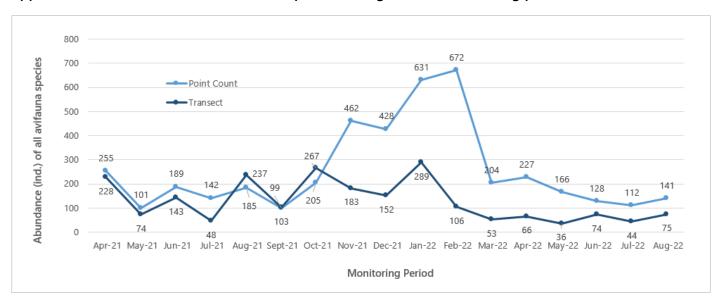
Appendix F.3.1 Abundance of all avifauna species throughout the monitoring period

An overall total of 216 avifauna individuals was recorded in the monitoring area during the August 2022 monitoring period, of which 141 individuals were recorded from the point count method and 75 individuals from the transect walk method. Relative to the August 2016 baseline data (point count method = 160; and transect walk = 140), current decreases in total abundance for the point count method (t-value = 0.22; p-value = 0.83;  $\alpha$  = 0.05); and transect walk method (t-value = 0.21; p-value = 0.83;  $\alpha$  = 0.05) were observed. These decreases are

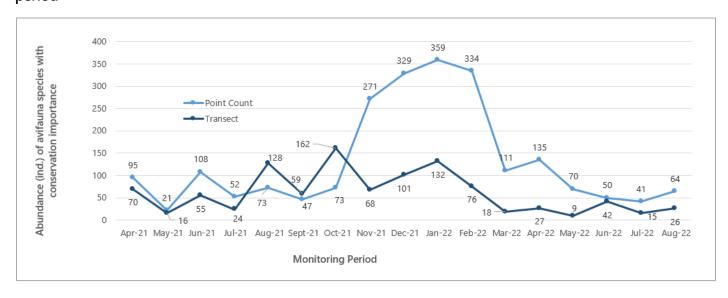
Appendix F.3.2 Abundance of avifauna species with conservation importance throughout the monitoring period

Of the 216 avifauna individuals recorded in the monitoring area during the August 2022 monitoring period, 90 individuals (point count method = 64 individuals; transect walk method = 26 individuals) were of conservation importance. With reference to August 2016 data, current results showed decreases in total abundance for the point count method (t-value = -0.20; p-value = 0.84;  $\alpha$  = 0.05); and in transect walk method (t-value = 1.78; p-value = 0.09;  $\alpha$  = 0.05) results were noted. Details of these findings are summarized in **Table 5.6**; and **Appendices F.6.3** and **F.6.4**.

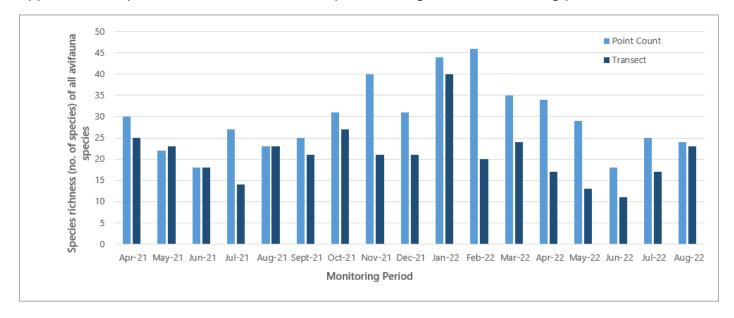
Appendix F.4.1 Species richness of all avifauna species throughout the monitoring period

A total of 30 avifauna species (species richness) were recorded during the August 2022 monitoring period, of which, 24 species were recorded by the point count method while 23 species were noted by the transect walk method. Relative to the baseline data (point count method = 26 species; transect walk method = 30 species), decreases in total species richness for both the point count and transect walk methods were noted. In terms of Shannon diversity index (H') values, current result in point count method showed no change from baseline reference value while an increase in transect walk method was noted. Details of these findings are summarized in **Table 5.7**.

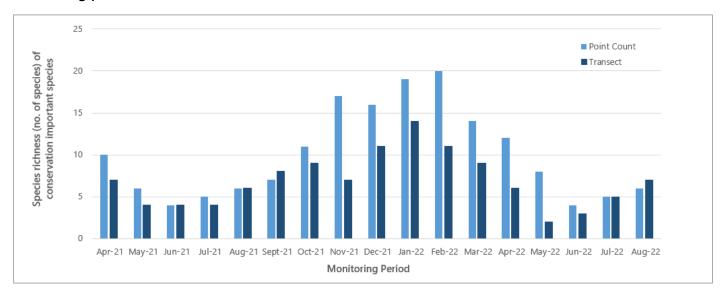
Appendix F.4.2 Species richness of avifauna species with conservation importance throughout the monitoring period

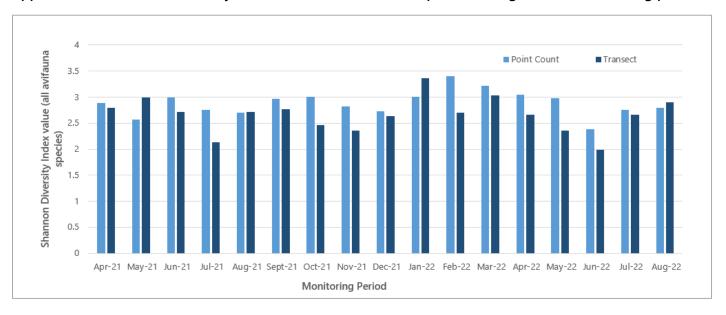
Appendix F.5.1 Shannon Diversity Index values of all avifauna species throughout the monitoring period

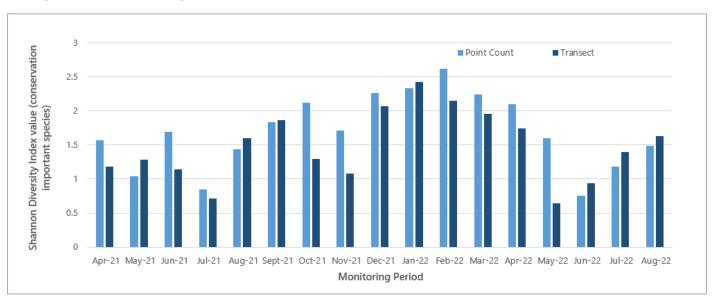
Appendix F.5.2 Shannon Diversity Index values of avifauna species with conservation importance throughout the monitoring period

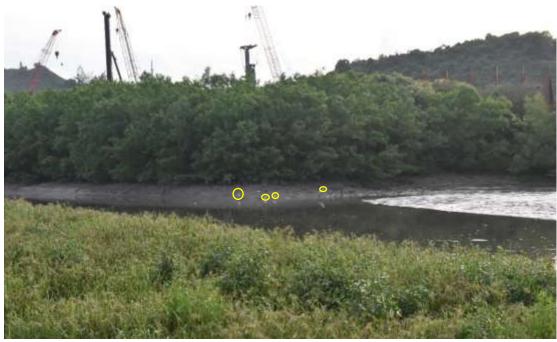
Appendix O.2.1a: Pre-roost aggregate of Chinese Pond heron *Ardeola bacchus*, Great Egret *Ardea alba*, and Little Egret *Egretta garzetta* in the mudflat area east of the Project boundary observed on 12 August 2022 around 18:40

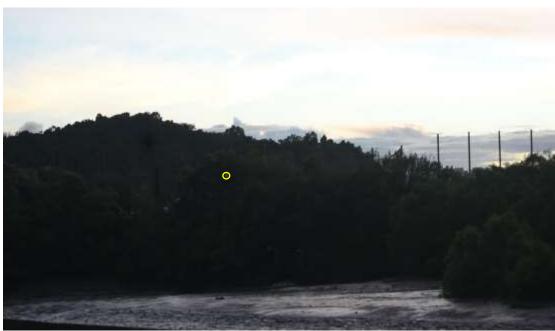
Appendix O.2.2a: Active night roost on *Sonneratia apetala* and *S. caseolaris* mangrove roosting substrate located east of the Project boundary observed on 12 August 2022 around 19:02

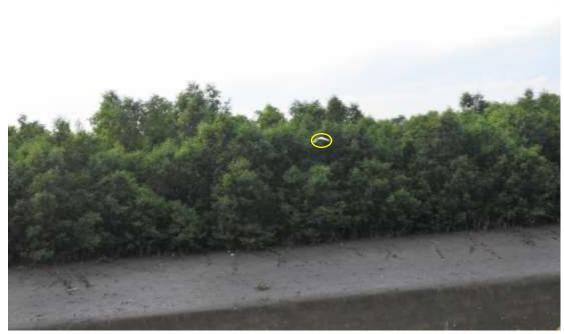
Appendix O.2.2b: One of the individuals using the active night roost with *Sonneratia apetala* and *S. caseolaris* mangrove roosting substrate located northeast of the Project boundary observed on 12 August 2022 around 19:02

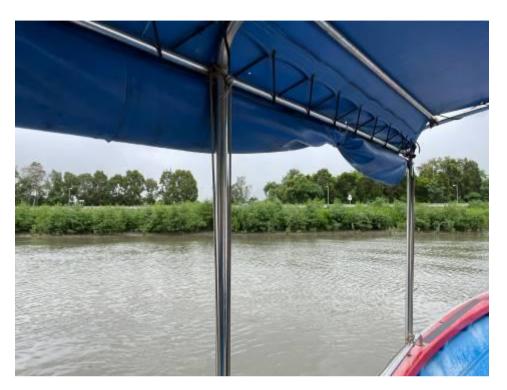
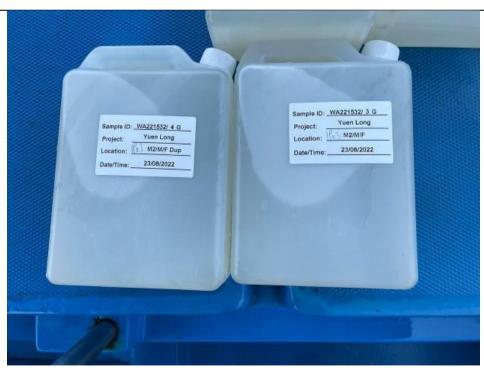
Monitoring Station: M2

Date of investigation: 23 August 2022 (Flood Tide)

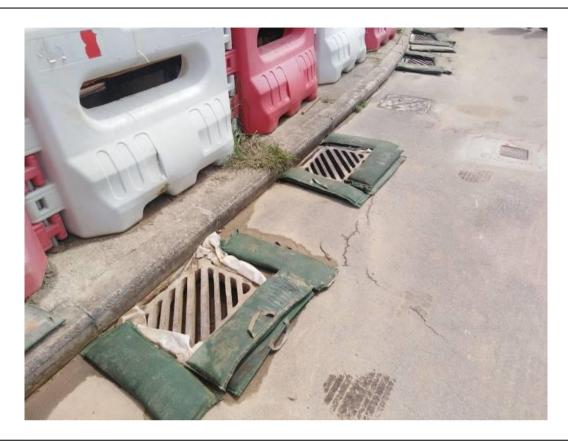
Annex D – Site Inspection

Date of site inspection: 24 August 2022 Gullies were bunded by sand bags to prevent surface runoff.
