# Monthly EM&A Report (June 2022)

0120/20/ED/0489 01

**Contract No. SPW 07/2020 Environmental Team for Construction of Yuen Long Effluent Polishing Plant Stage 1**

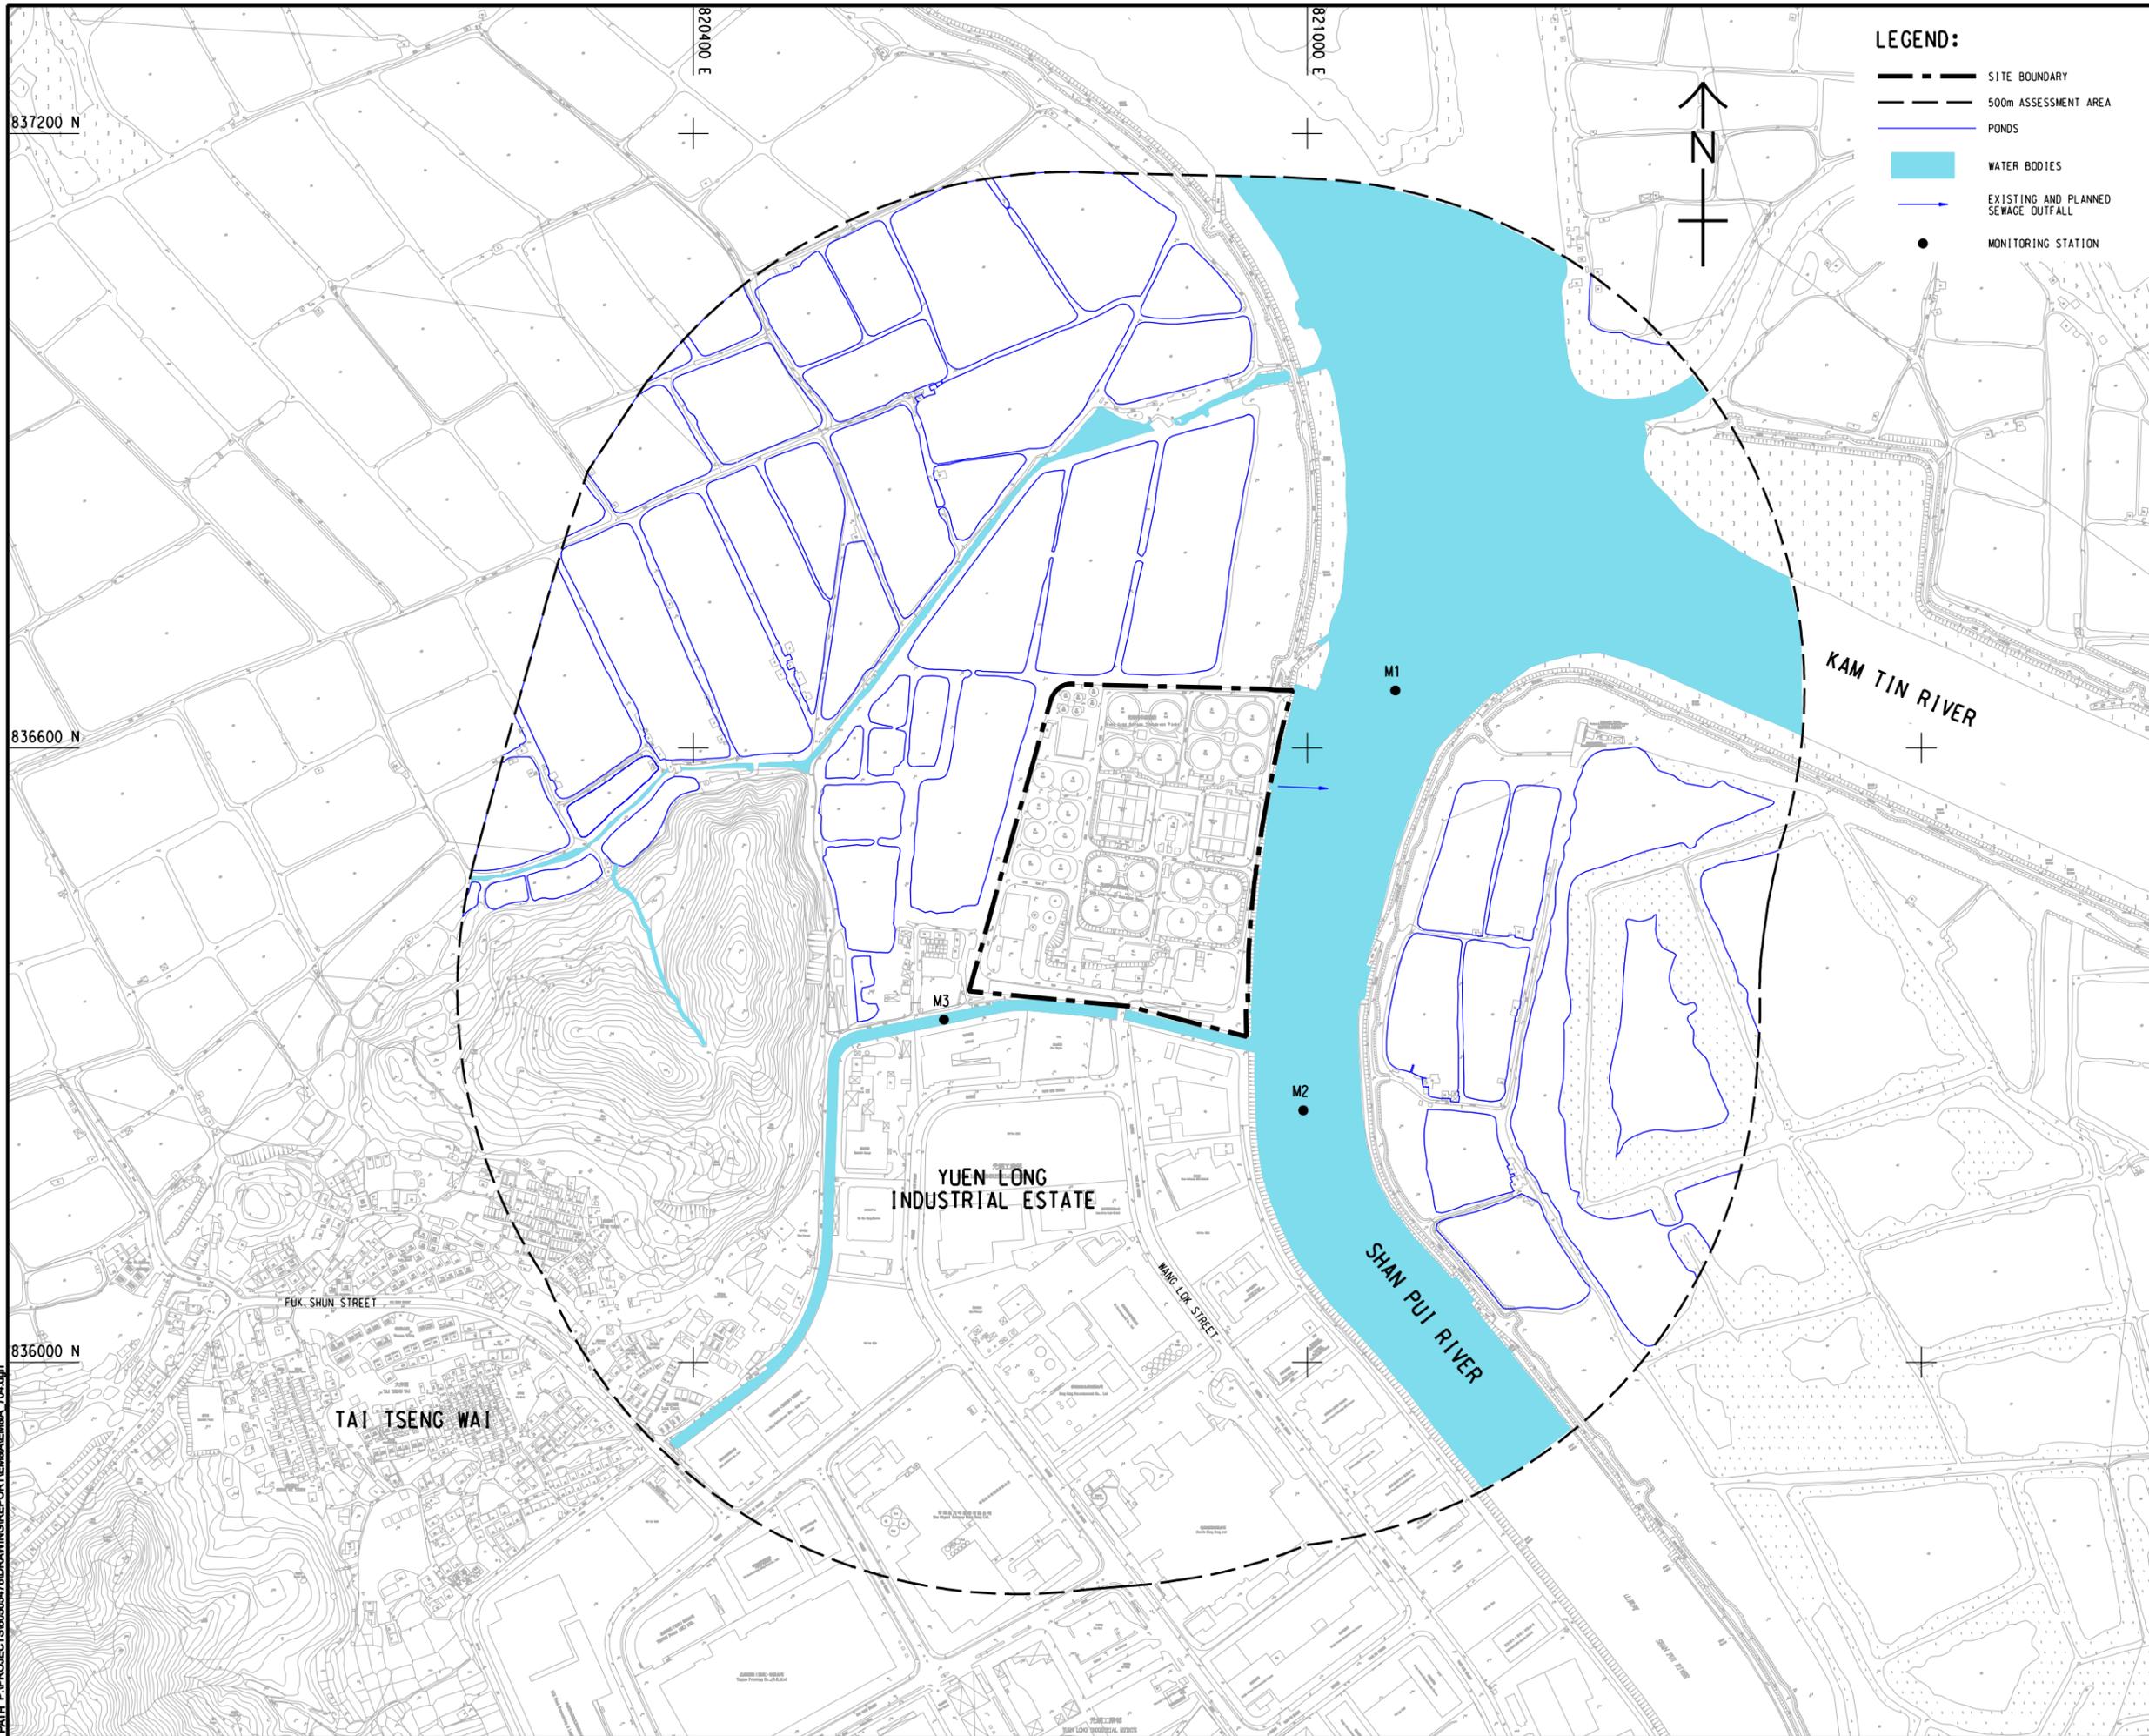
Water Quality Monitoring Locations

- SITE BOUNDARY
- 500m ASSESSMENT AREA
- PONDS
- WATER BODIES
- EXISTING AND PLANNED SEWAGE OUTFALL
- MONITORING STATION

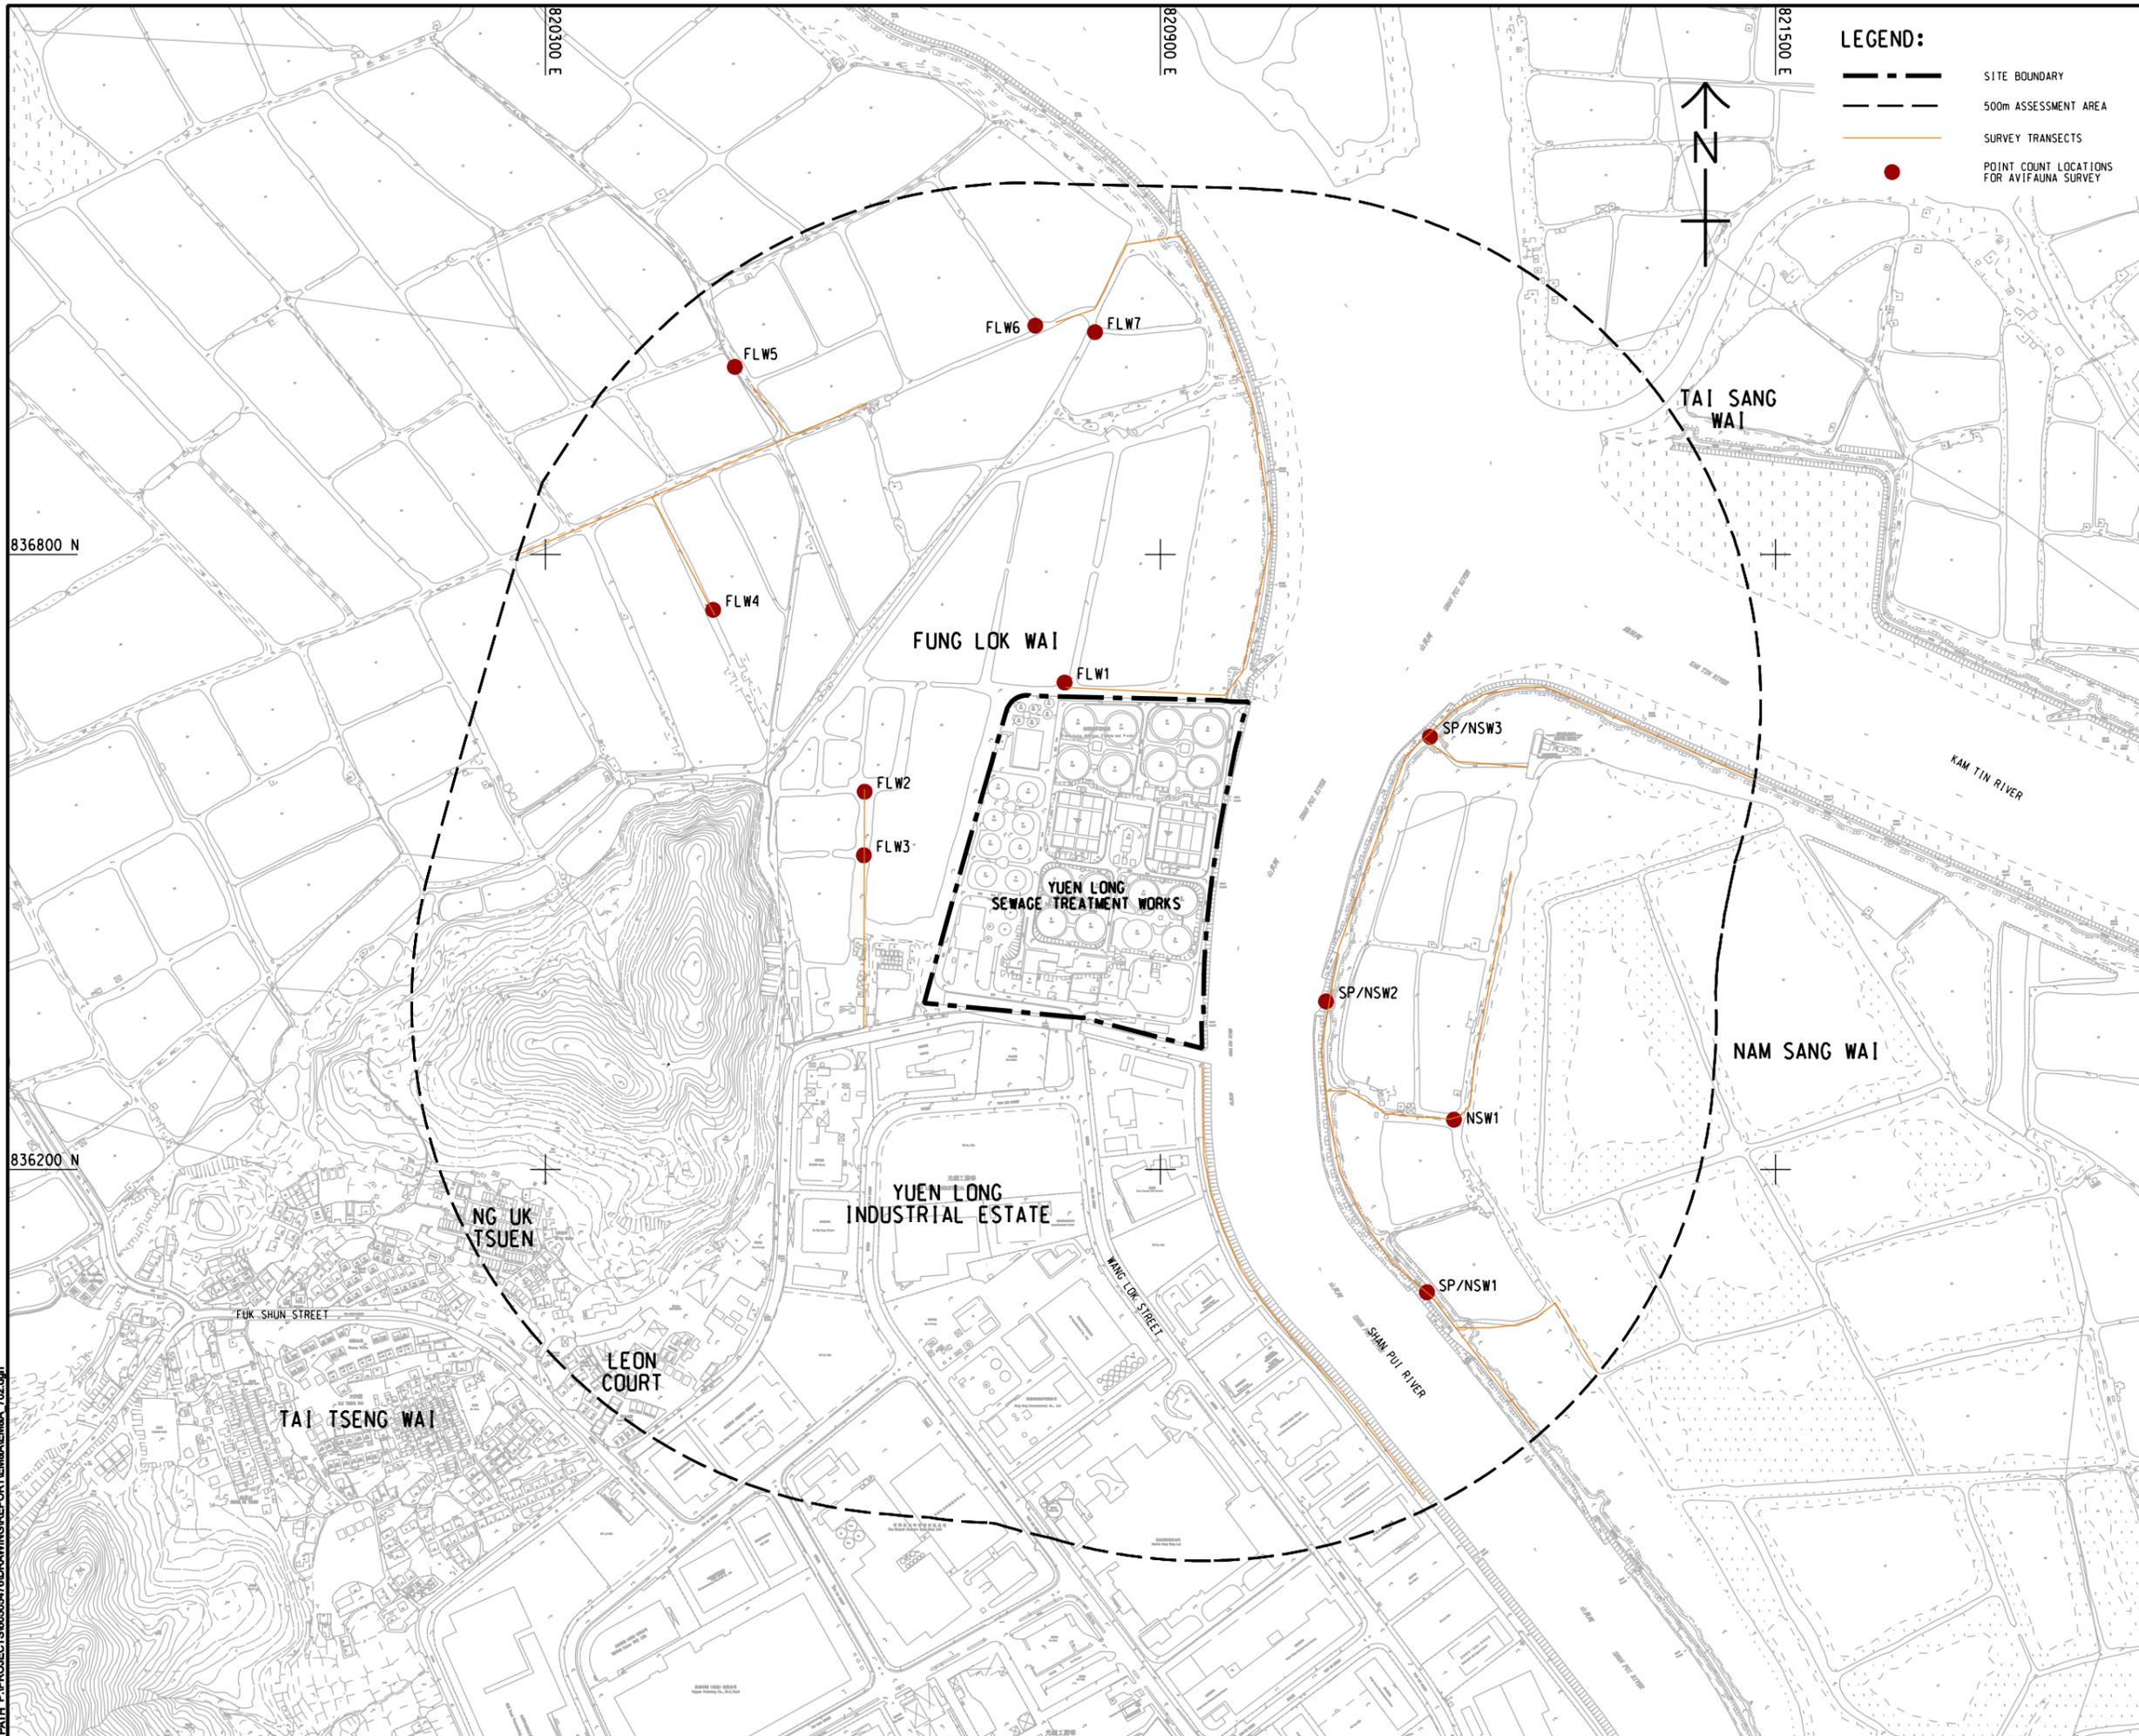
Ecology Monitoring Locations

- SITE BOUNDARY
- 500m ASSESSMENT AREA
- SURVEY TRANSECTS
- POINT COUNT LOCATIONS FOR AVIFAUNA SURVEY

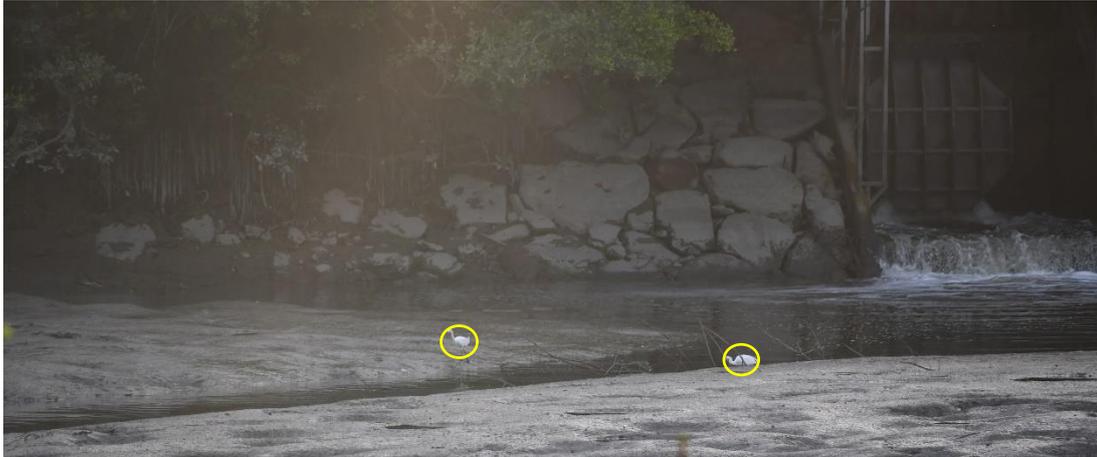
Appendix O.2.1a: Pre-roost aggregate of Little Egret *Egretta garzetta* in the mudflat area east of the Project boundary observed on 17 June 2022 around 19:05

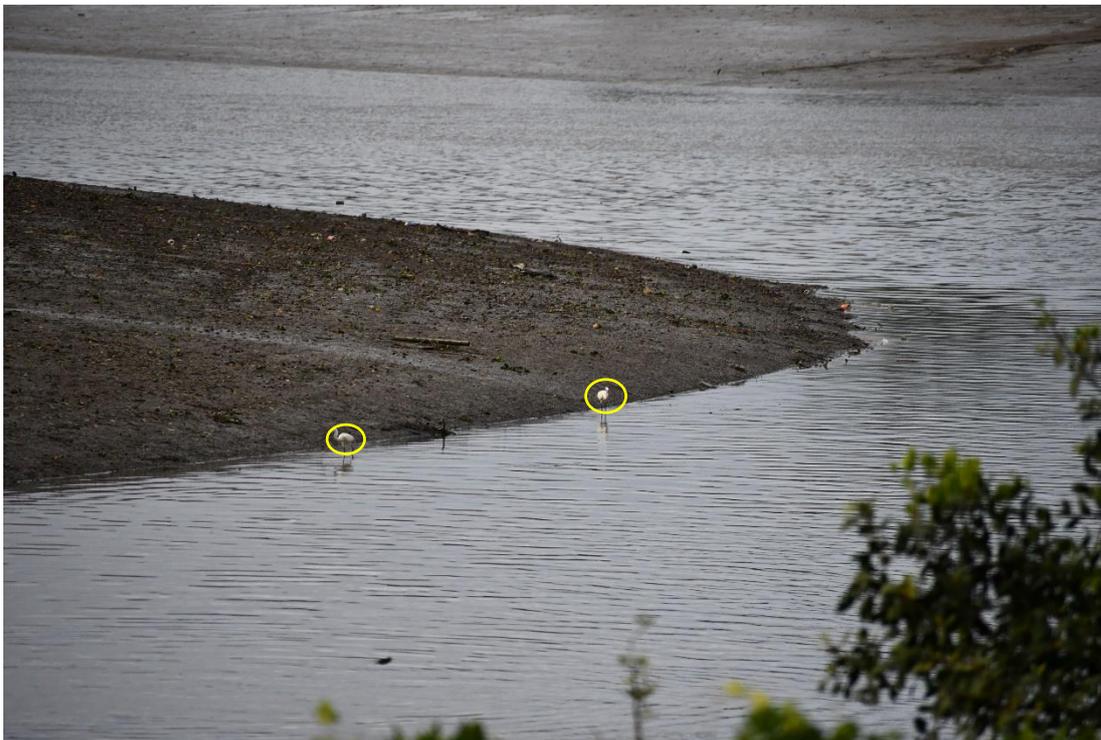
Appendix O.2.1b: Pre-roost aggregate of Little Egret *Egretta garzetta* in the mudflat area northeast of the Project boundary observed on 17 June 2022 around 19:05

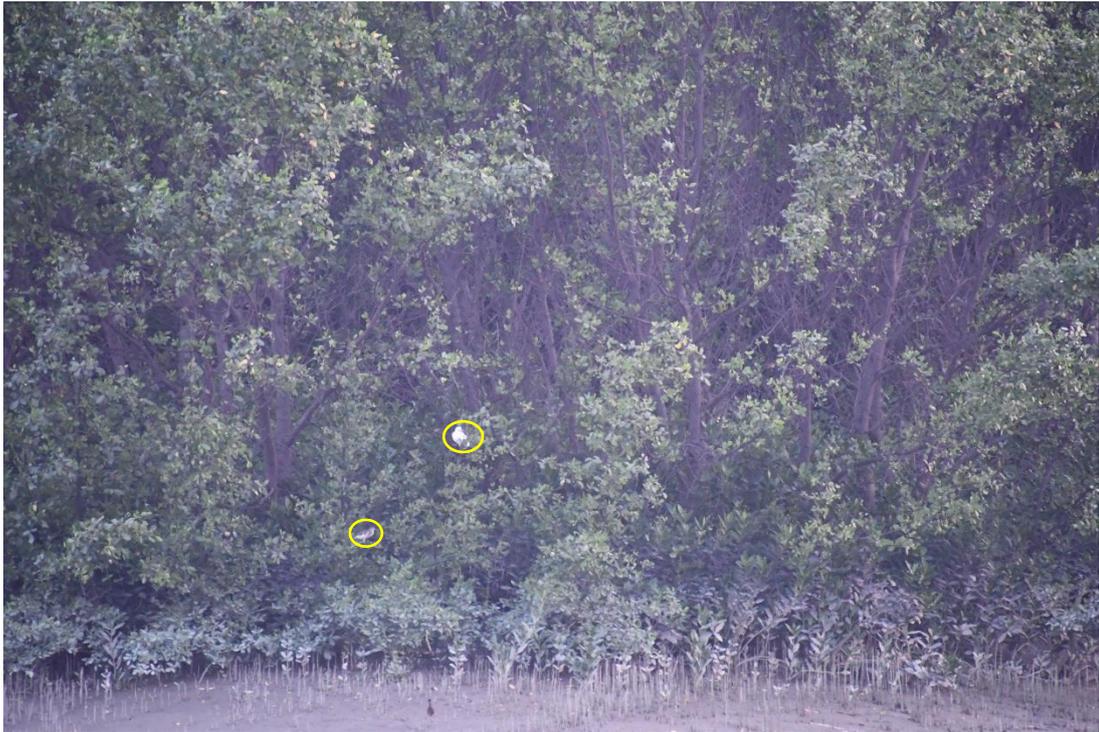
For the final night roost at around 19:21, Chinese Pond Heron (1 individual) and Little Egret (1 individual) were observed at the roosting area ANR1 utilizing the understory layer of the roosting substrate *Sonneratia apetala* and *S. caseolaris*; concurrently, similar two species (Chinese Pond Heron with 3 individuals; and Little Egret with 2 individuals) were also noted at ANR2 that utilized the canopy layer of the aforementioned roosting substrate.

No disturbance (construction related and/or otherwise) to the active night roost areas was observed during the period. Bird droppings were observed within the vicinity of the roosting area located east of the Project boundary.

Appendix O.2.2a: Active night roost on *Sonneratia apetala* and *S. caseolaris* mangrove roosting substrate located east of the Project boundary observed on 17 June 2022 around 19:21

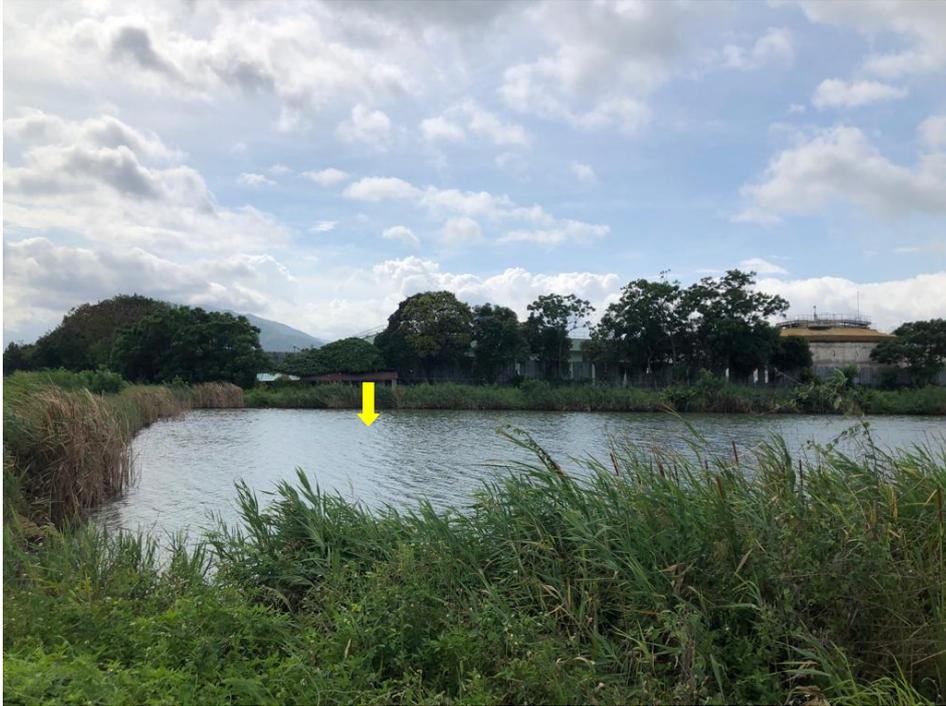
Annex G – Site Photos showing no project-related disturbance during the Ecological Monitoring of Birds  
(June 2022)

Annex G.1. Active Pond at Fung Lok Wai, west of the Project Site

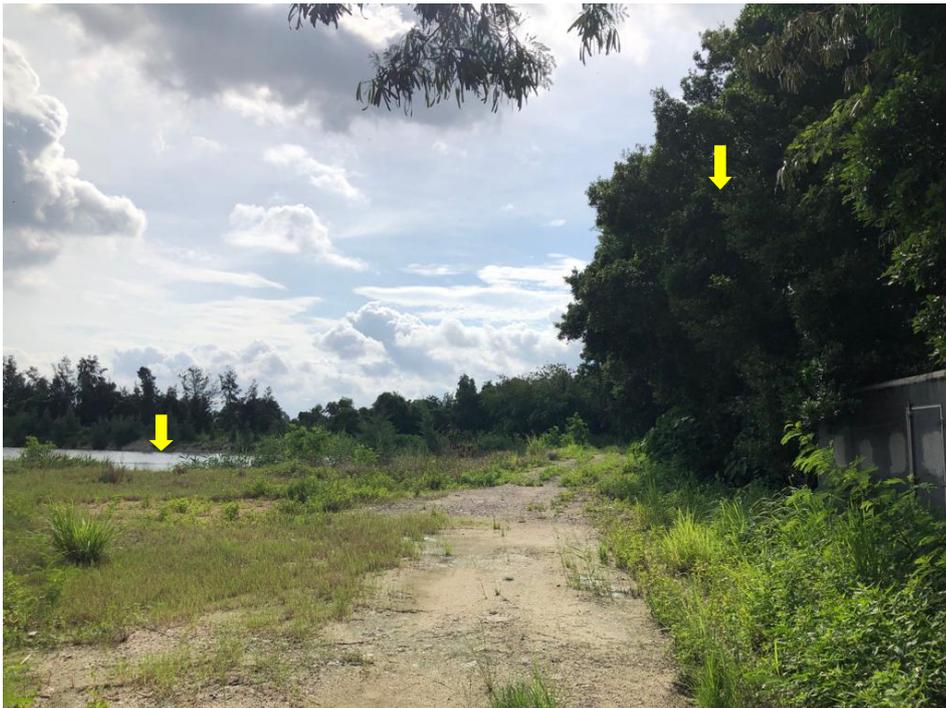
Annex G.2. Active Pond and *Ficus microcarpa* Chinese Pond Heron nesting site at Fung Lok Wai, north of the Project Site

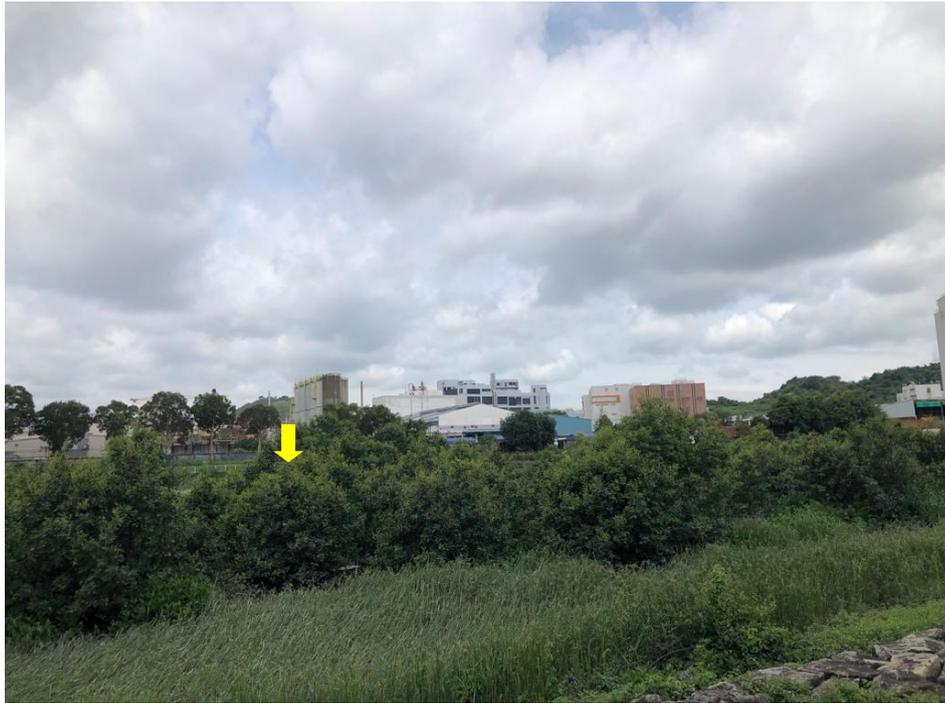
Annex G.3. Mangrove habitat at Nam Sang Wai, east of the Project Site

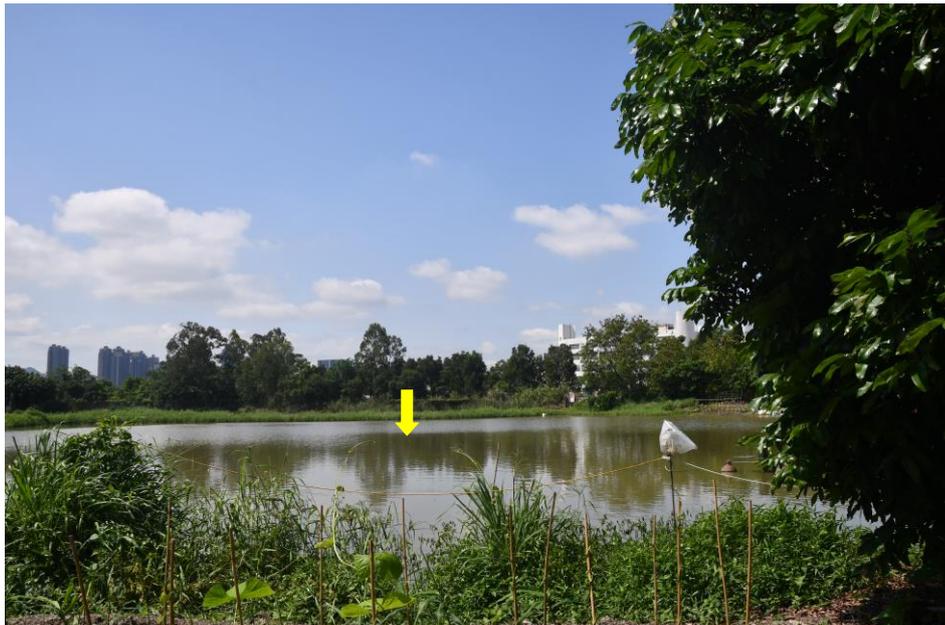
Annex G.4. Active Pond at Nam Sang Wai, far east of the Project Site
