Monthly EM&A Report (July 2021)

0120/20/ED/0368 04

Contract No. SPW 07/2020 Environmental Team for Construction of Yuen Long Effluent Polishing Plant Stage 1 Contract No. SPW 07/2020 Environmental Team for Construction of Yuen Long Effluent Polishing Plant Stage 1

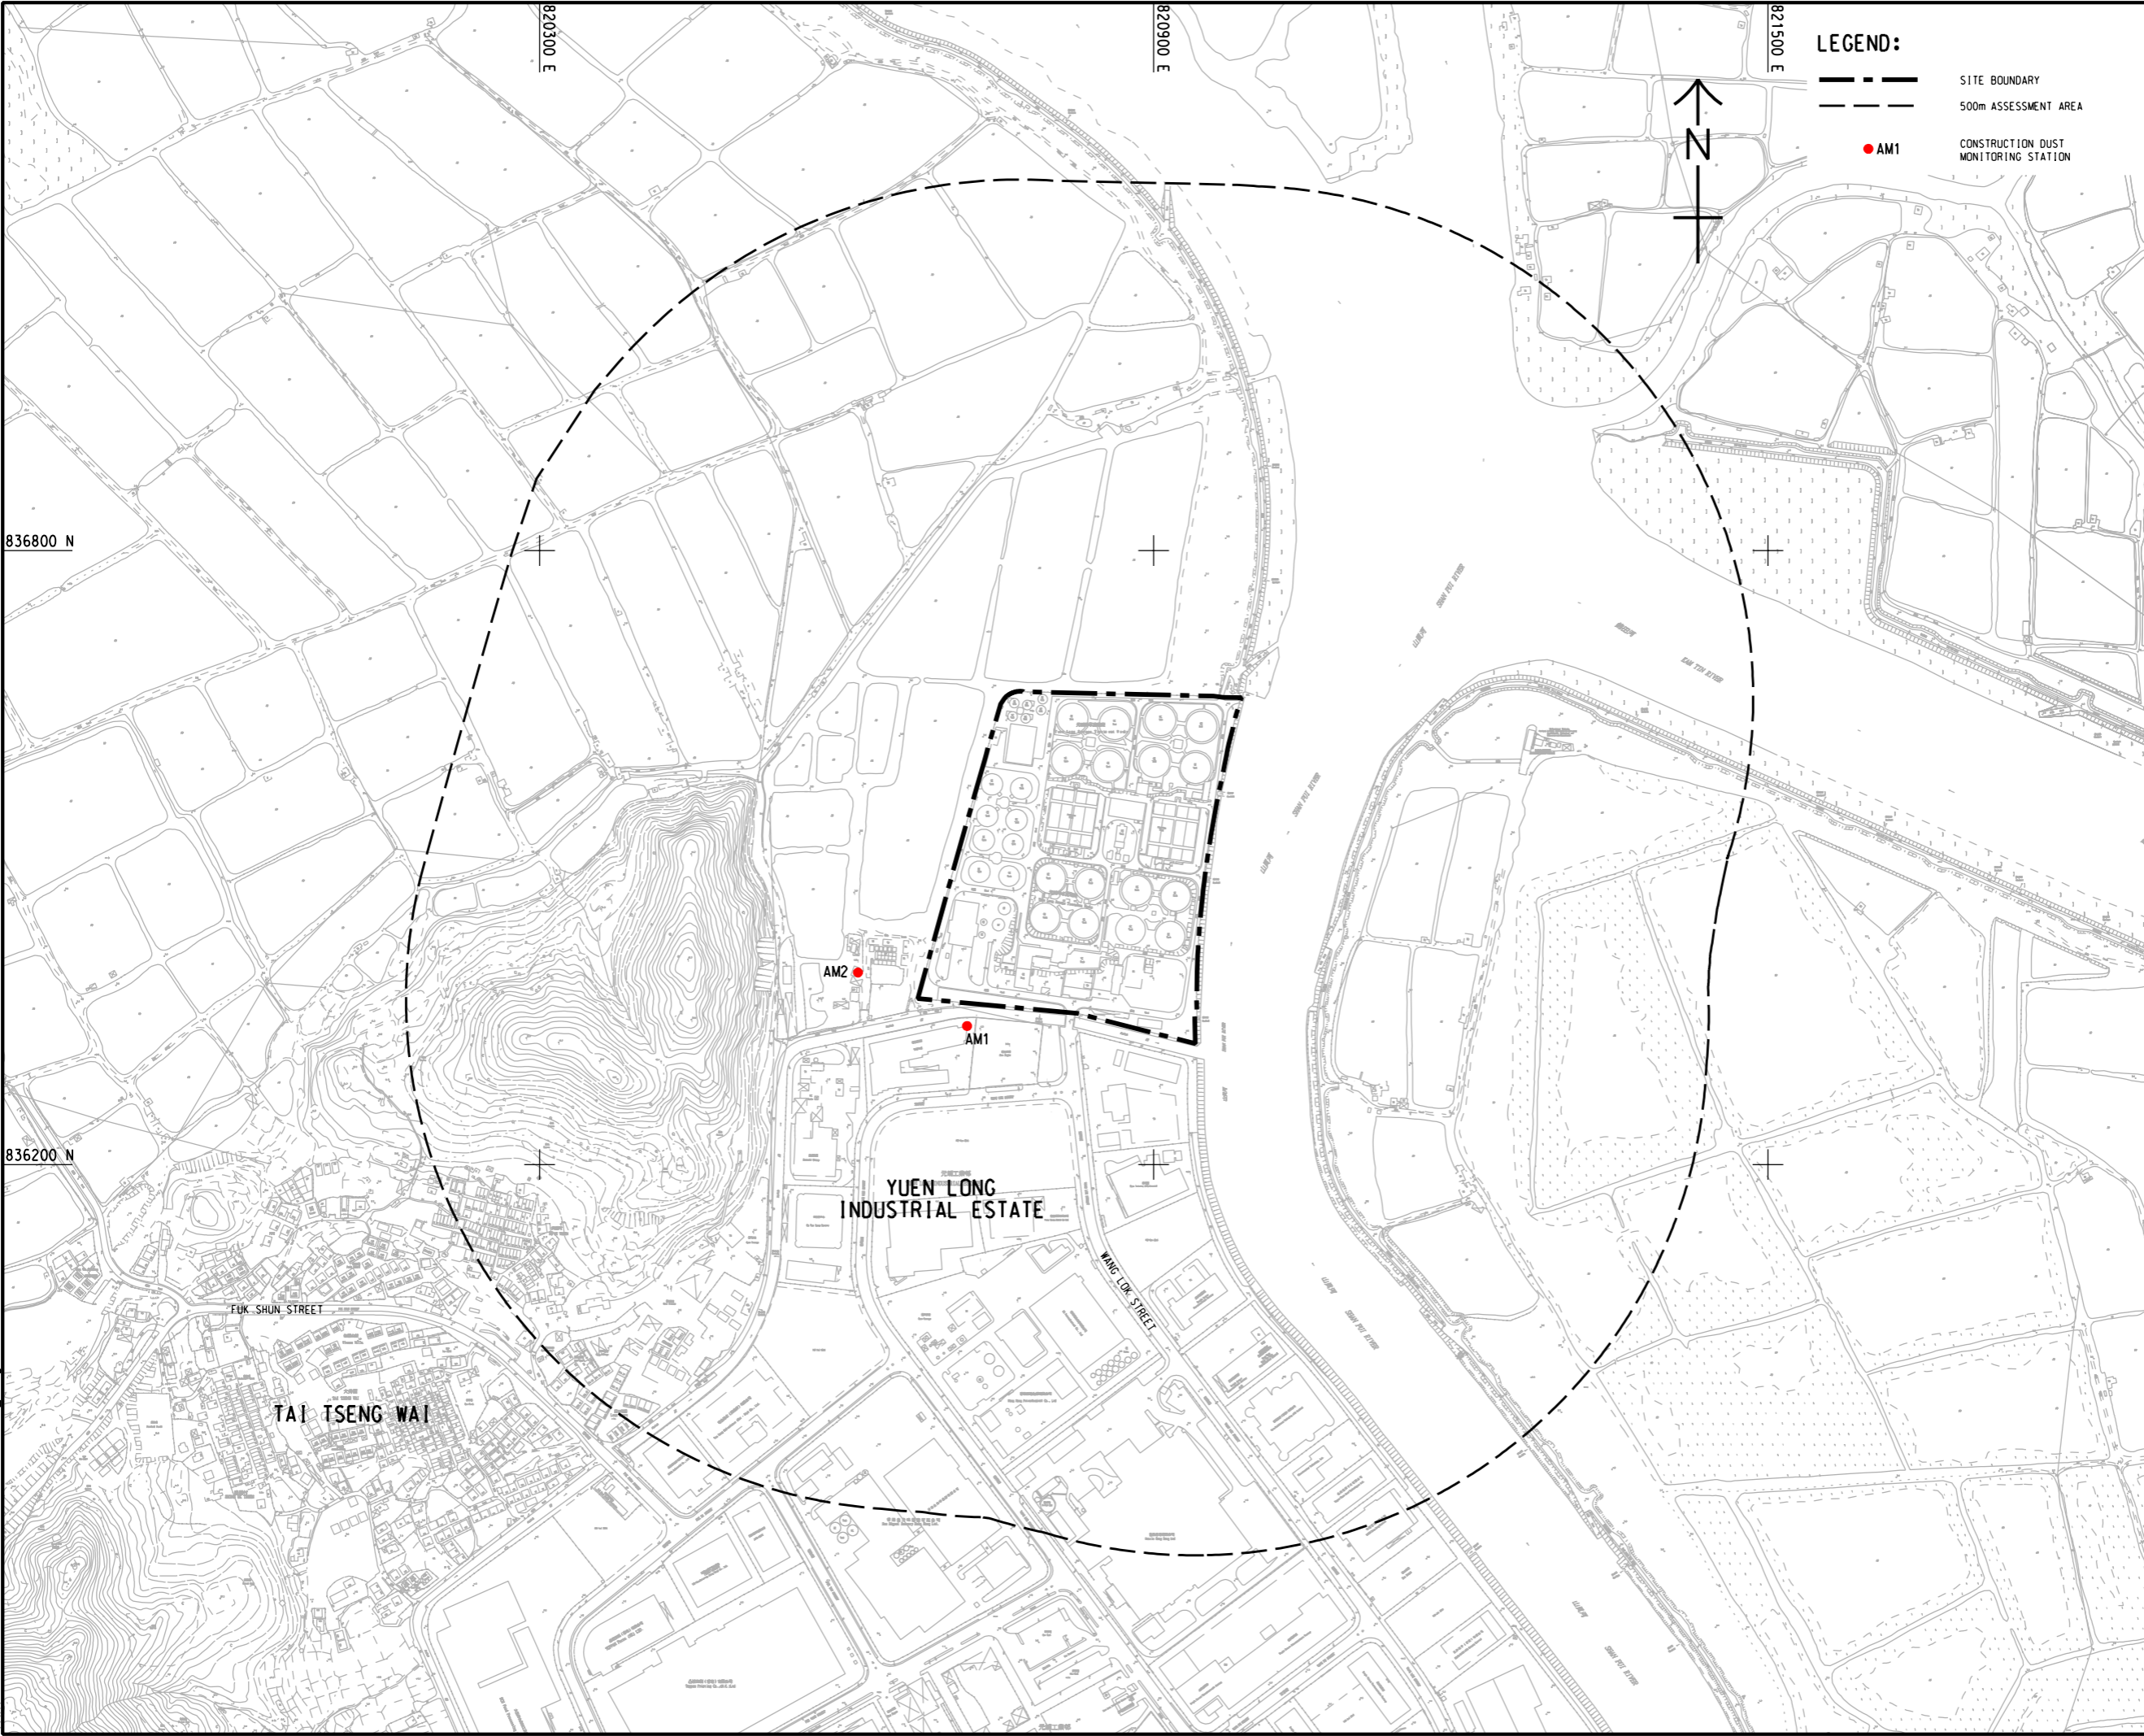
Air Quality Monitoring Locations

- SITE BOUNDARY
- 500m ASSESSMENT AREA
- AM1 CONSTRUCTION DUST MONITORING STATION

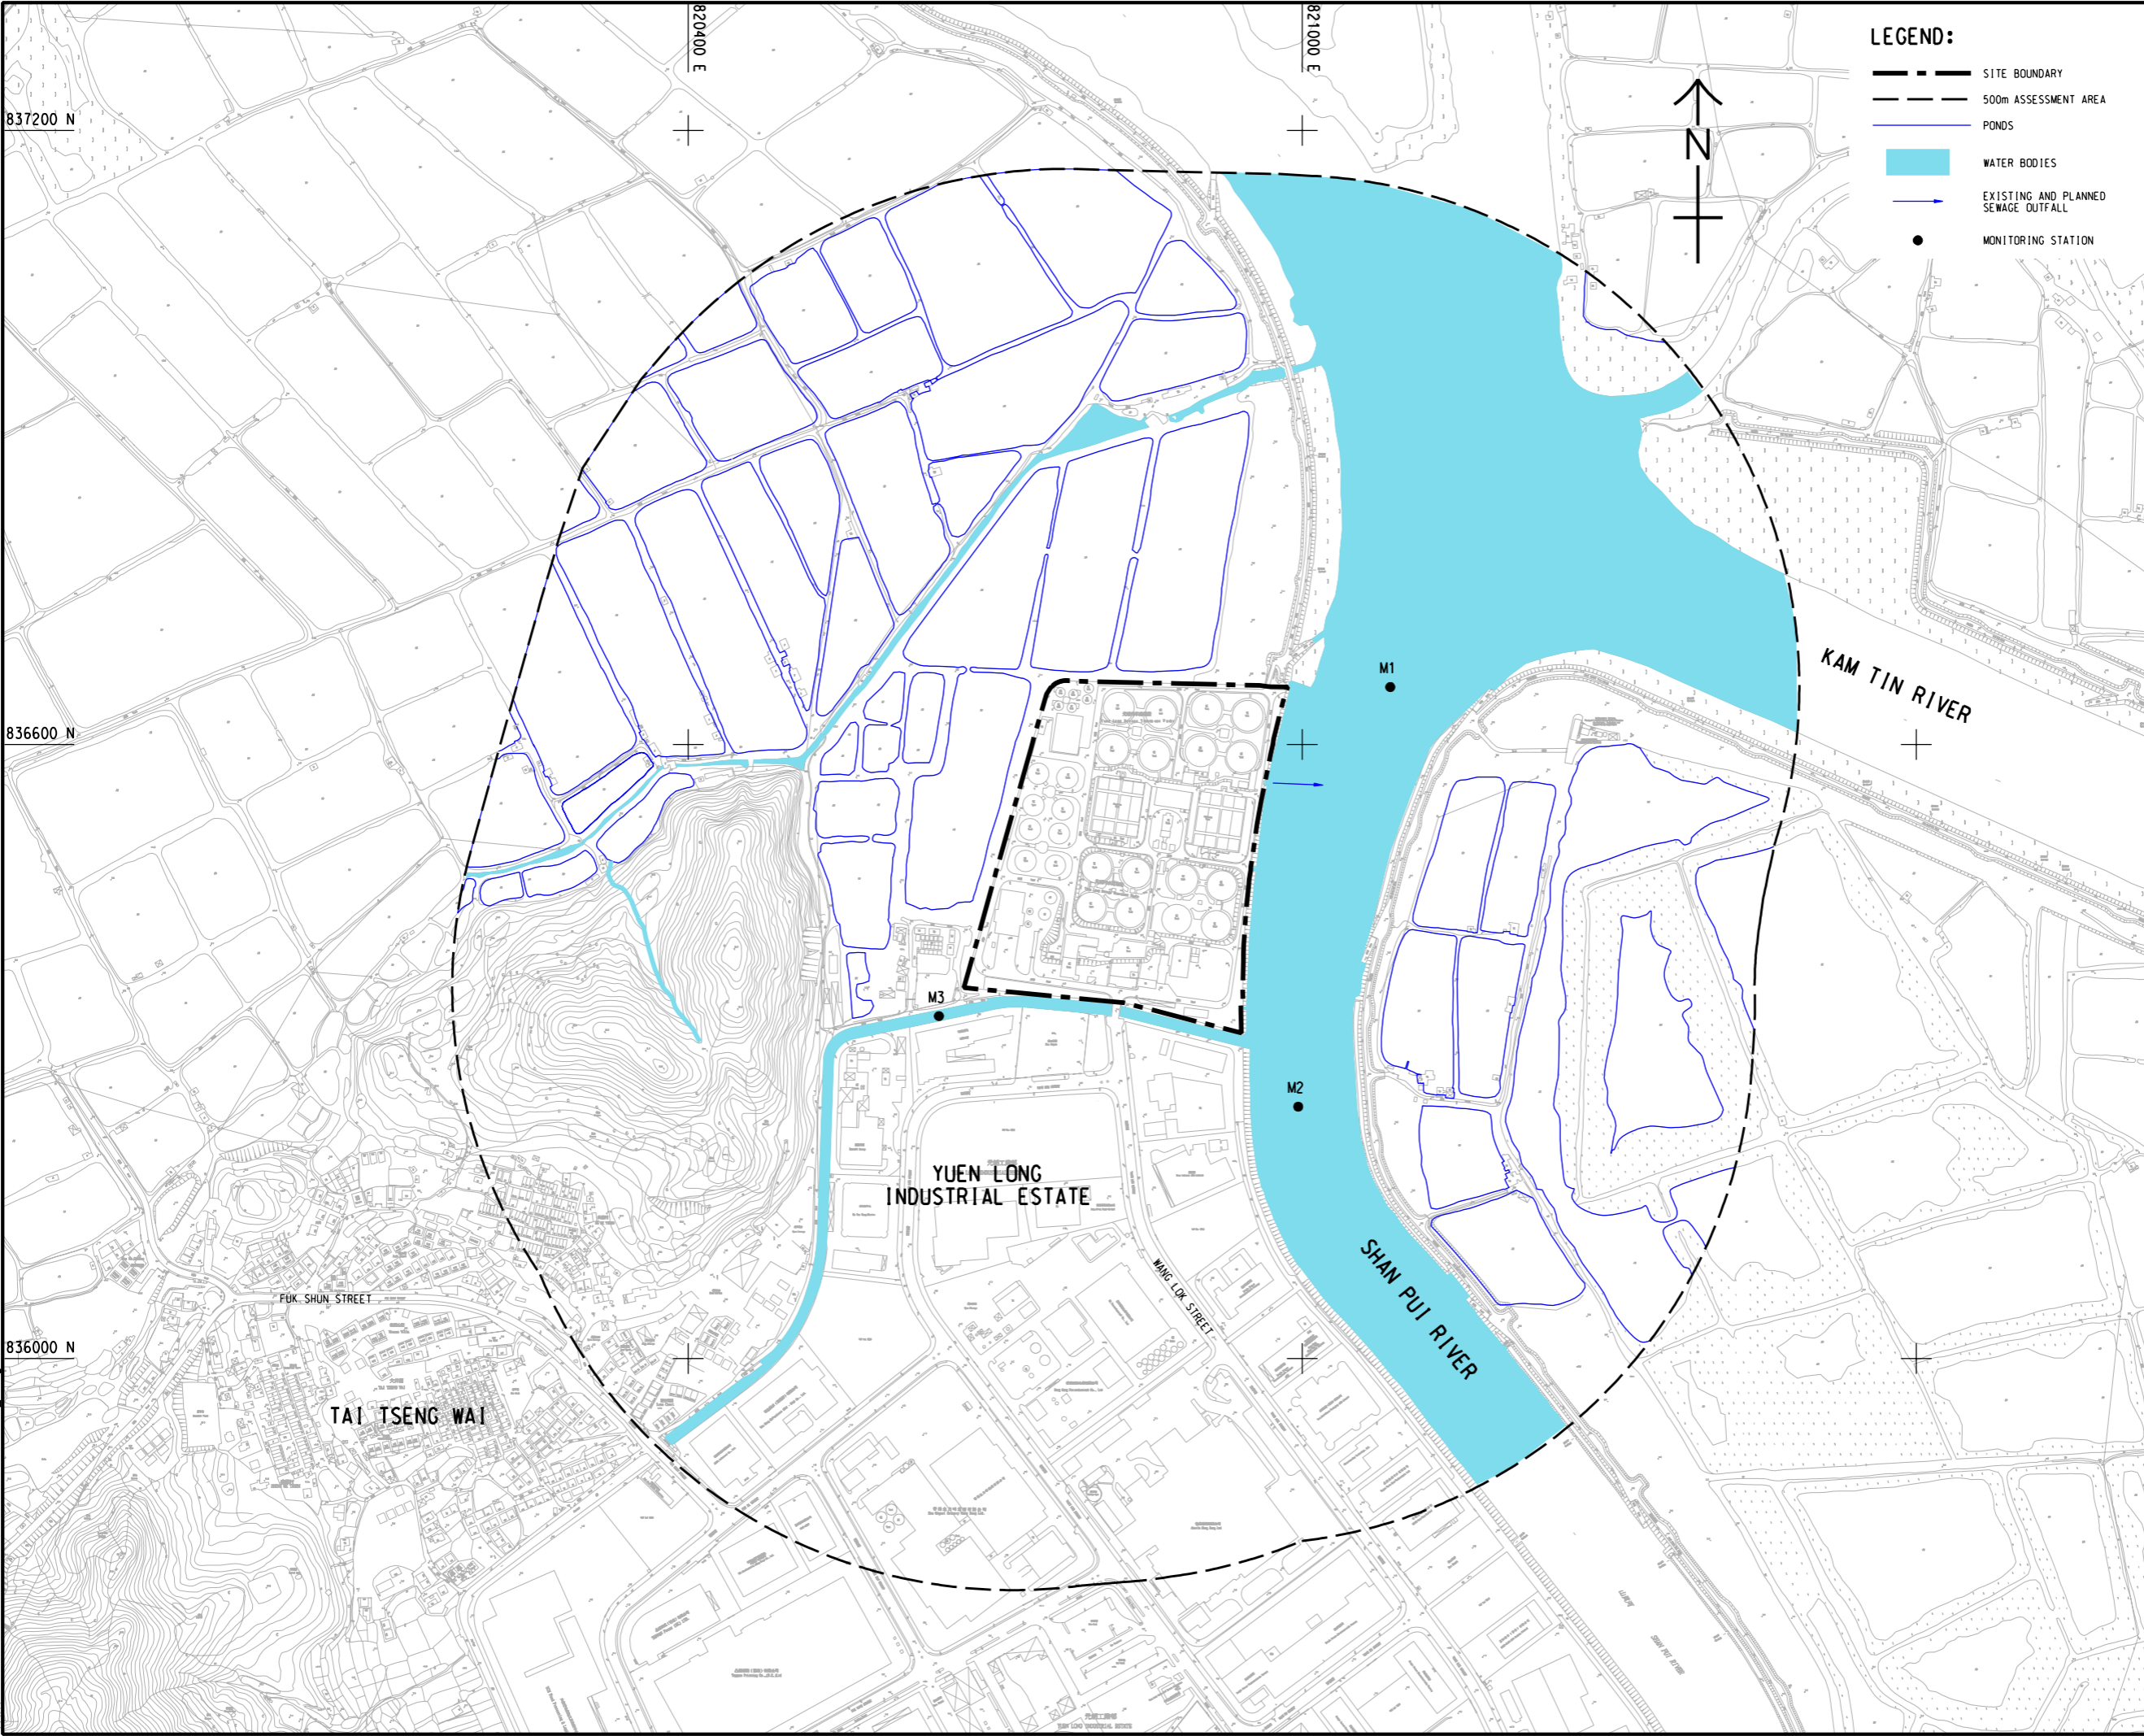
Water Quality Monitoring Locations

- SITE BOUNDARY
- - - 500m ASSESSMENT AREA
- PONDS
- WATER BODIES
- EXISTING AND PLANNED SEWAGE OUTFALL
- MONITORING STATION

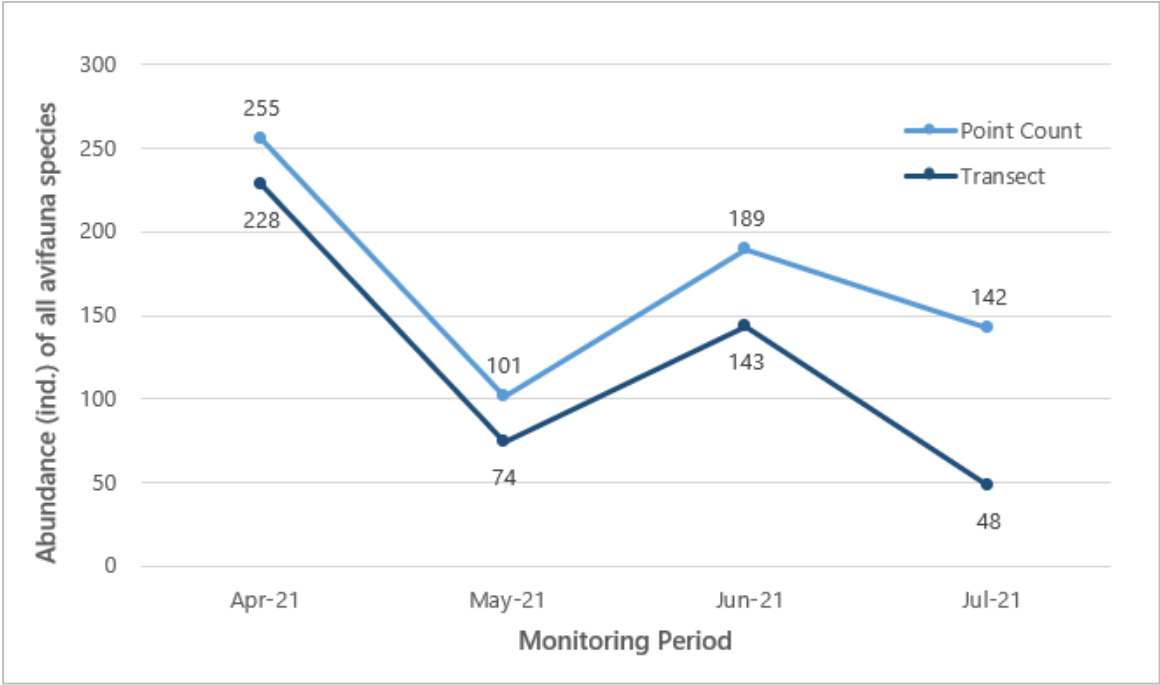
Appendix F.4.1 Abundance of all avifauna species throughout the monitoring period

A total 190 avifauna ind. was recorded in the monitoring area during the July 2021 monitoring period, of which 142 ind. were recorded from the point count method and 48 ind. from the transect walk method. Relative to the July 2017 baseline data, no significant decrease (p -value = 0.94; $\alpha = 0.05$) in total abundance was observed. In June 2017, a total of 201 ind. was

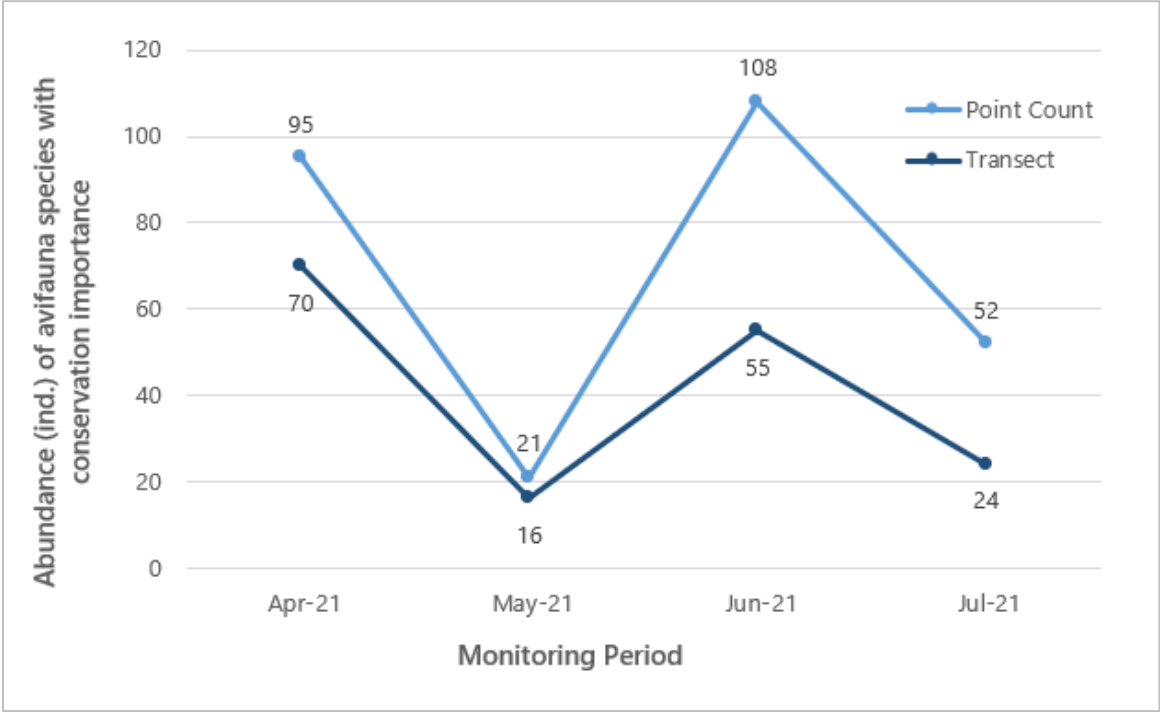
Appendix F.4.2 Abundance of avifauna species with conservation importance throughout the monitoring period

Of the 190 avifauna individuals recorded in the monitoring area during the July 2021 monitoring period, 76 ind. were of conservation importance. A total of 52 ind. was recorded from point count method and 24 ind. were from transect walk method. With reference to July 2017 data (80 ind. from point count method and 8 ind. from transect walk method), a current decrease in abundance from the point count method was noted. However, this decrease was not significant ($p\text{-value} = 0.95$; $\alpha = 0.05$). These findings are summarized in **Table 5.6**.

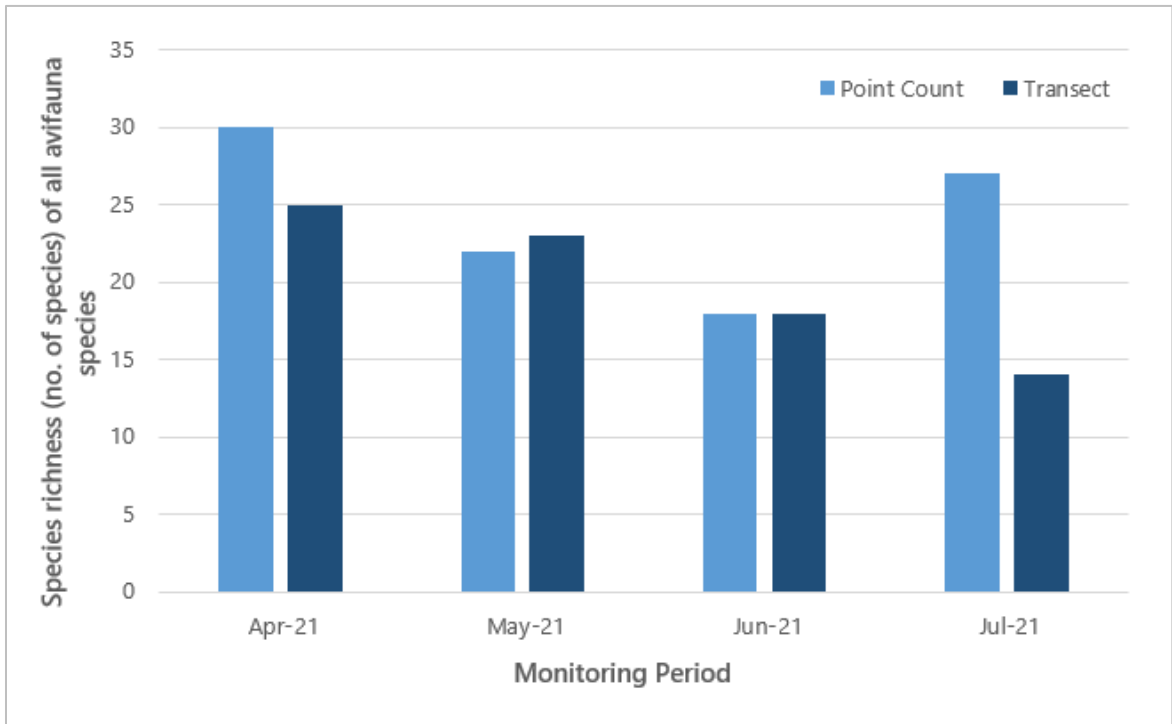
Appendix F.5.1 Species richness of all avifauna species throughout the monitoring period

A total of 30 avifauna species (species richness) was recorded during the July 2021 monitoring period, of which 27 species were identified using point count method and also 14 species using transect walk method. Relative to the July 2017 baseline data, a decrease in the total species richness from 31 species in July 2017 to 30 species in the current monitoring period was noted. However, in terms of Shannon diversity index (H'), increases from baseline reference values were observed in point count method (from $H'=2.73$ in July 2017 to $H'=2.75$ in July 2021) and transect walk method (from $H'=0.93$ in July 2017 to $H'=2.13$ in July 2021). The increase in H' noted for the transect walk method was significant (t -value = 4.08; t -crit = 1.99; p -value =

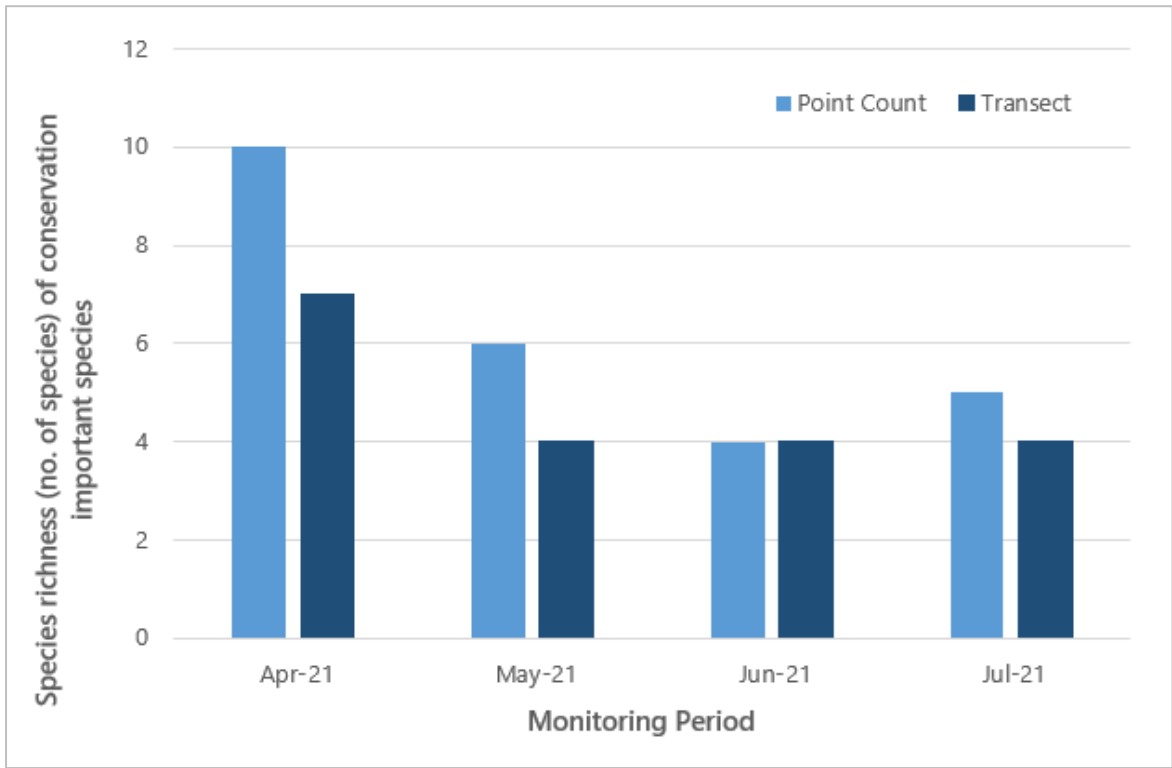
Appendix F.5.2 Species richness of avifauna species with conservation importance throughout the monitoring period

Of the 30 species of avifauna identified during the July 2021 monitoring period, five species of conservation importance were identified from the point count method and four species from the transect walk method. Relative to the baseline values in July 2017, the number of species with conservation importance recorded from the point count method remained the same while an increase by one species from the transect walk method was noted. In terms of H', a significant decline (t-value = 3.46; t-crit = 1.99; p-value = 0.0009; $\alpha = 0.05$) was observed from the point count method, from H' = 1.36 in July 2017 to H' = 0.85 of the current period. However, the significant decline was observed to be due to other factors and not project-related. i.e. dominance of Chinese Pond Heron. On the other hand, no significant decline

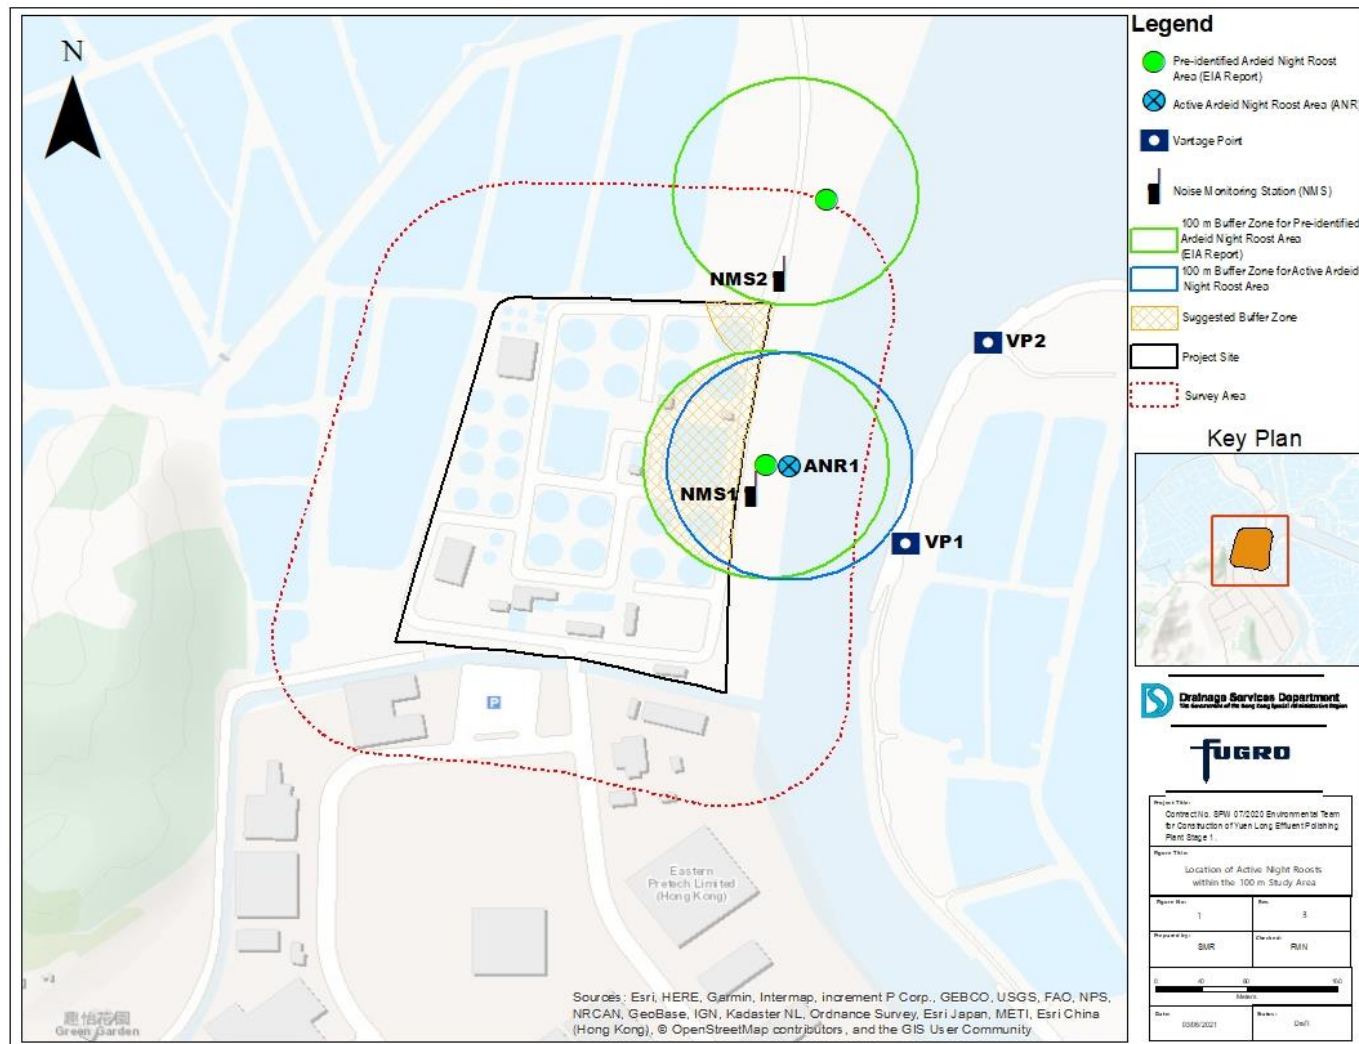
O.1 Map of the Monitoring Area, Vantage Points for Observation of Active Night Roost and Noise Monitoring Stations

Appendix O.1: Monitoring Area, Vantage Points for Observation of Active Night Roost and Noise Monitoring Stations

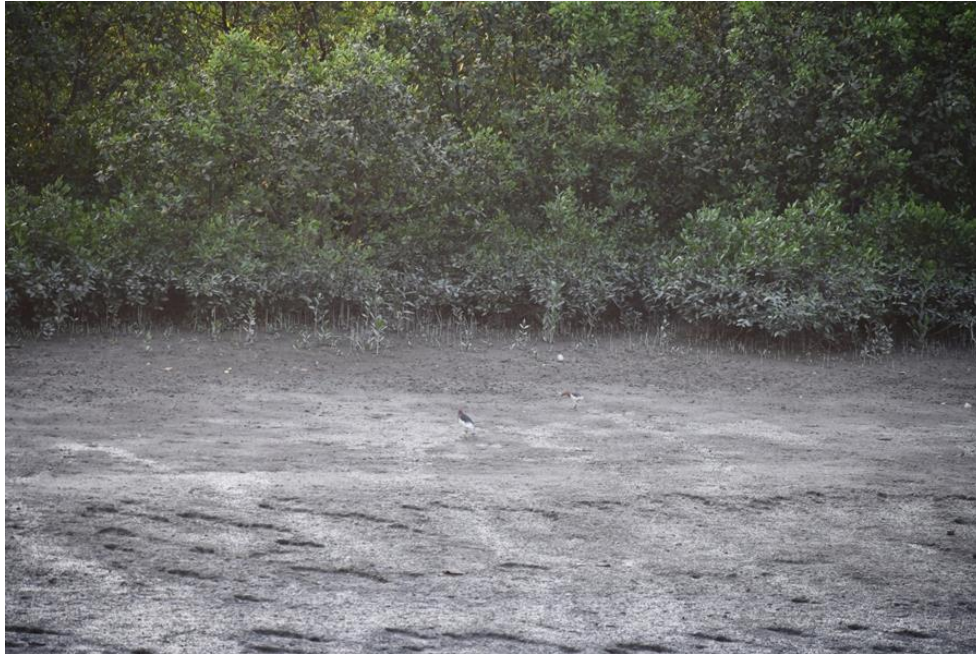
Appendix O.2.1a: Pre-roost aggregate of the Chinese Pond Heron in the mudflat area northeast of the Project boundary observed on 09 July 2021 around 18:31

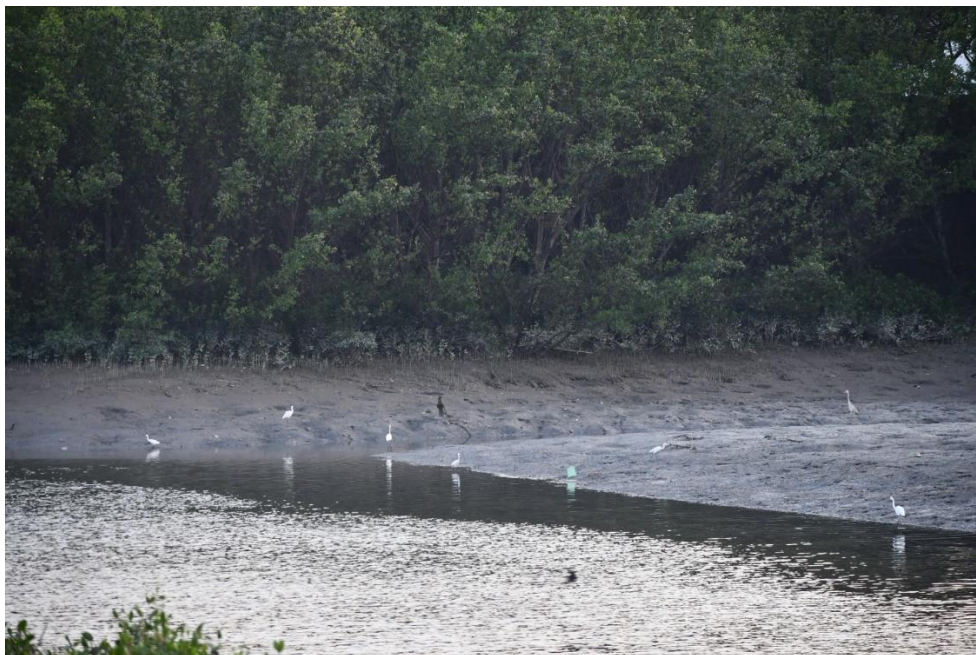
Appendix O.2.1b: Pre-roost aggregate of the Eastern Cattle Egret *Bubulcus coromandus* and Little Egret *Egretta garzetta* in the mudflat area east of the Project boundary observed on 09 July 2021 around 18:50

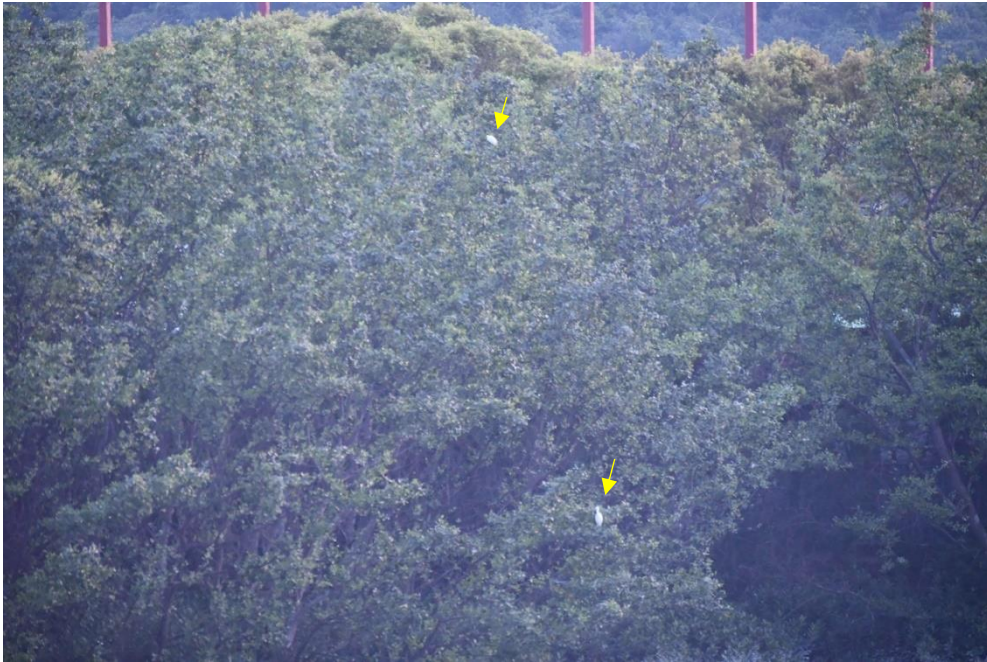
Appendix O.2.2: Active night roost on *Sonneratia apetala* and *S. caseolaris* mangrove roosting substrate located east of the Project boundary observed on 09 July 2021 around 19:04

One active ardeid night roost site (ANR1) was observed within the Survey Area during the July 2021 monitoring period. This roost was located at the mangrove strip in the east portion of the Project boundary. This was used by individuals of Chinese Pond Heron and Little Egret. The other night roost site (ANR2) was not used during the period.

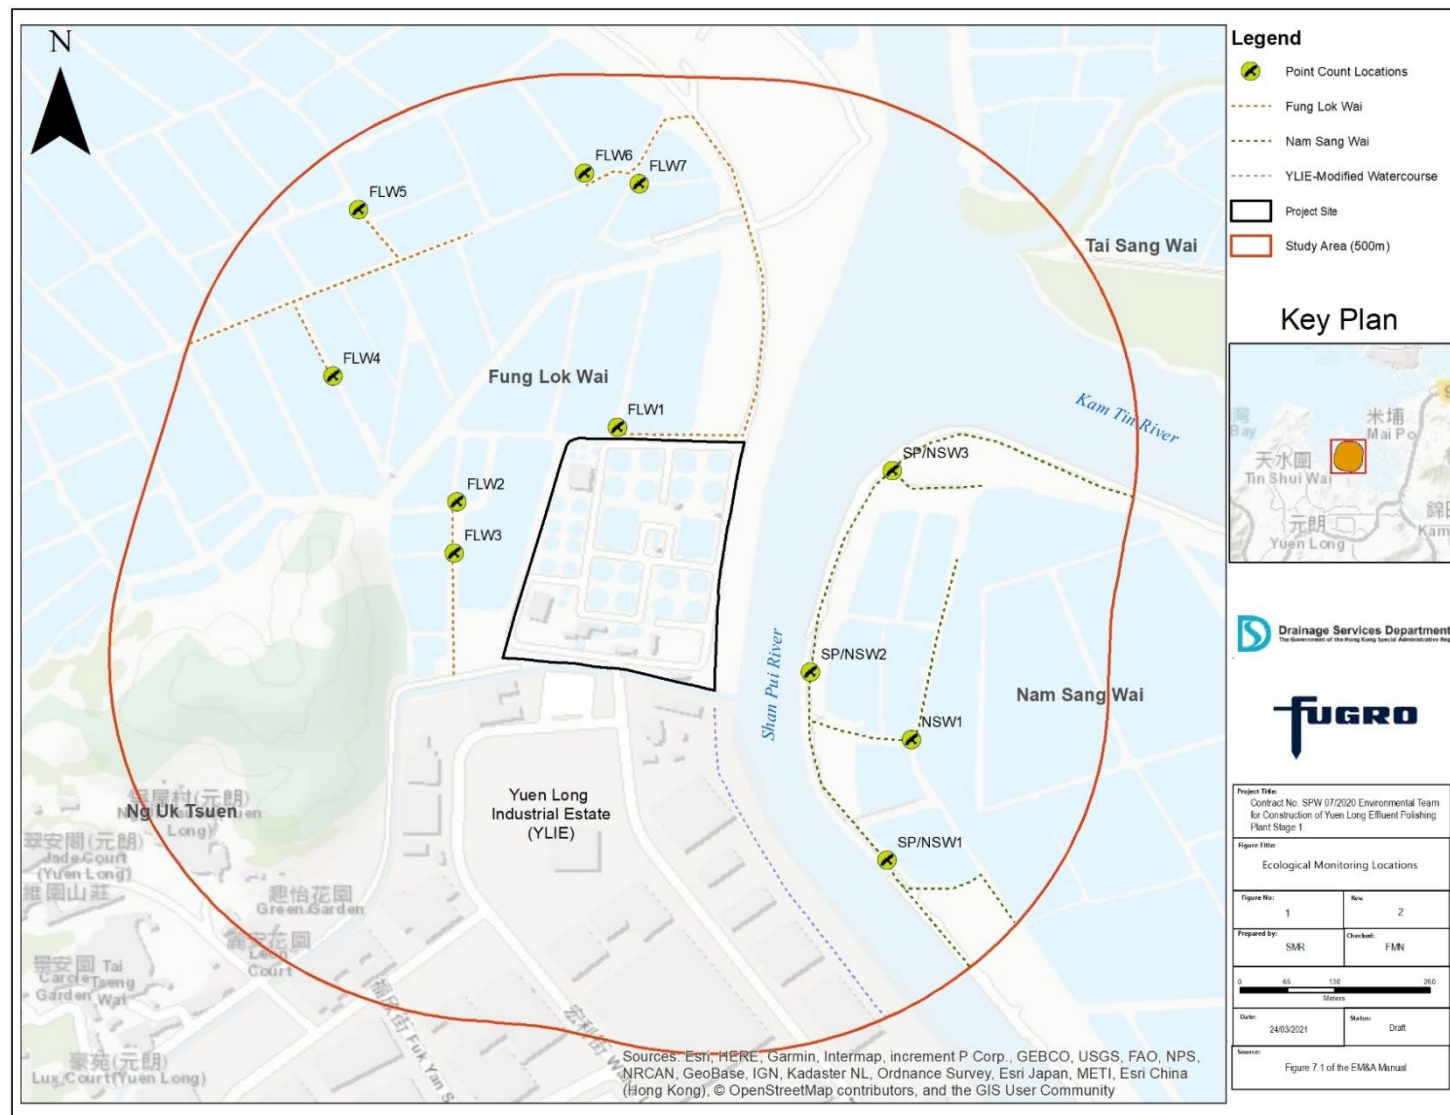
Appendix P: Ecological bird monitoring area with the locations of point count sites and transect routes

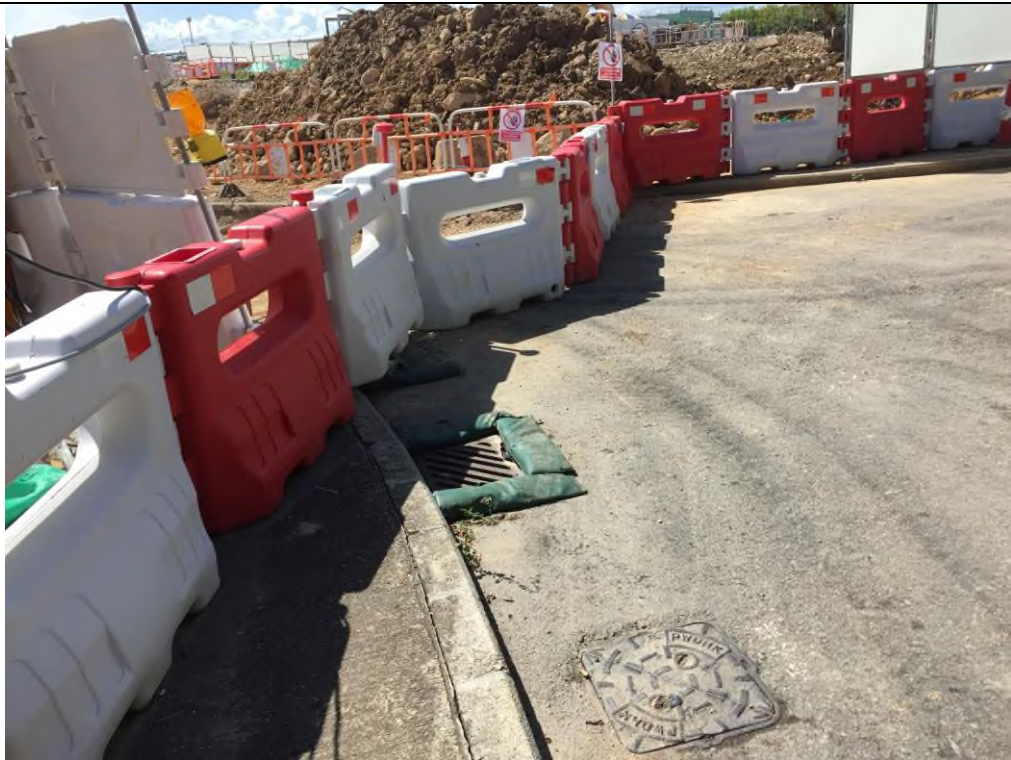
Date of site inspection: 7 July 2021

Gullies were bunded by sand bags to prevent surface runoff.

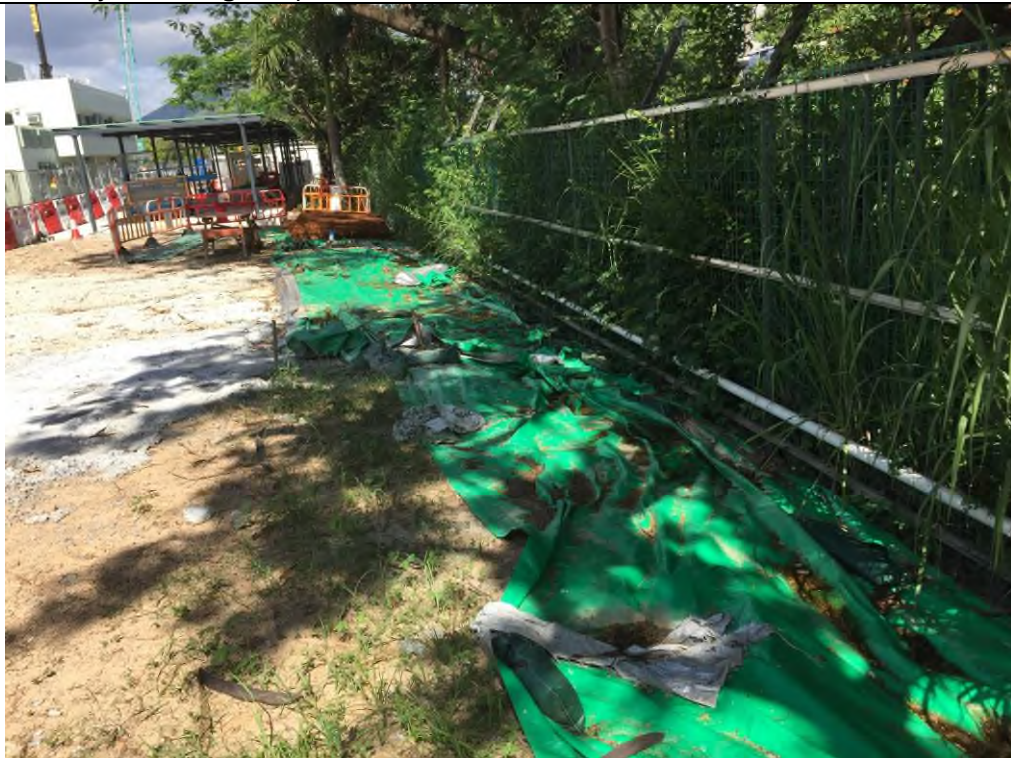
Date of site inspection: 7 July 2021

The surrounding of the construction site areas were covered by impermeable sheeting to prevent surface runoff.

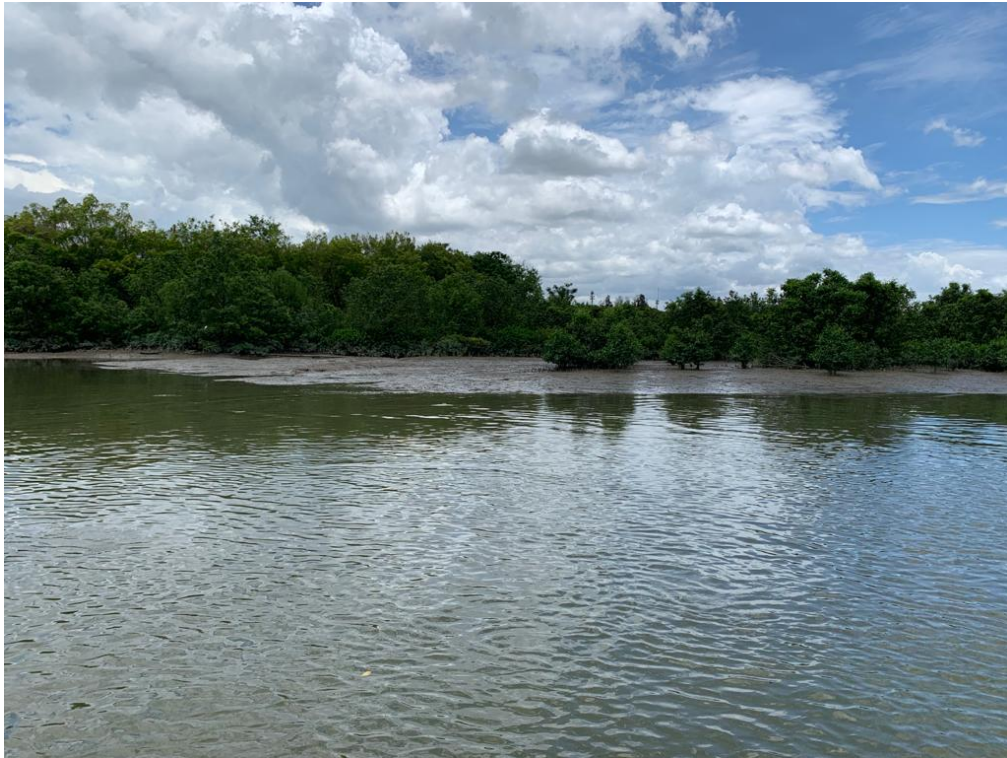
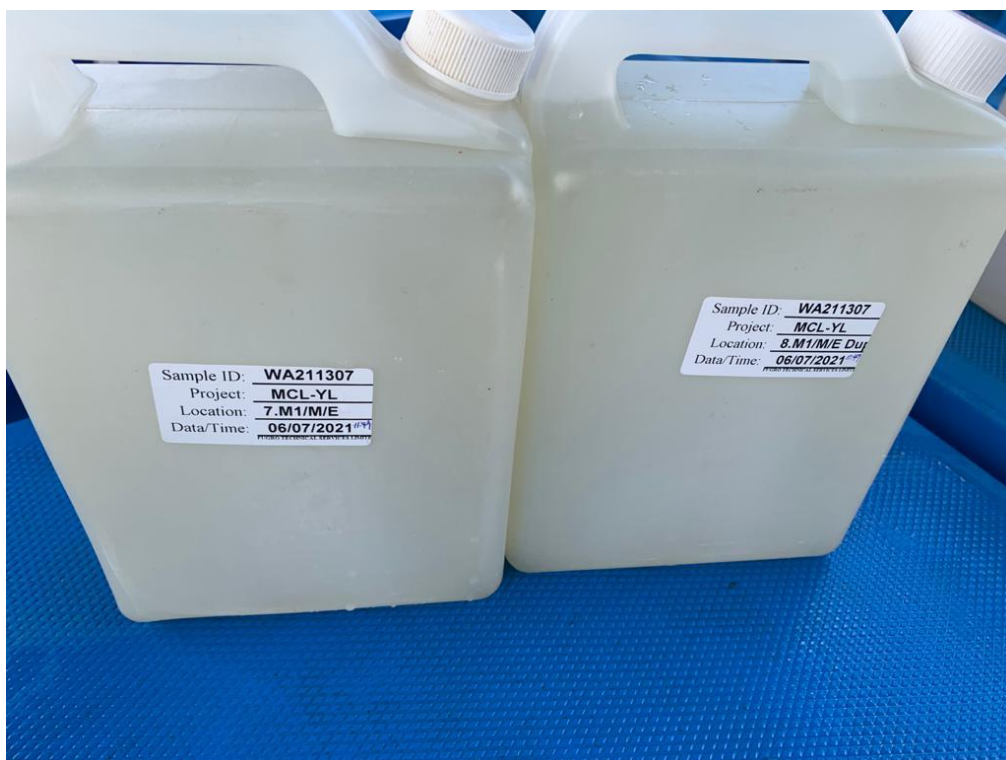
Monitoring Station: M1

Reference No.:	IR20210706_M1_SS			
Project:	Contract No. SPW 07/2020 Environmental Team for Construction of Yuen Long Effluent Polishing Plant Stage 1			
Date:	2021/07/06			
Conclusion:		DO	Turbidity	SS
	<input checked="" type="checkbox"/> Due to change or/and influences of ambient condition in the vicinity, not Project related <input type="checkbox"/> Due to influences of construction activities under this project in the vicinity, considered to be Project related			M1
Mitigation Measures:	The following mitigation measures have been taken: 1. Channels, earth bunds or sand bag barriers were provided on site to properly direct stormwater to silt removal facilities; 2. The surfaces of construction site areas near the drainages were paved; 3. Manholes were adequately covered and temporarily sealed so as to prevent silt, construction materials or debris from getting into the drainage system, and; 4. Channels and manholes were maintained and the deposited silt and grit were removed after rainstorm to prevent overflows and localised flooding.

Date of investigation: 6 July 2021 (**Ebb Tide**)

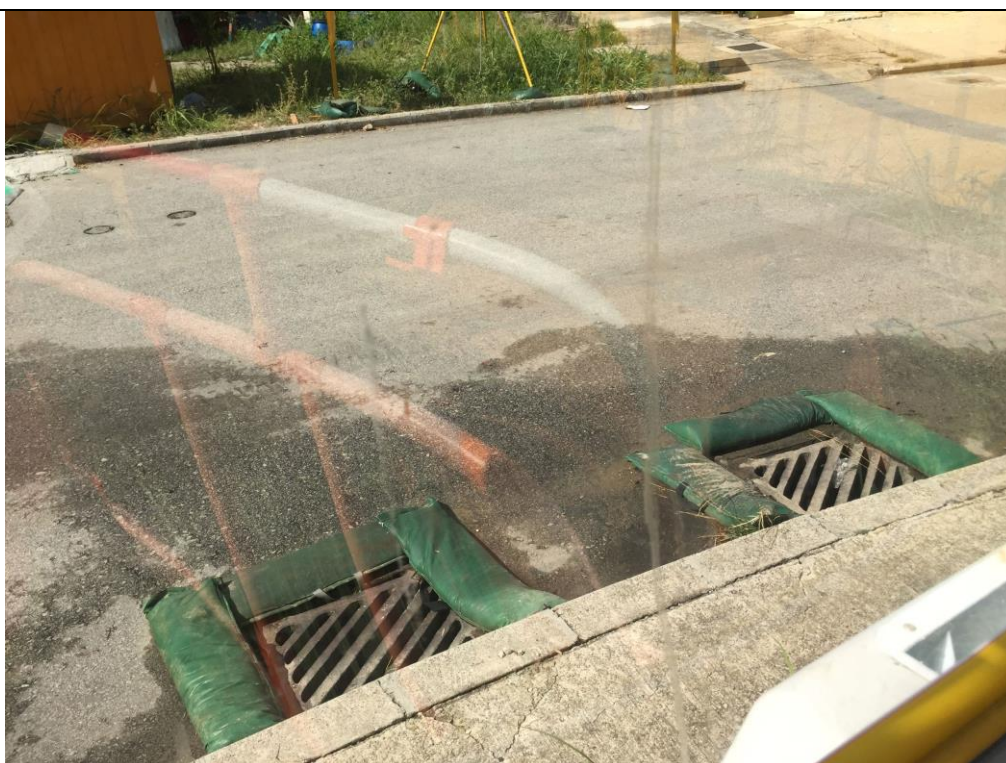
Date of site inspection: 15 July 2021

Gullies were bunded by sand bags to prevent surface runoff.

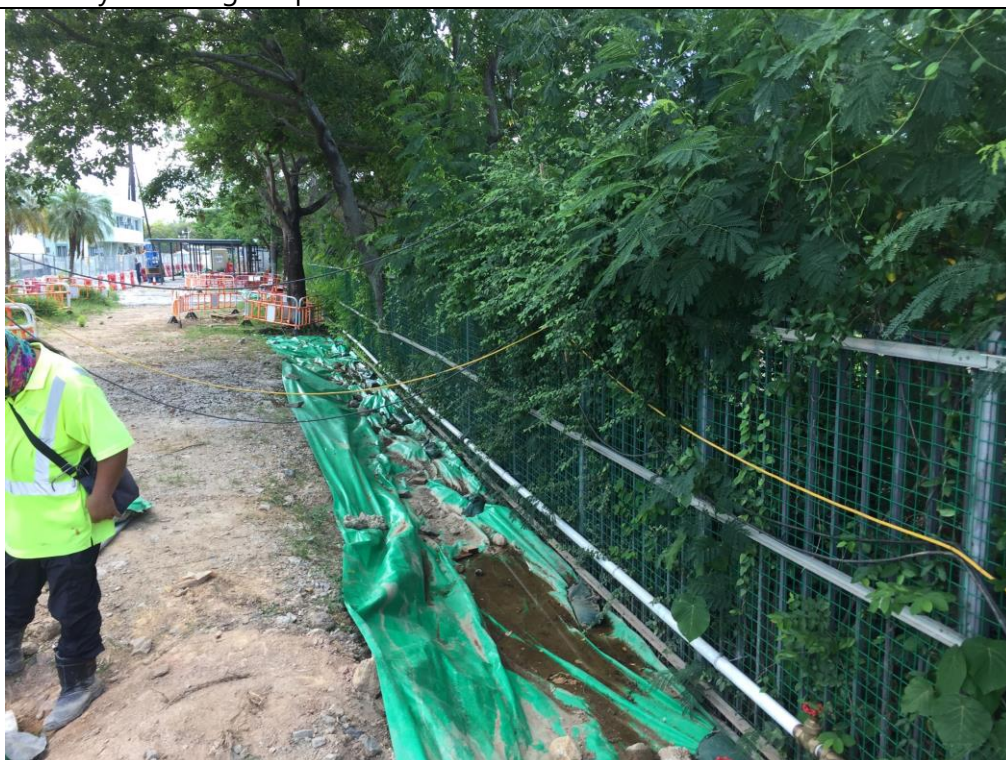
Date of site inspection: 15 July 2021

The surrounding of the construction site areas were covered by impermeable sheeting to prevent surface runoff.
