Monthly EM&A Report (July 2021)

0120/20/ED/0368 04

Contract No. SPW 07/2020 Environmental Team for Construction of Yuen Long Effluent Polishing Plant Stage 1 Contract No. SPW 07/2020 Environmental Team for Construction of Yuen Long Effluent Polishing Plant Stage 1

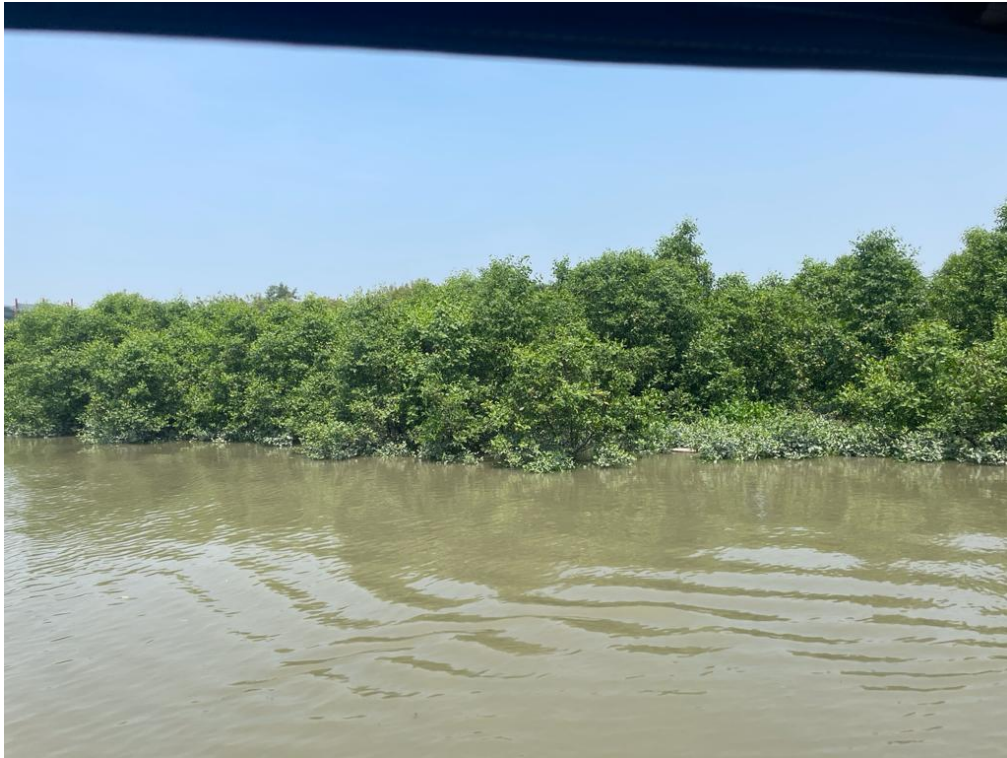
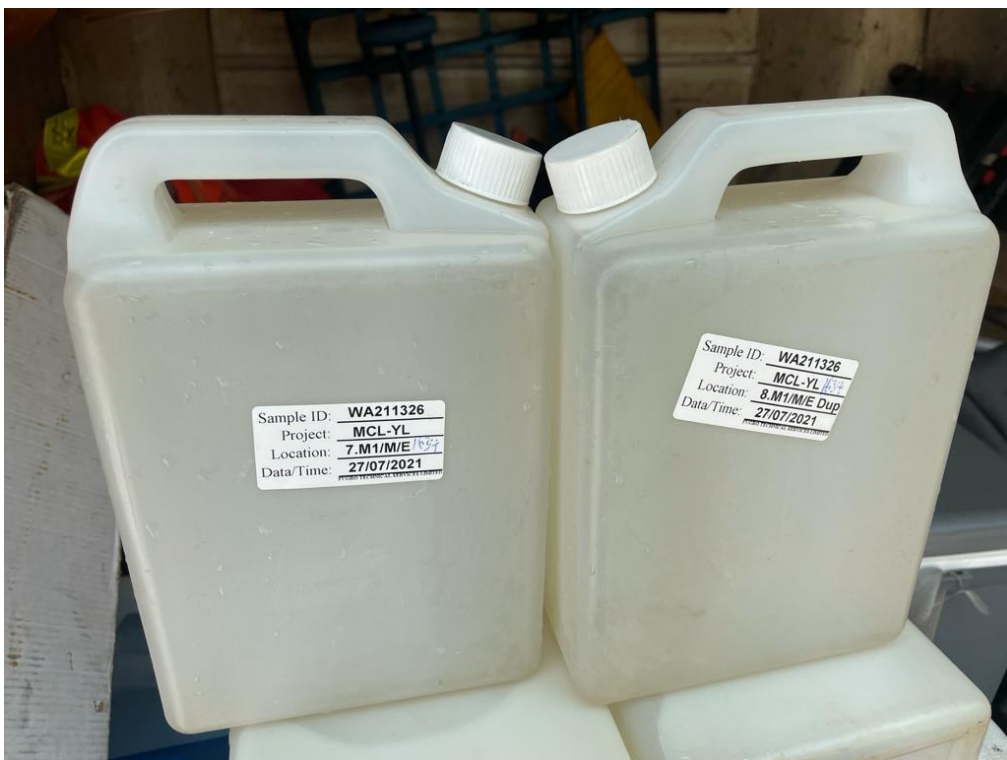
Monitoring Station: M1

Reference No.:	IR20210727_M1_SS			
Project:	Contract No. SPW 07/2020 Environmental Team for Construction of Yuen Long Effluent Polishing Plant Stage 1			
Date:	2021/07/27			
Conclusion:		DO	Turbidity	SS
	<input checked="" type="checkbox"/> Due to change or/and influences of ambient condition in the vicinity, not Project related <input type="checkbox"/> Due to influences of construction activities under this project in the vicinity, considered to be Project related			M1
Mitigation Measures:	The following mitigation measures have been taken: 1. Channels, earth bunds or sand bag barriers were provided on site to properly direct stormwater to silt removal facilities; 2. The surfaces of construction site areas near the drainages were paved; 3. Manholes were adequately covered and temporarily sealed so as to prevent silt, construction materials or debris from getting into the drainage system, and; 4. Channels and manholes were maintained and the deposited silt and grit were removed after rainstorm to prevent overflows and localised flooding.

Date of investigation: 27 July 2021 (**Ebb Tide**)

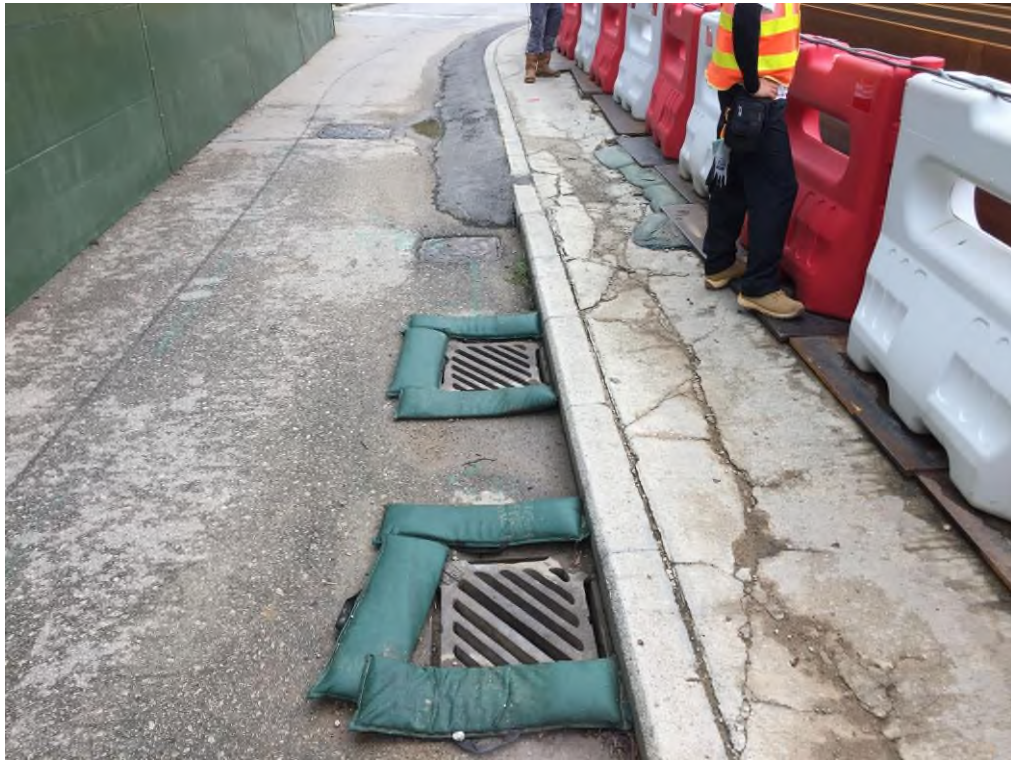
Date of site inspection: 28 July 2021

Gullies were bunded by sand bags to prevent surface runoff.

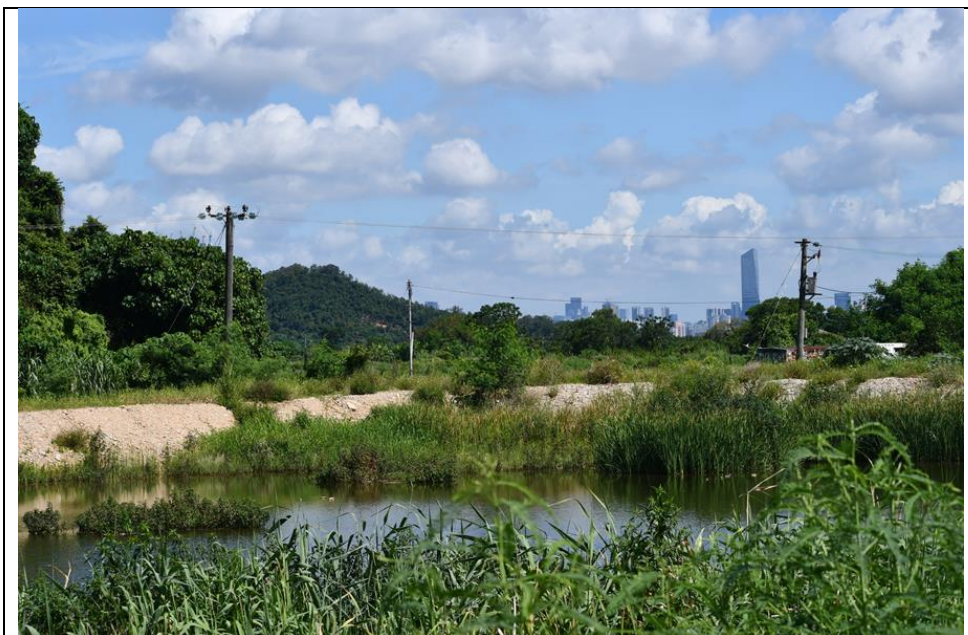
Annex F.1. Active Pond at Fung Lok Wai, north of the Project Site

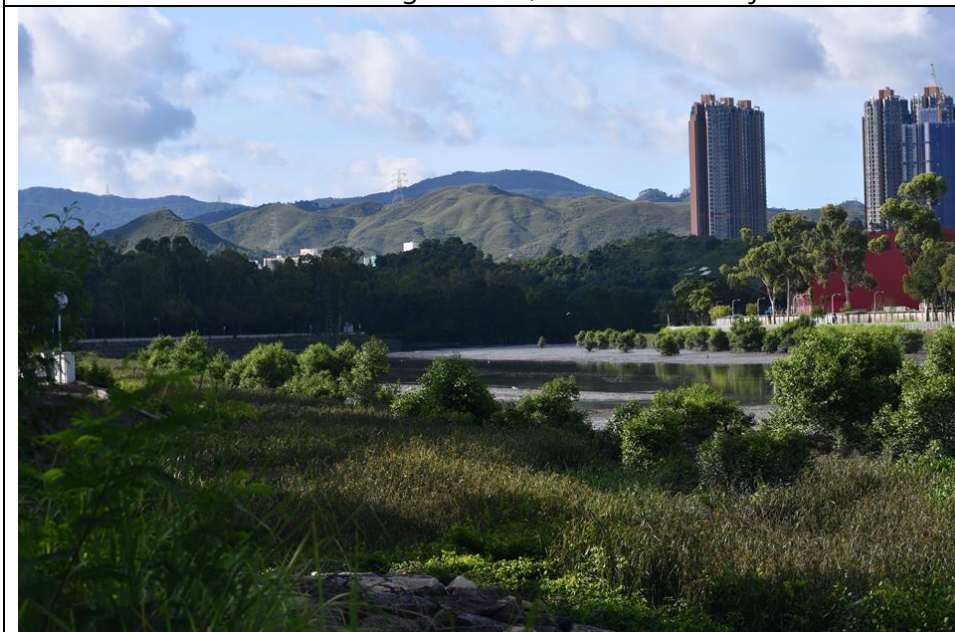
Annex F.2. Modified Watercourse, southeast of the Project Site

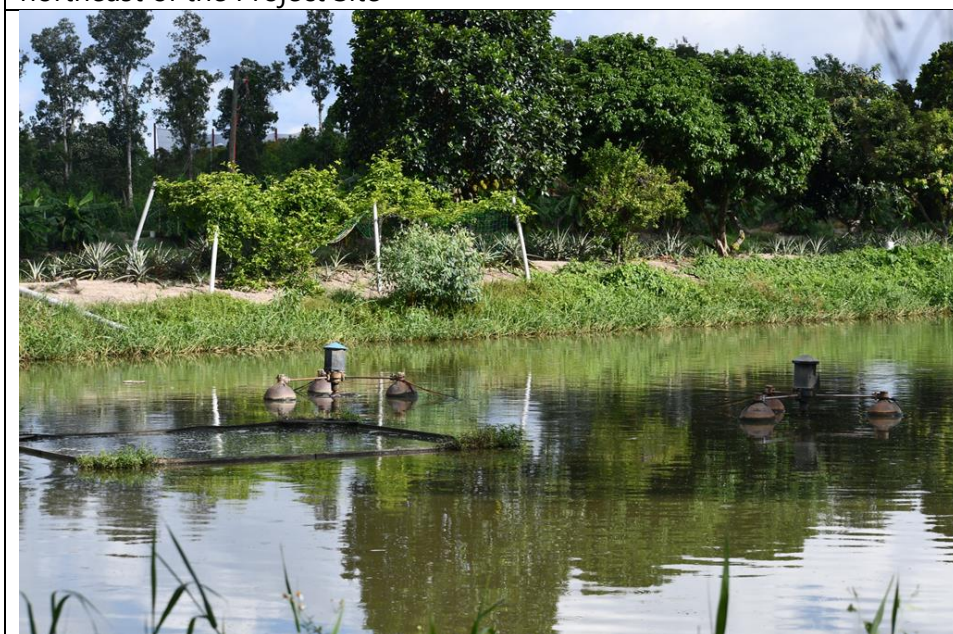
Annex F.4. Active Pond at Nam Sang Wai, far east of the Project Site

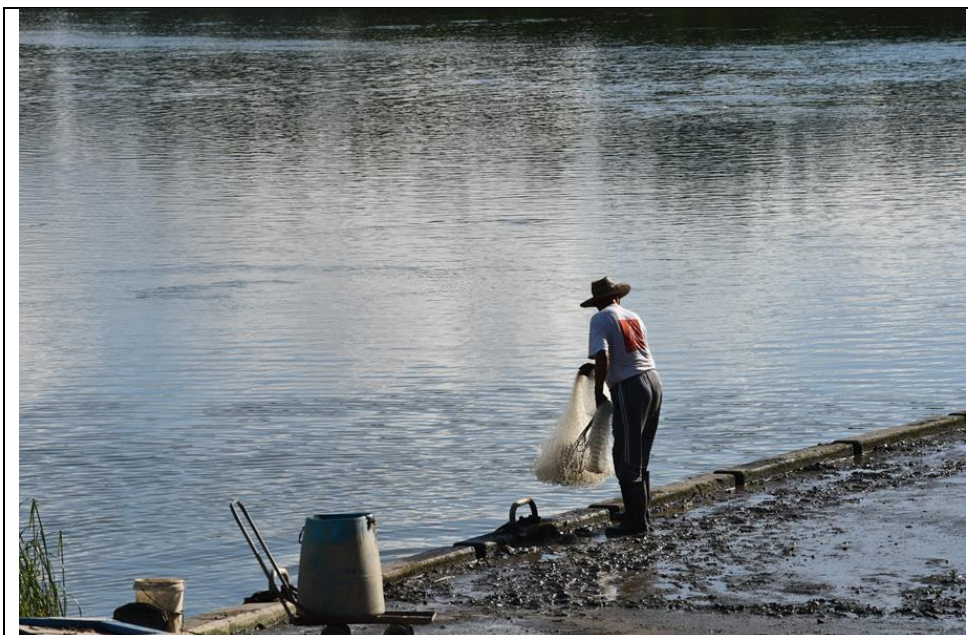
Annex F.5. Fishing activity at a portion of the modified watercourse, east of the Project Site
