Monthly EM&A Report (June 2021)

Contract No. SPW 07/2020 Environmental Team for Construction of Yuen Long Effluent Polishing Plant Stage 1 Contract No. SPW 07/2020 Environmental Team for Construction of Yuen Long Effluent Polishing Plant Stage 1

Contract No. SPW 07/2020
Environmental Team for Construction of Yuen Long Effluent Polishing Plant Stage 1
Baseline Monitoring Report
Responses to Comment as identified from IEC dated 12 July 2021

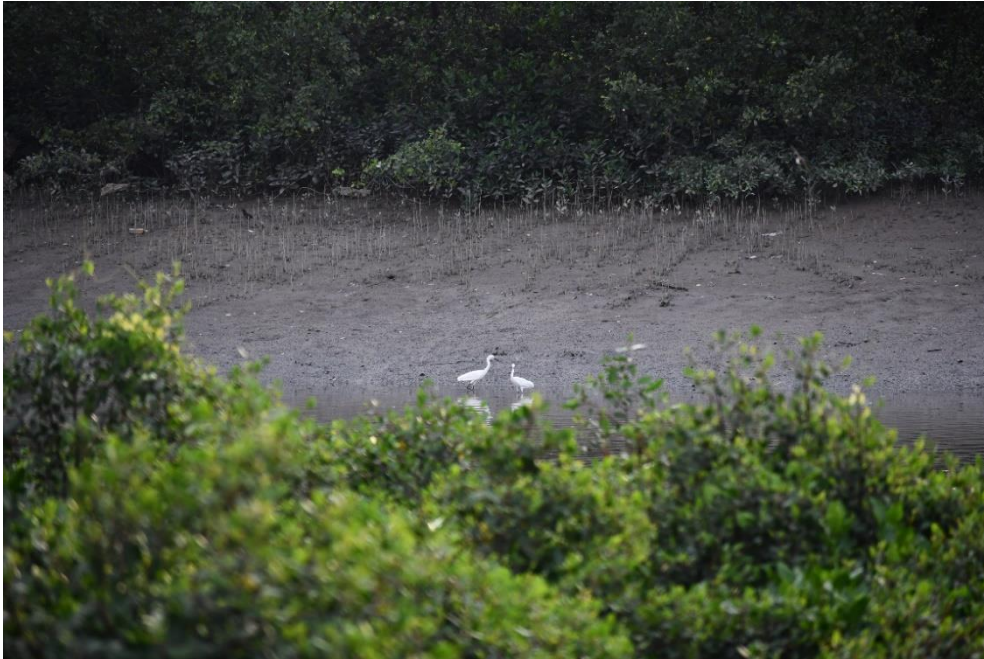
Appendix O.2.1a: Pre-roost aggregate of the Little Egret in the mudflat area east of the Project boundary observed on 11 June 2021 around 18:22

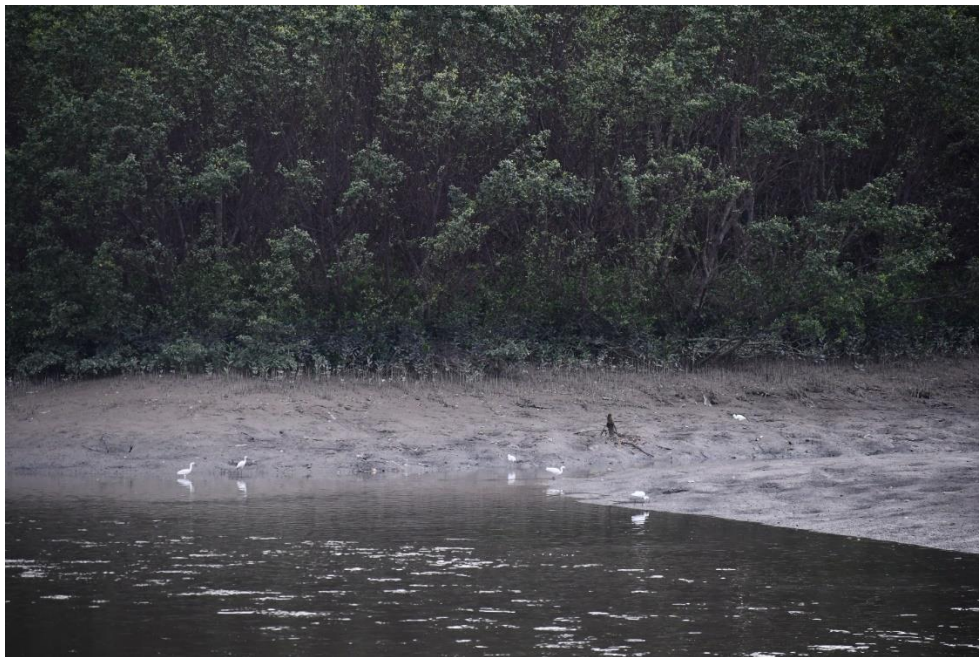
Appendix O.2.1b: Pre-roost aggregate of the Little Egret in the mudflat area northeast of the Project boundary observed on 11 June 2021 around 18:22

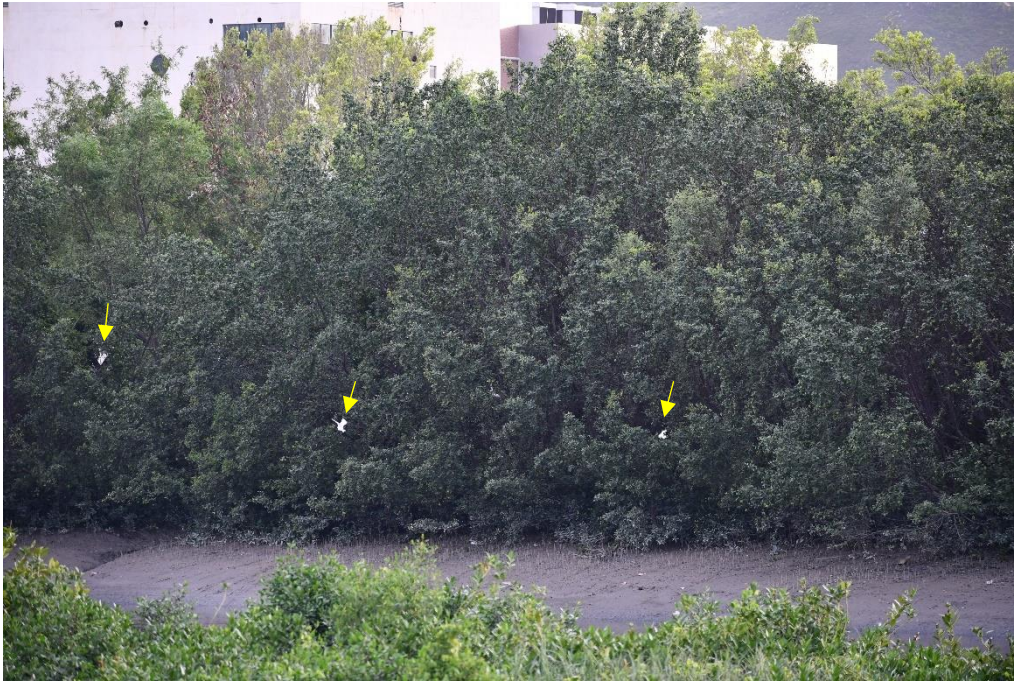
Appendix O.2.2: Active night roost on *Sonneratia apetala* and *S. caseolaris* mangrove roosting substrate located east of the Project boundary observed on 11 June 2021 around 18:50

One active ardeid night roost site (ANR1) was observed within the Survey Area during the June 2021 monitoring period. This roost was located at the mangrove strip in the east portion of the Project boundary. This was used by individuals of Little Egret. The other night roost site (ANR2) was not used during the period.

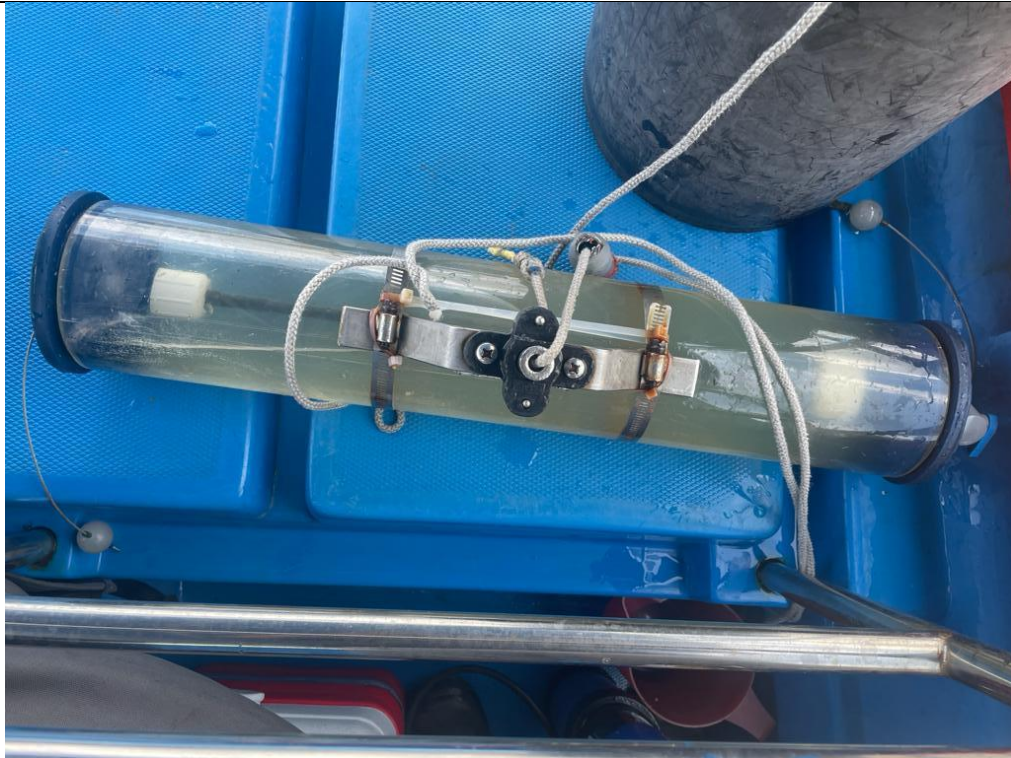
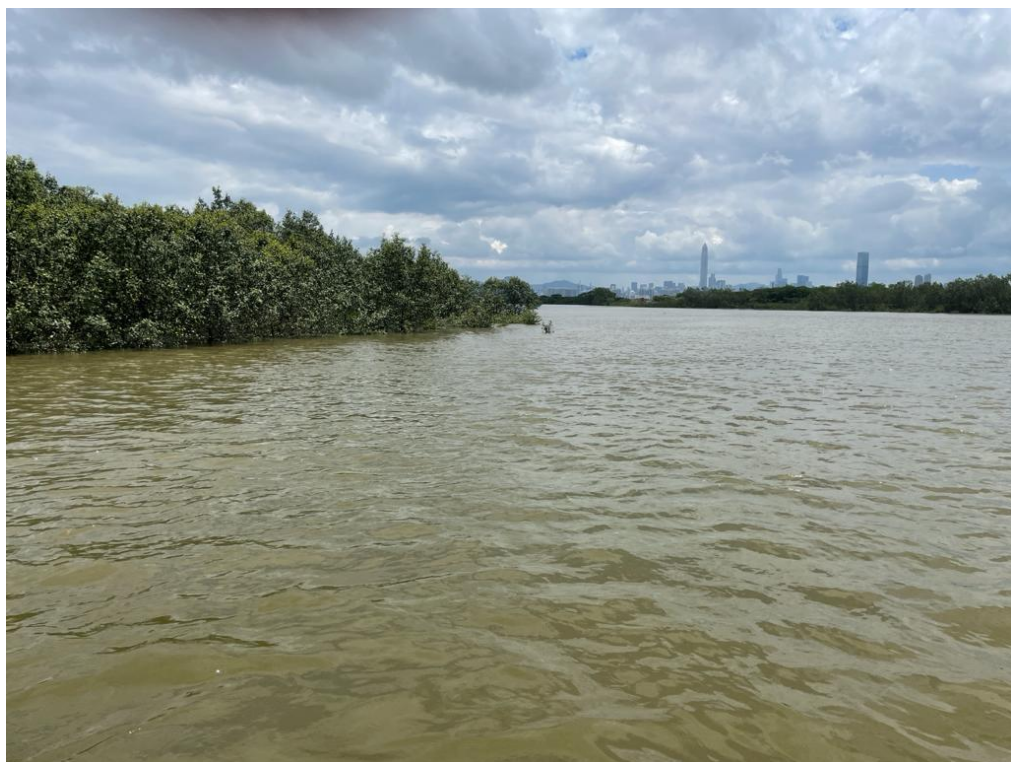
Monitoring Station: M1

Date of investigation: 08 June 2021 (**Ebb Tide**)

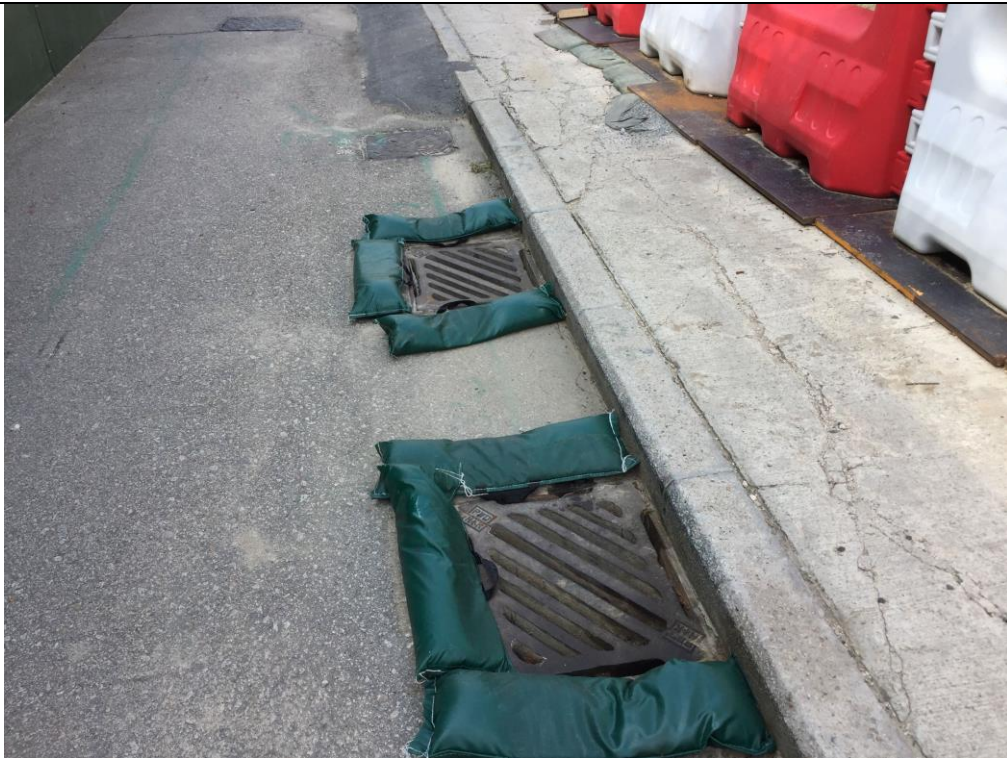
Date of site inspection: 8 June 2021

Gullies were banded by sand bags to prevent surface runoff.

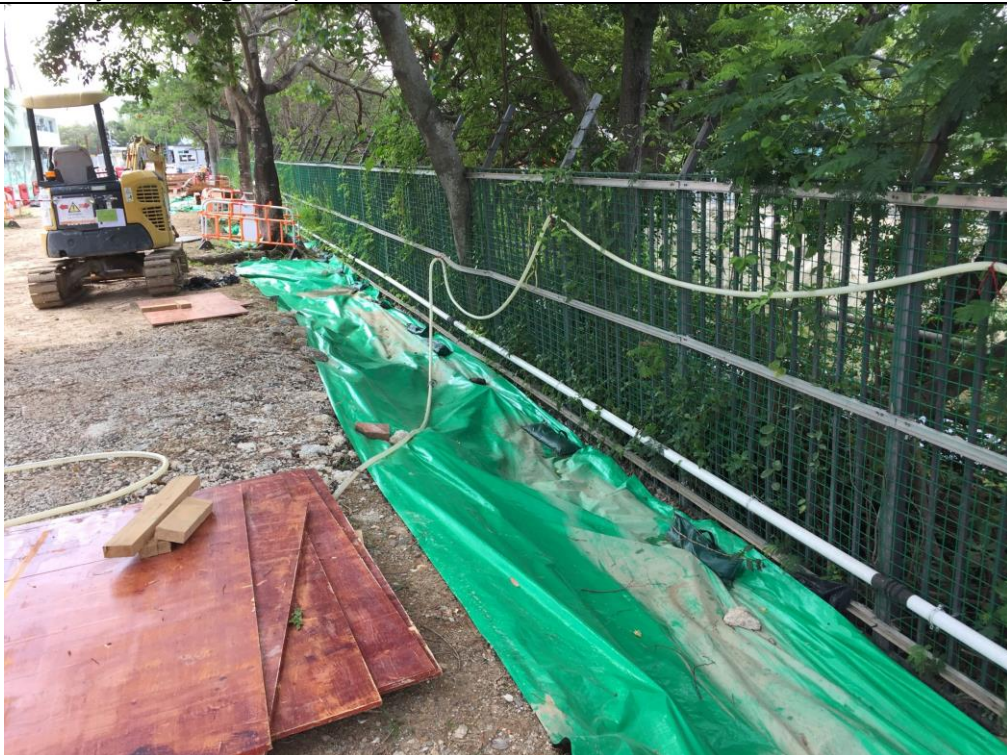
Date of site inspection: 8 June 2021

The surrounding of the construction site areas were covered by impermeable sheeting to prevent surface runoff.

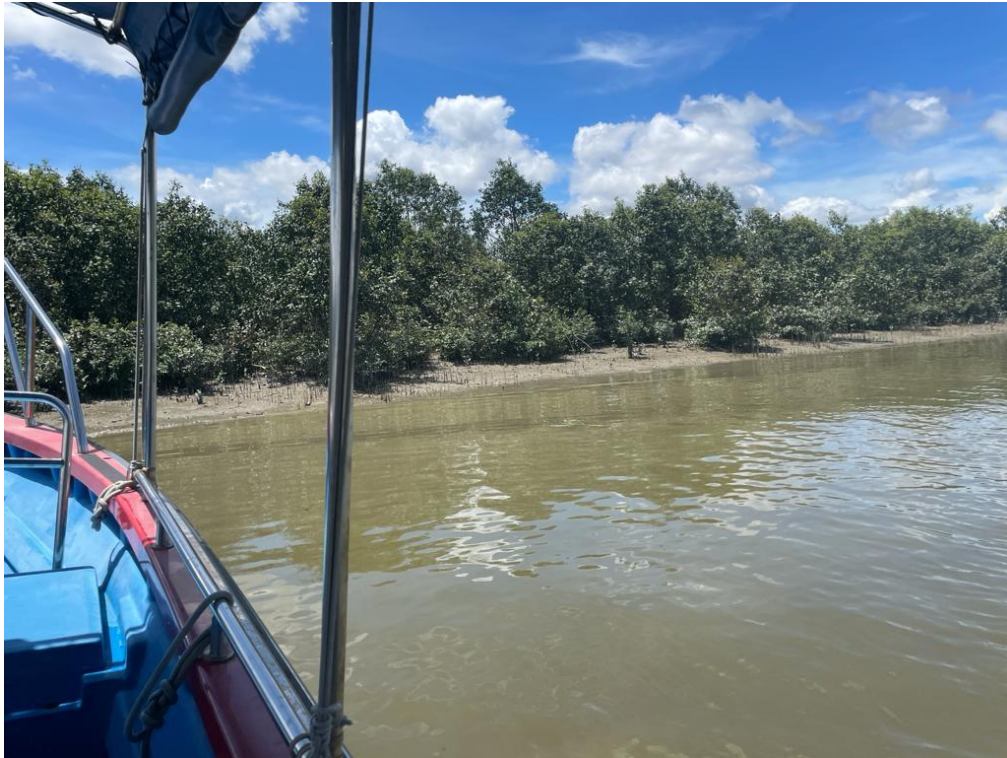
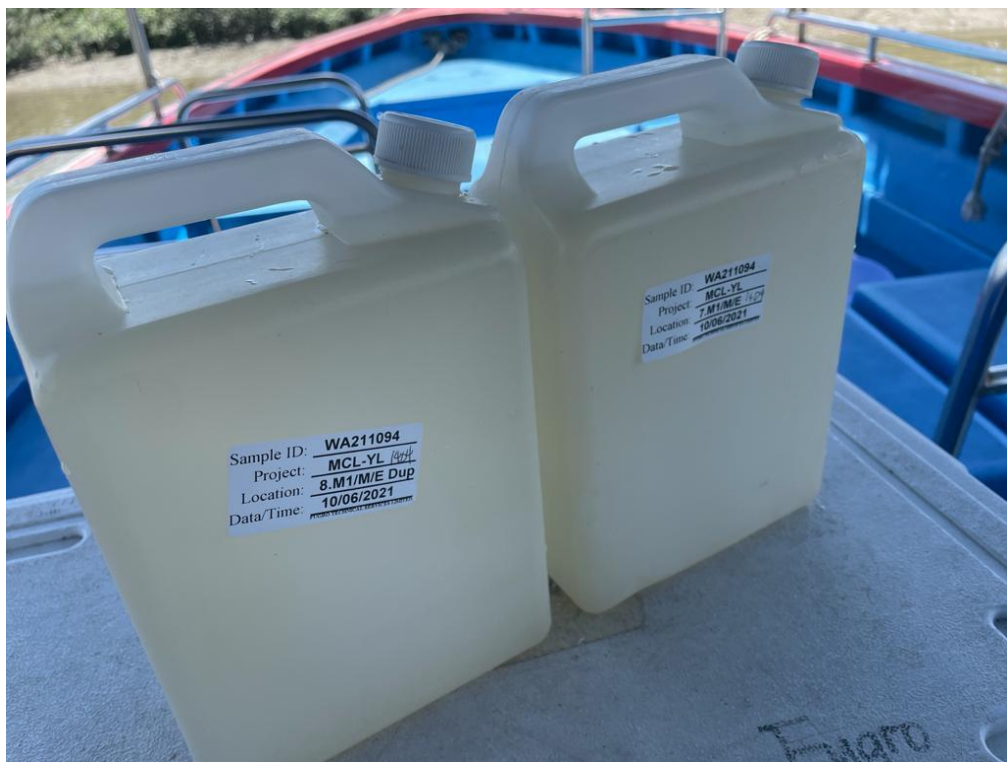
Monitoring Station: M1

Date of investigation: 10 June 2021 (**Ebb Tide**)

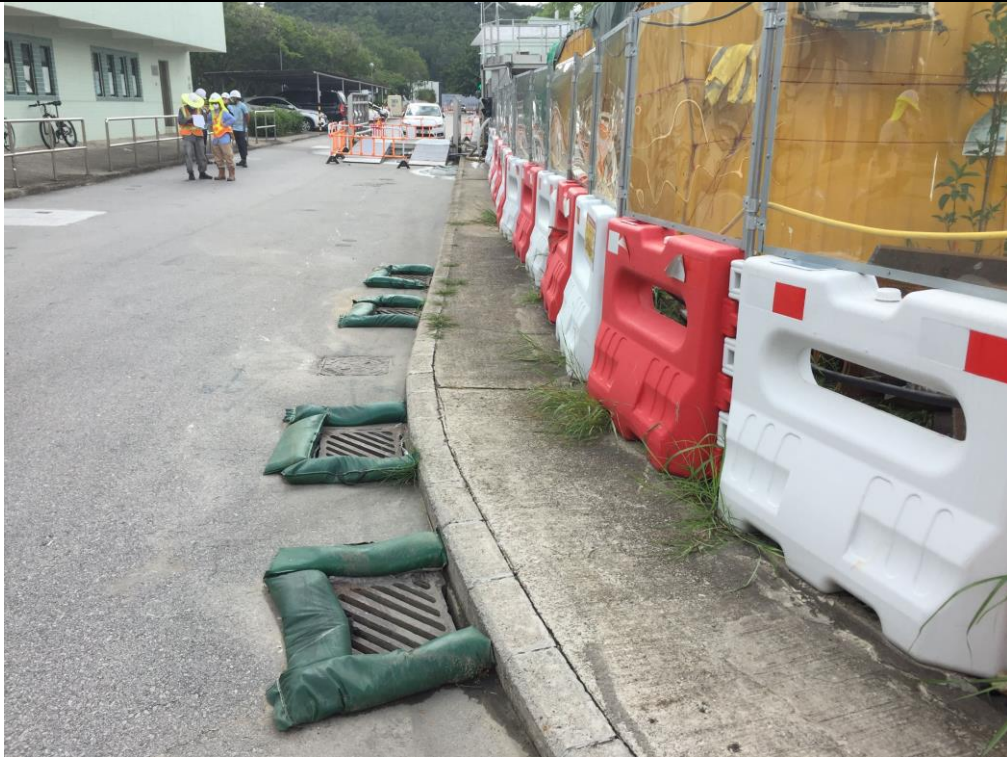
Date of site inspection: 16 June 2021

Gullies were bunded by sand bags to prevent surface runoff.

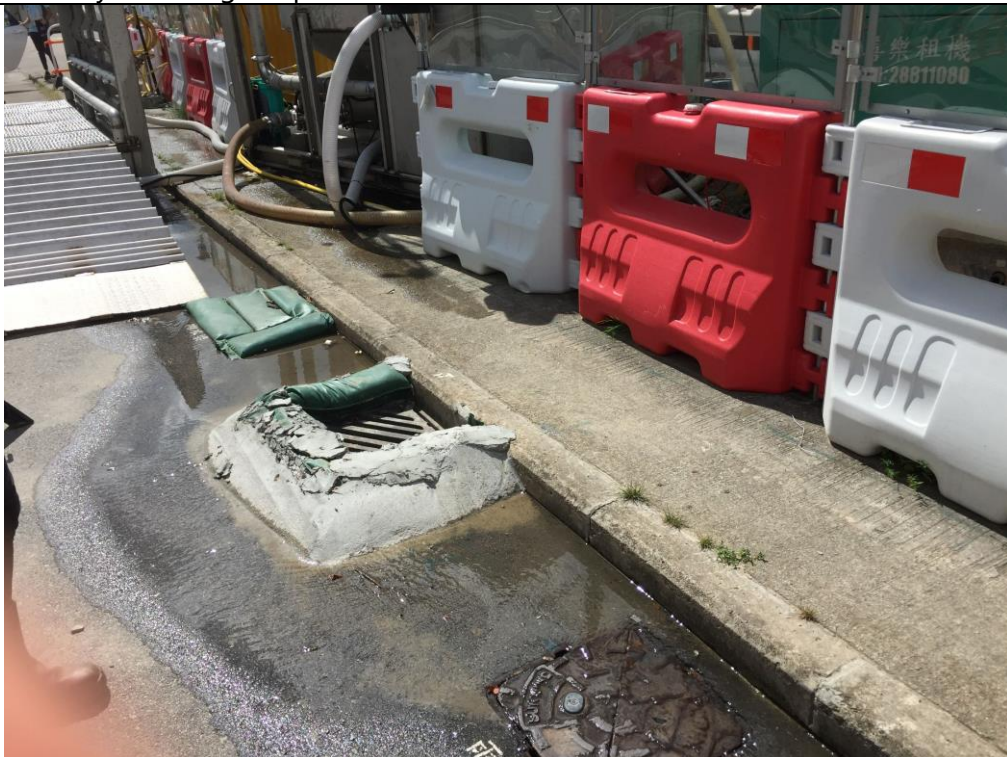
Date of site inspection: 16 June 2021

The surrounding of gullies near the construction site areas were temporarily sealed.

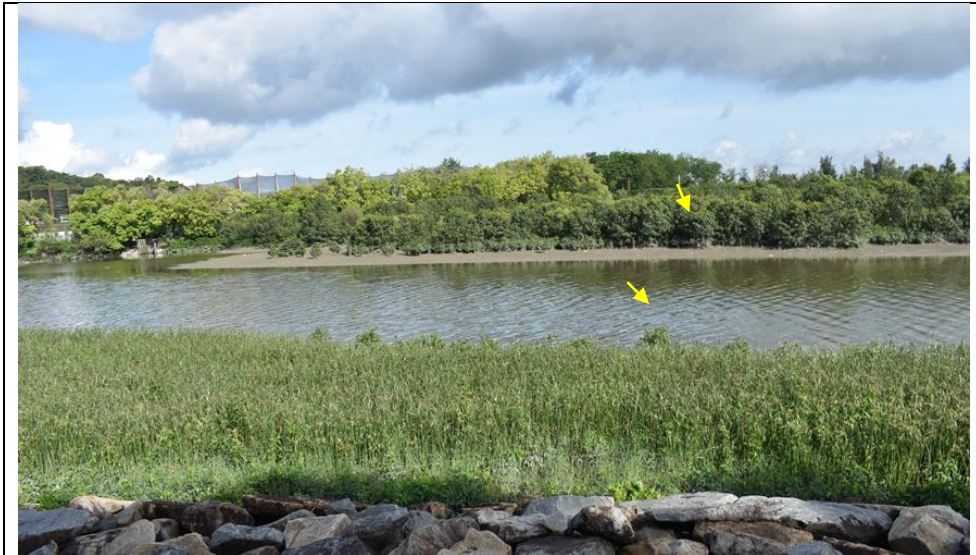
Annex F.3. Mangrove habitat and modified watercourse east of the Project Site
