**Contract No. SPW 02/2023
Environmental Team for
Construction of Yuen Long
Effluent Polishing Plant
Stage 1**

**Monthly EM&A Report (September 2023)
Drainage Services Department**

2023-10-18

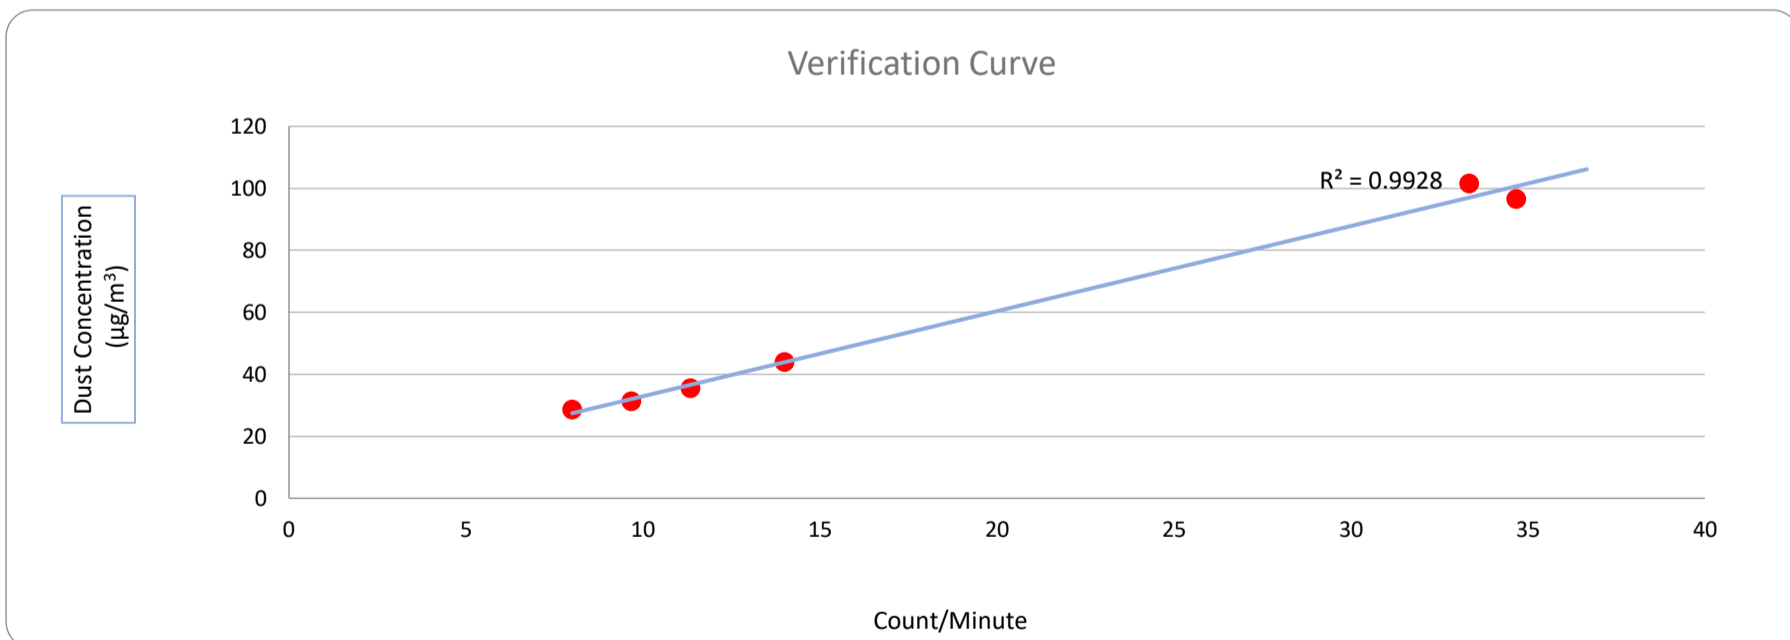
Linear Regression of y on x

Slope, K factor:	2.7466	Intercept:	5.4440	*Correlation Coefficient, R:	0.9964
Verification Test Result: <u>Strong Correlation, Results were accepted.</u>			* If the Correlation Coefficient, R is <0.5. Checking and Re-verification are required.

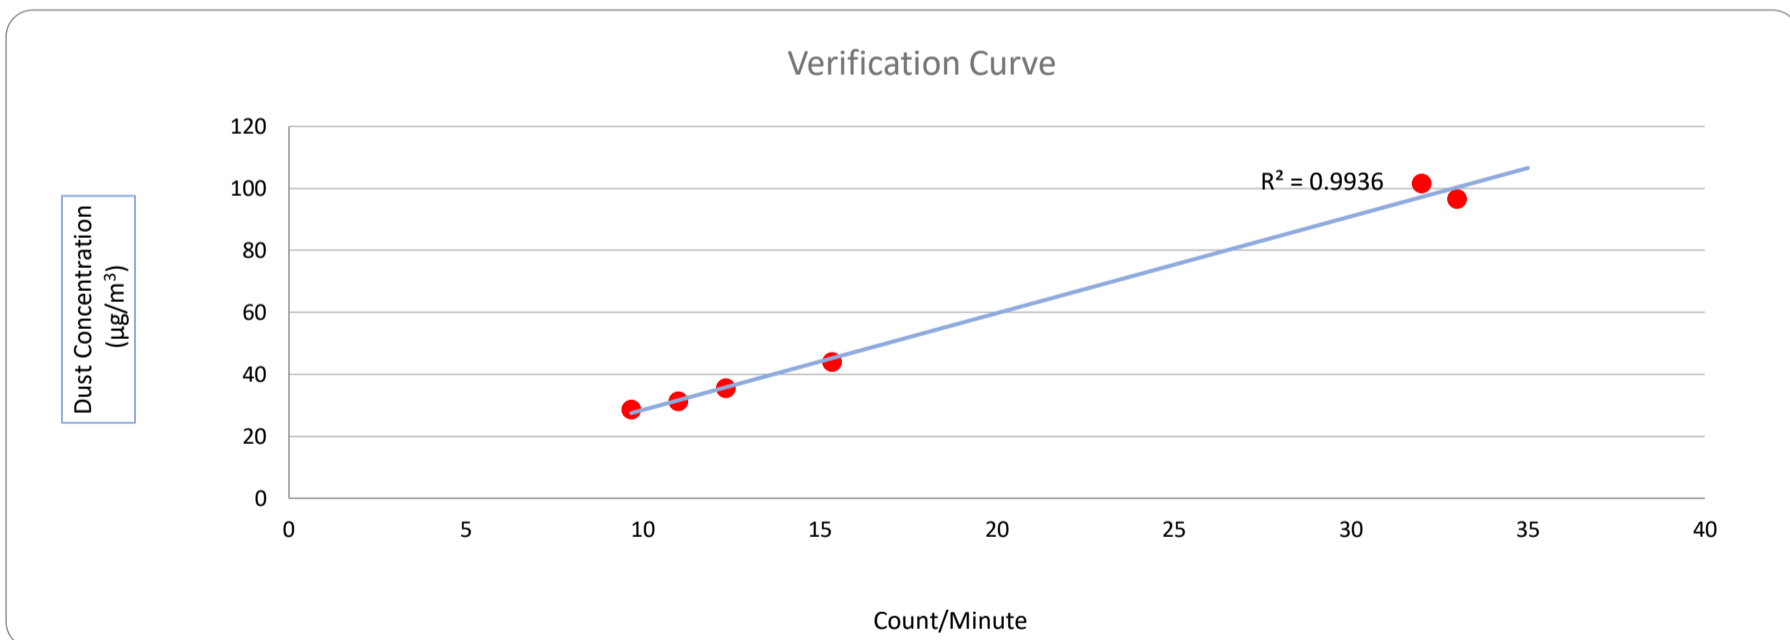
Linear Regression of y on x

Slope, K factor:	3.1227	Intercept:	-2.7291	*Correlation Coefficient, R:	0.9968
Verification Test Result: <u>Strong Correlation, Results were accepted.</u>				* If the Correlation Coefficient, R is <0.5. Checking and Re-verification are required.

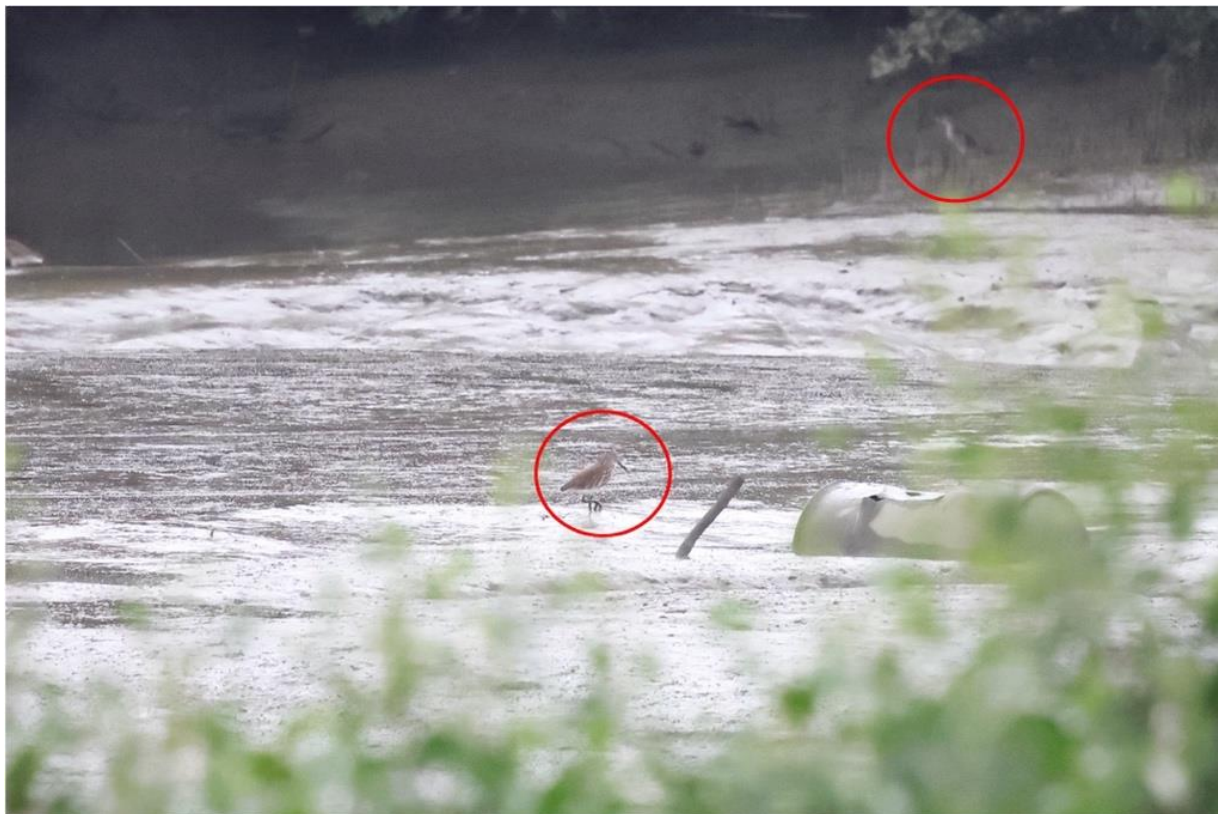
Appendix O.2.1a: Pre-roost aggregate of Chinese Pond Heron *Ardeola bacchus* in the mudflat area east of the Project boundary observed on 21 September 2023 around 18:02

The monitoring activity was conducted on 21 September 2023 and started around 17:21 (one hour before sunset) on a low tide condition. During the pre-roost period (PRP), the period when avian individuals gather first before flying into a night roost, individuals of Chinese Pond Heron *Ardeola bacchus* (4) were observed in pre-roost aggregate (PRA) around 18:25 at the mudflat east side ANR1 of the Project boundary while other individuals of Chinese Pond Heron *Ardeola bacchus* (9) were concurrently noted at the mudflat northeast side ANR2 of the Project boundary (**Table 17**).

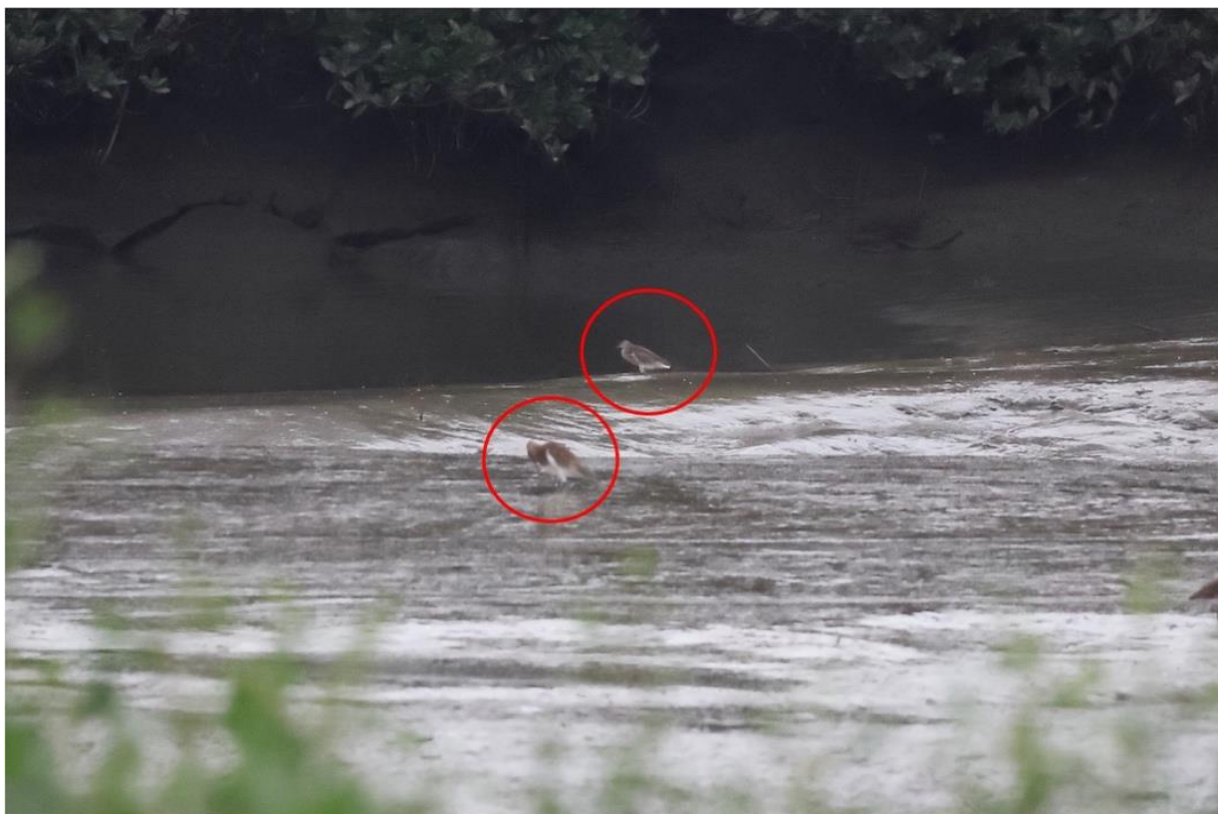
Appendix O.2.1b: Pre-roost aggregate of Chinese Pond Heron *Ardeola bacchus* in the mudflat area of the Project boundary observed on 21 September 2023 around 18:10

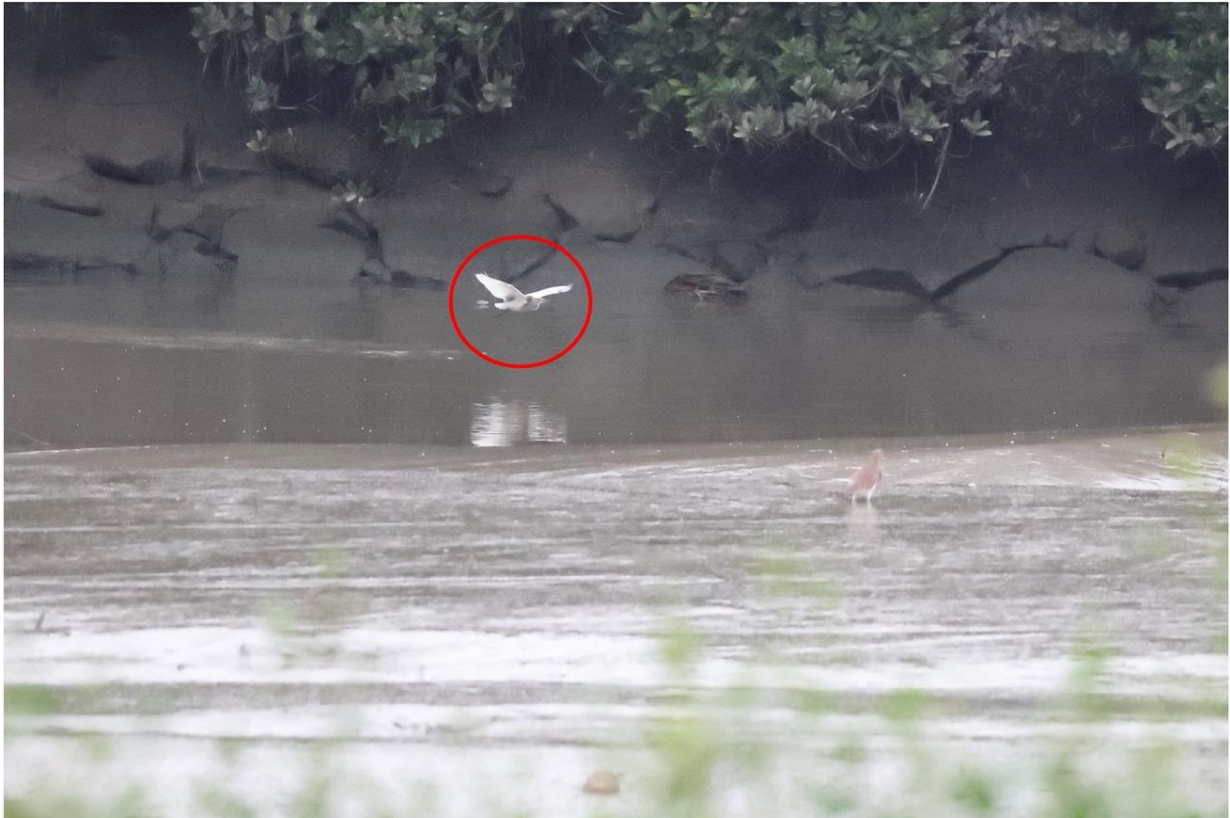
Appendix O.2.2a: Active night roost of Chinese Pond Heron *Ardeola bacchus* located northeast of the Project boundary observed on f the Project boundary observed on 21 September 2023 around 18:10.

For the final night roost at around 18:50, individuals of Chinese Pond Heron *Ardeola bacchus* (4) were observed at the roosting area ANR1 utilizing the understory to canopy layer of the roosting substrate *Sonneratia apetala* and *S. caseolaris*; while Chinese Pond Heron *Ardeola bacchus* (9) were noted at ANR2 that utilized the understory to canopy layer of the aforementioned roosting substrate.

No disturbance (construction related and/or otherwise) to the active night roost areas was observed during the period. Bird droppings were observed within the vicinity of the roosting area located east of the Project boundary.

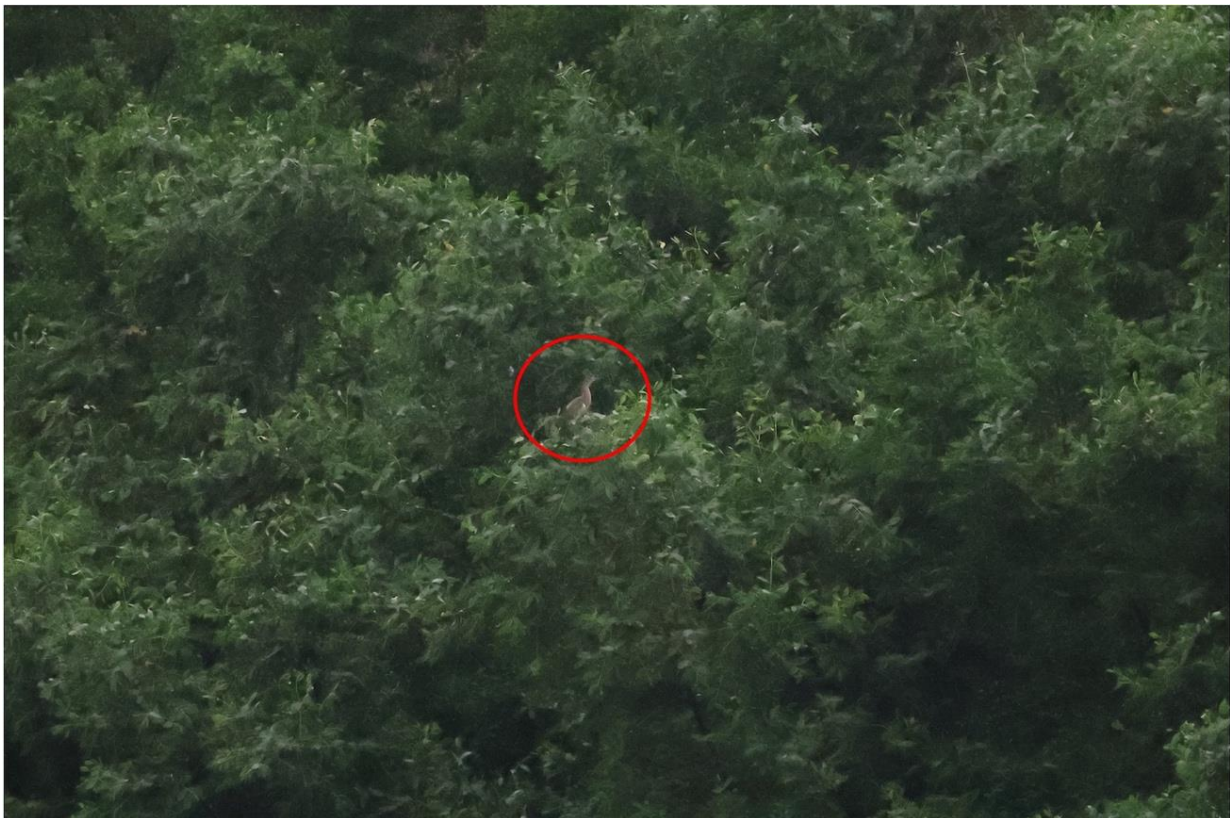
Appendix O.2.2b: Active night roost on *Sonneratia apetala* and *S. caseolaris* mangrove roosting substrate located northeast of the Project boundary observed on 21 September 2023 around 18:20.
