**Contract No. SPW 02/2023
Environmental Team for
Construction of Yuen Long
Effluent Polishing Plant
Stage 1**

**Monthly EM&A Report (June 2025)
Drainage Services Department**

**EP Condition 3.4 – Monthly EM&A Report for June
2025**

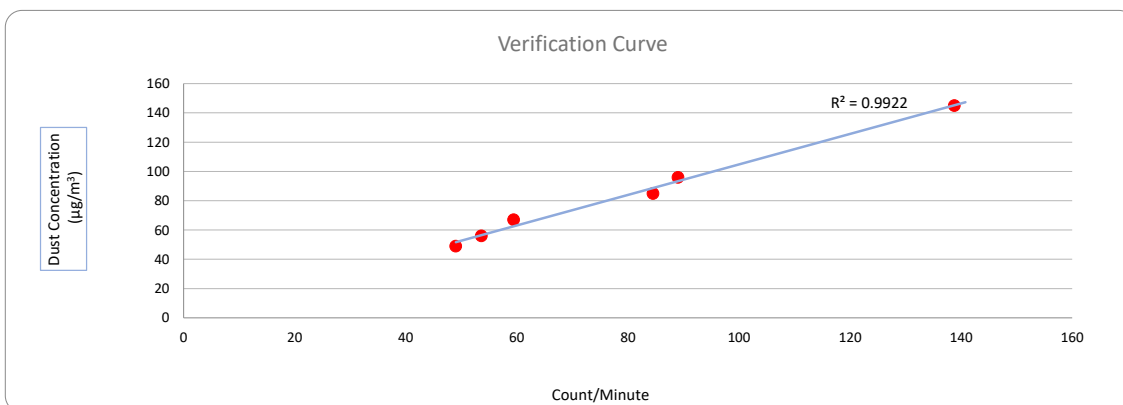
Linear Regression of y on x

Slope, K factor:	<u>1.0418</u>	Intercept:	<u>0.6307</u>	*Correlation Coefficient,R:	<u>0.9961</u>
Verification Test Result:	<u>Strong Correlation, Results were accepted.</u>			* If the Correlation Coefficient, R is <0.5. Checking and Re-verification are required.

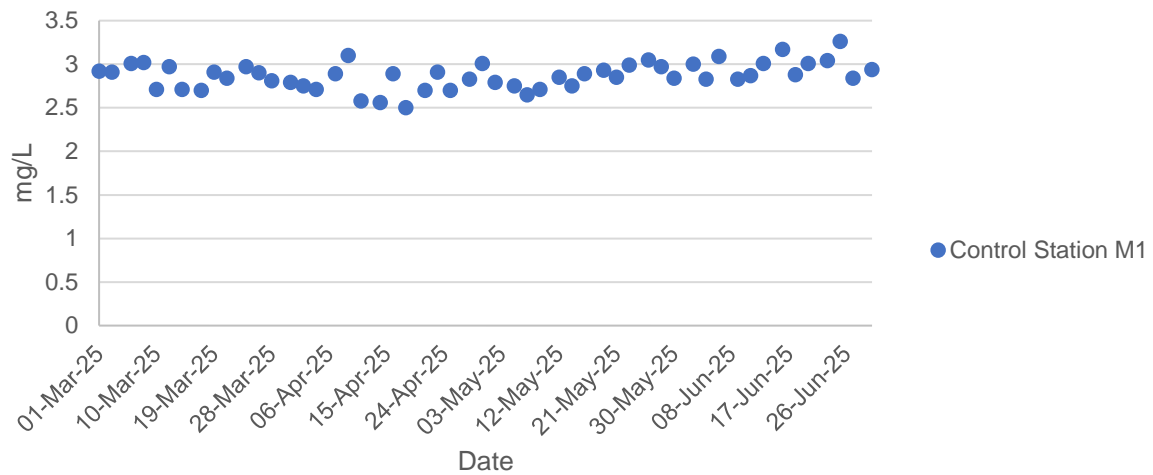
Dissolved Oxygen at Mid-Flood Tide

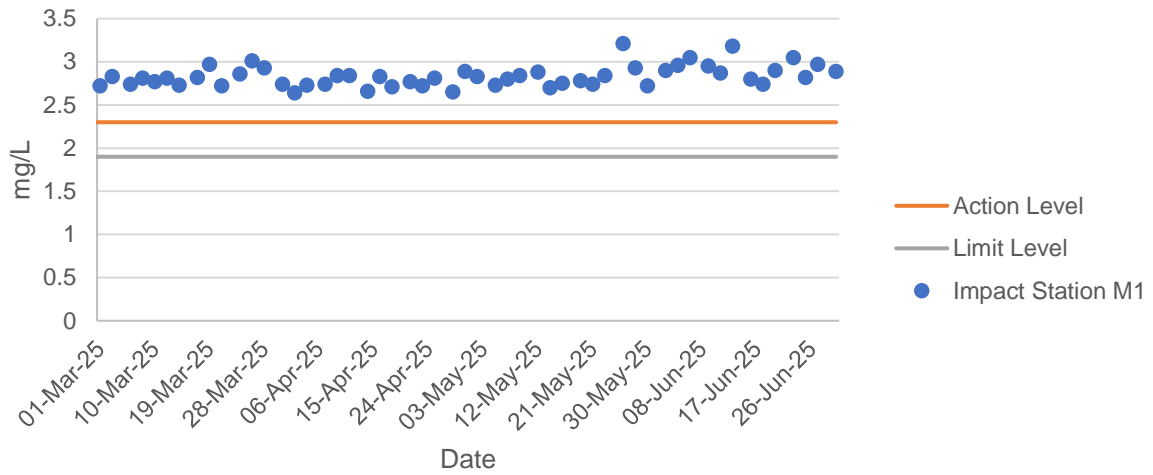
Dissolved Oxygen at Mid-Ebb Tide

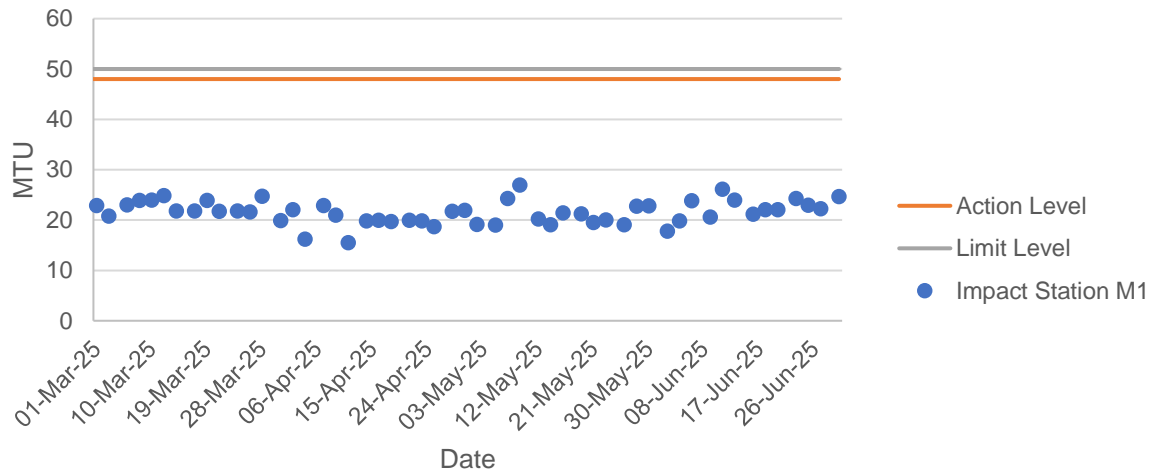
Turbidity at Mid-Ebb Tide

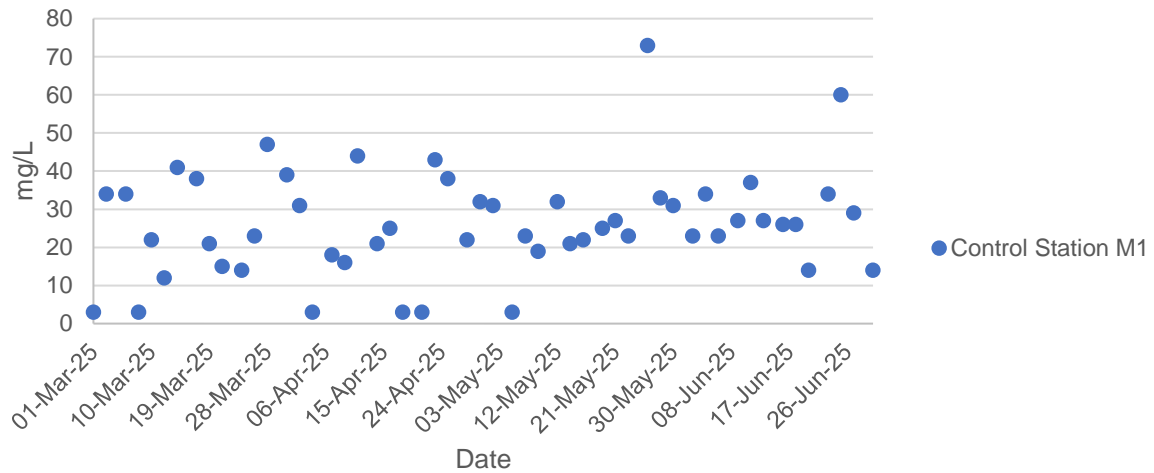
Total Suspended Solids at Mid-Flood Tide

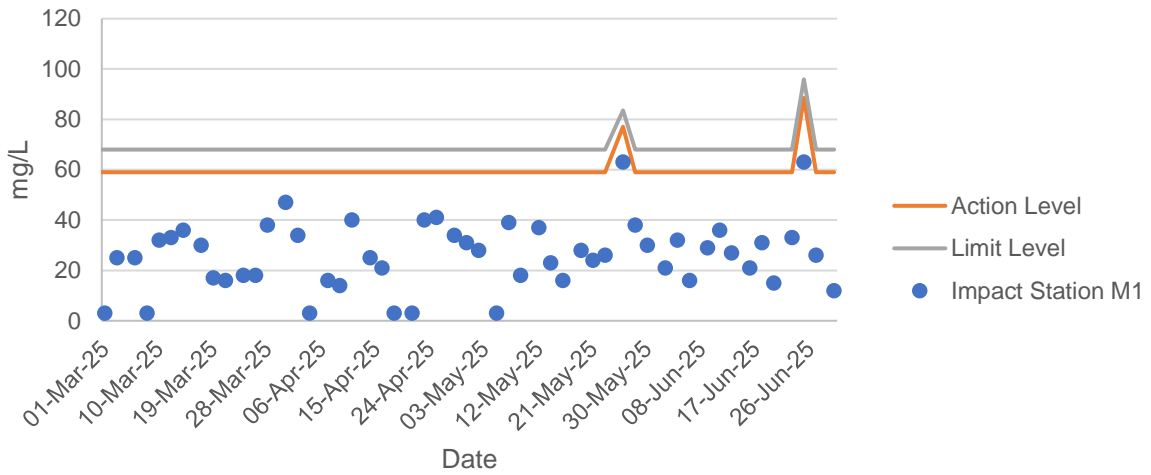
Total Suspended Solids at Mid-Ebb Tide

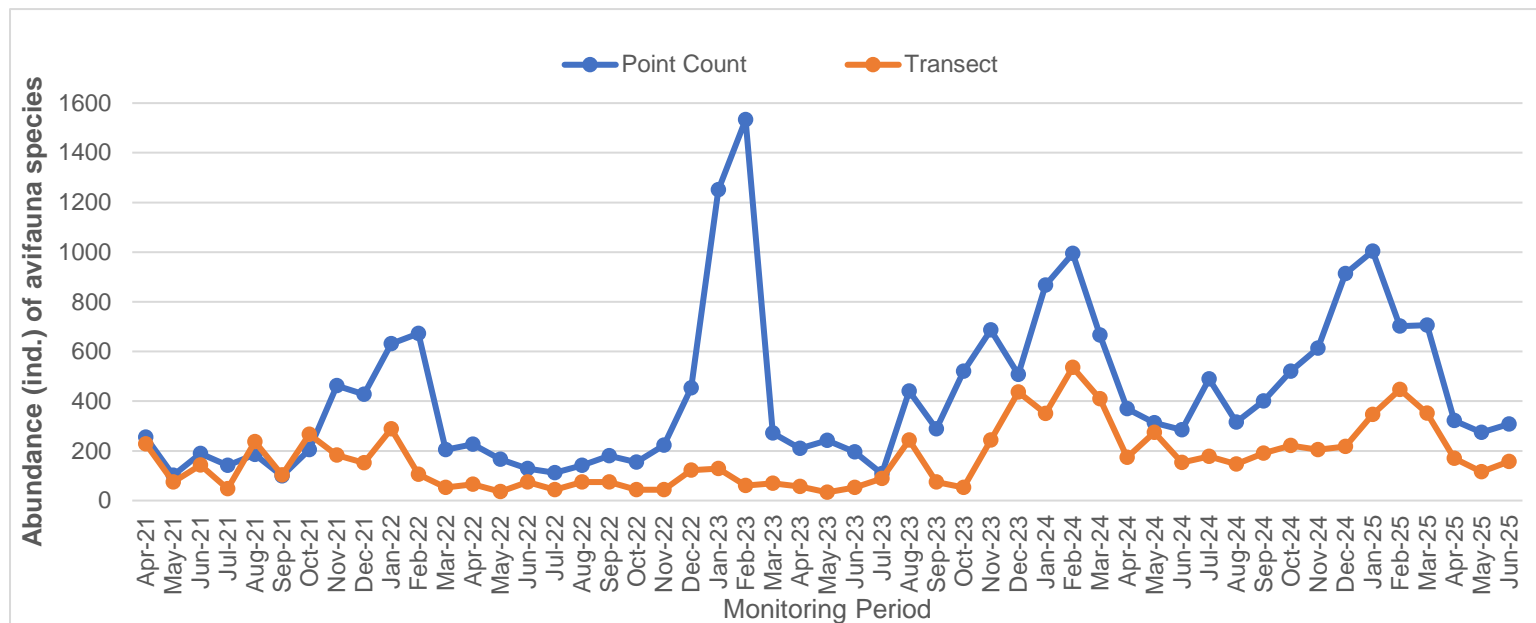
Appendix F.3.1 Abundance of all avifauna species throughout the monitoring period

An overall total of 465 avifauna individuals were recorded in the monitoring area during the June 2025 monitoring period, of which 308 individuals were recorded from the point count method and 157 individuals from the transect walk method. Relative to the June 2017 baseline data (point count method = 121; and transect walk = 69), increases were noted for both the point count and transect walk methods.

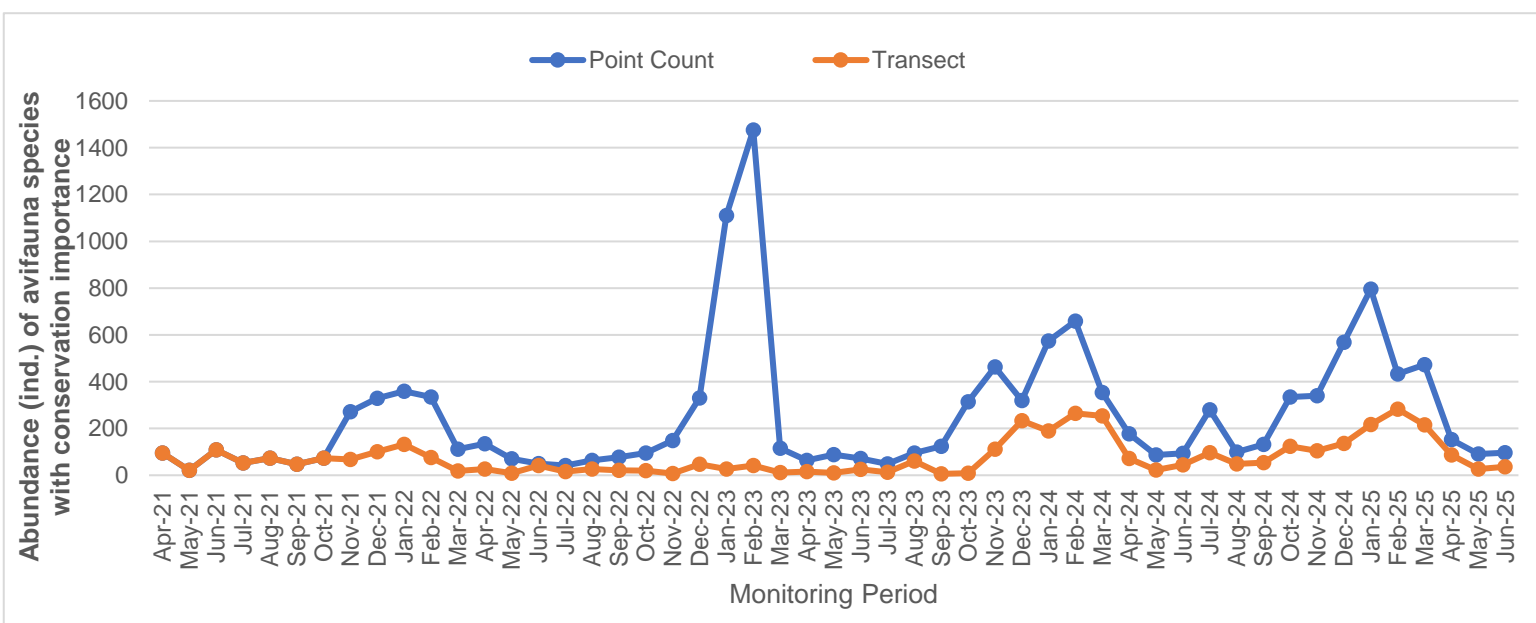
Appendix F.3.2 Abundance of avifauna species with conservation importance throughout the monitoring period

Of the 465 avifauna individuals recorded in the monitoring area during the June 2025 monitoring period, 132 individuals (point count method = 96 individuals; transect walk method = 36 individuals) were of conservation importance. With reference to June 2017 data, (point count method = 45; and transect walk = 40), an increase was noted for point count method and a slight decrease was noted for transect walk method. Details of these findings are summarized in **Table 21**.

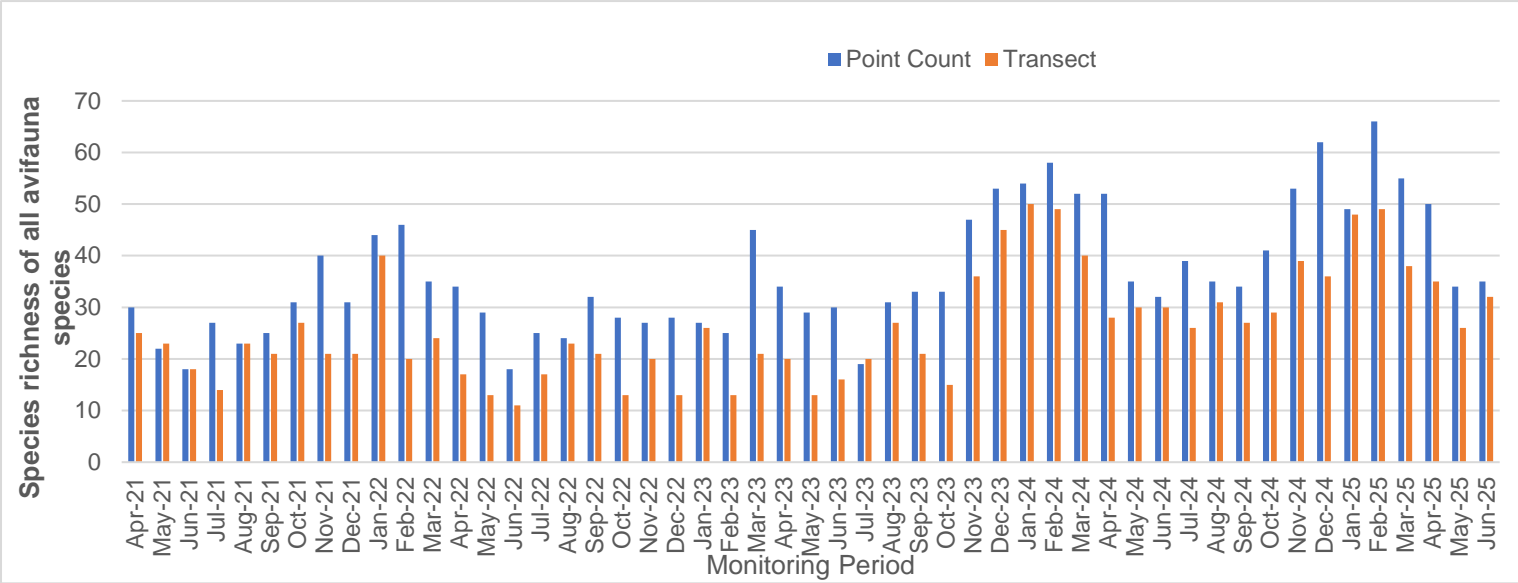
Appendix F.4.1 Species richness of all avifauna species throughout the monitoring period

A total of 43 avifauna species (species richness) were recorded during the June 2025 monitoring period, of which, 35 species were recorded by the point count method while 32 species were noted by the transect walk method. Relative to the baseline data (point count method = 25 species; transect walk method = 13 species), an increase in total species richness for both transect walk count and point count methods were recorded. In terms of Shannon diversity index (H') values, current result in point count method showed an increase (t-value = 1.84; t-crit = 1.97; p-value = 6.63E-02; α = 0.05) relative to the baseline reference value. The current results in the transect walk method also showed a significant increase (t-value = 7.51; t-crit = 1.98; p-value = 8.20E-12; α = 0.05) from baseline reference value. Details of these findings are summarized in **Table 22**, **Appendix F.6.1**, and **Appendix F.6.2**.

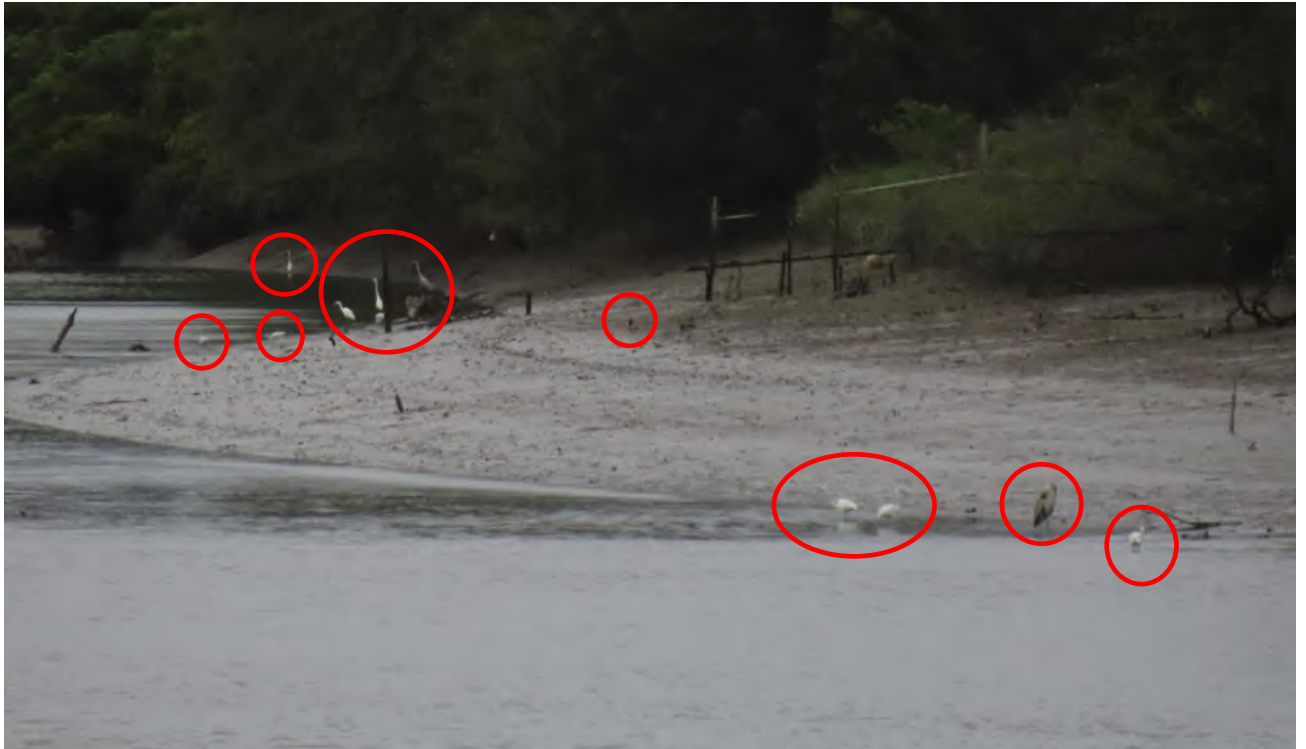
Appendix O.2.1a: Pre-roost aggregate of ardeids in the mudflat northeast side of the Project boundary (ANR2) observed on 11 June 2025 at around 18:37.

The monitoring activity was conducted on 11 June 2025 and started around 18:07 (one hour before sunset) on a low tide condition. During the pre-roost period (PRP), the period when avian individuals gather first before flying into a night roost, individuals of Chinese Pond Heron *Ardeola bacchus* (9), Great Egret *Ardea alba* (1), Little Egret *Egretta garzetta* (5) and Grey Heron *Ardea cinerea* (1) were observed in pre-roost aggregate (PRA) around 18:37 at the mudflat east side ANR1 of the Project boundary while individuals of Chinese Pond Heron *Ardeola bacchus* (6), Great Egret *Ardea alba* (9), Little Egret *Egretta garzetta* (3) and Grey Heron *Ardea cinerea* (1) were concurrently noted at the mudflat northeast side ANR2 of the Project boundary (Table 17).

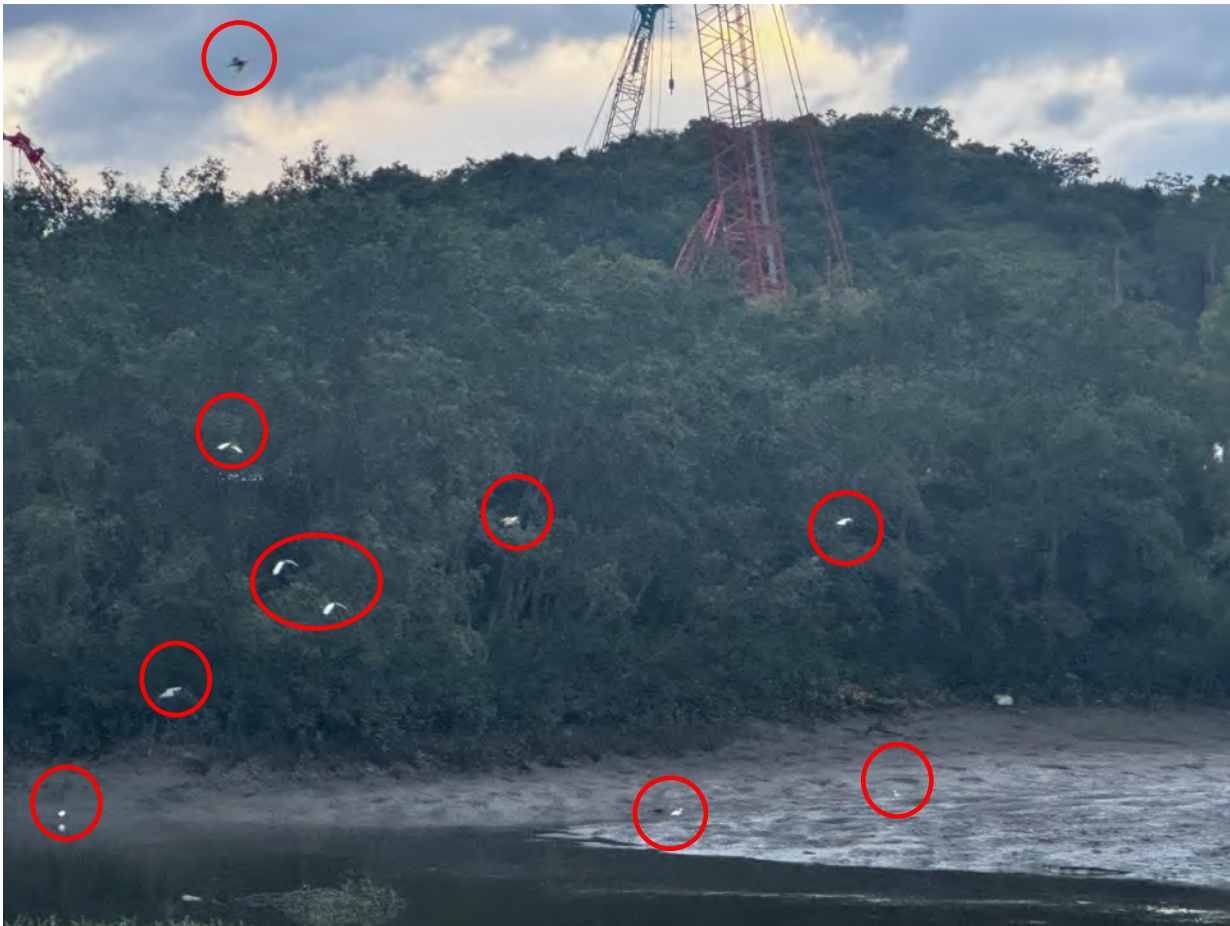
Appendix O.2.2a: Active night roost in the mudflat east side of the Project boundary (ANR1) observed on 11 June 2025 at around 18:57.

For the final night roost at around 18:57, individuals of Chinese Pond Heron *Ardeola bacchus* (25), Great Egret *Ardea alba* (3) and Little Egret *Egretta garzetta* (4) were observed at the roosting area ANR1 utilizing the understory to canopy layer of the roosting substrate *Sonneratia apetala* and *S. caseolaris*; while other individuals of Chinese Pond Heron *Ardeola bacchus* (11), Little Egret *Egretta garzetta* (2) and Grey Heron *Ardea cinerea* (1) were noted at ANR2 that utilized the understory to canopy layer of the aforementioned roosting substrate.

No disturbance (construction related and/or otherwise) to the active night roost areas was observed during the period. Bird droppings were observed within the vicinity of the roosting area located east of the Project boundary.
