**Contract No. SPW 02/2023
Environmental Team for
Construction of Yuen Long
Effluent Polishing Plant Stage
1**

**Monthly EM&A Report (August 2025)
Drainage Services Department**

**EP Condition 3.4 – Monthly EM&A Report for
August 2025**

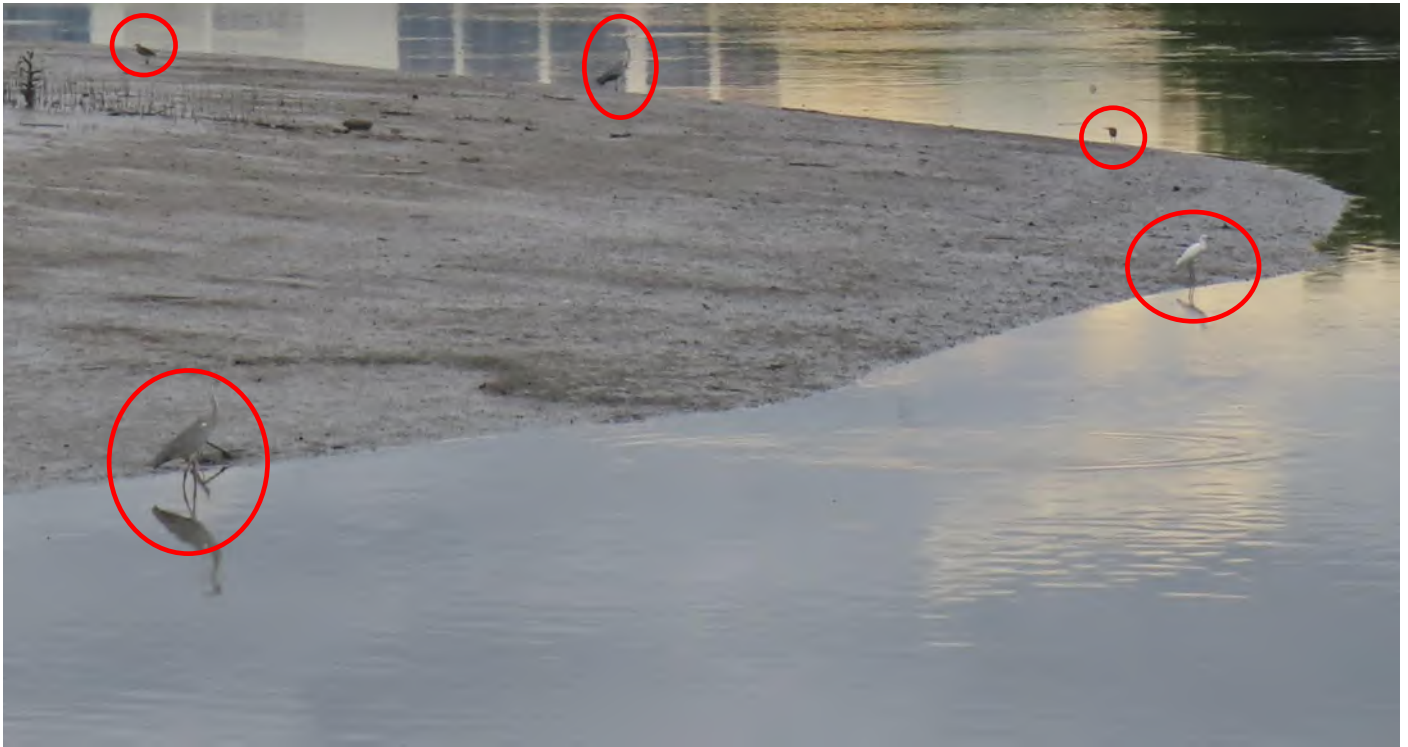
O.2.1 Pre-roosting Aggregate

Appendix O.2.1a: Pre-roost aggregate of ardeids in the mudflat northeast side of the Project boundary (ANR2) observed on 25 August 2025 at around 18:29.

The monitoring activity was conducted on 25 August 2025 and started around 17:46 (one hour before sunset) on a low tide condition. During the pre-roost period (PRP), the period when avian individuals gather first before flying into a night roost, individuals of Chinese Pond Heron *Ardeola bacchus* (2), Great Egret *Ardea alba* (1), Little Egret *Egretta garzetta* (1) and Grey Heron *Ardea cinerea* (1) were observed in pre-roost aggregate (PRA) around 18:29 at the mudflat east side ANR1 of the Project boundary while individuals of Chinese Pond Heron *Ardeola bacchus* (3), Great Egret *Ardea alba* (1), Little Egret *Egretta garzetta* (1) and Grey Heron *Ardea cinerea* (4) were concurrently noted at the mudflat northeast side ANR2 of the Project boundary (Table 17).

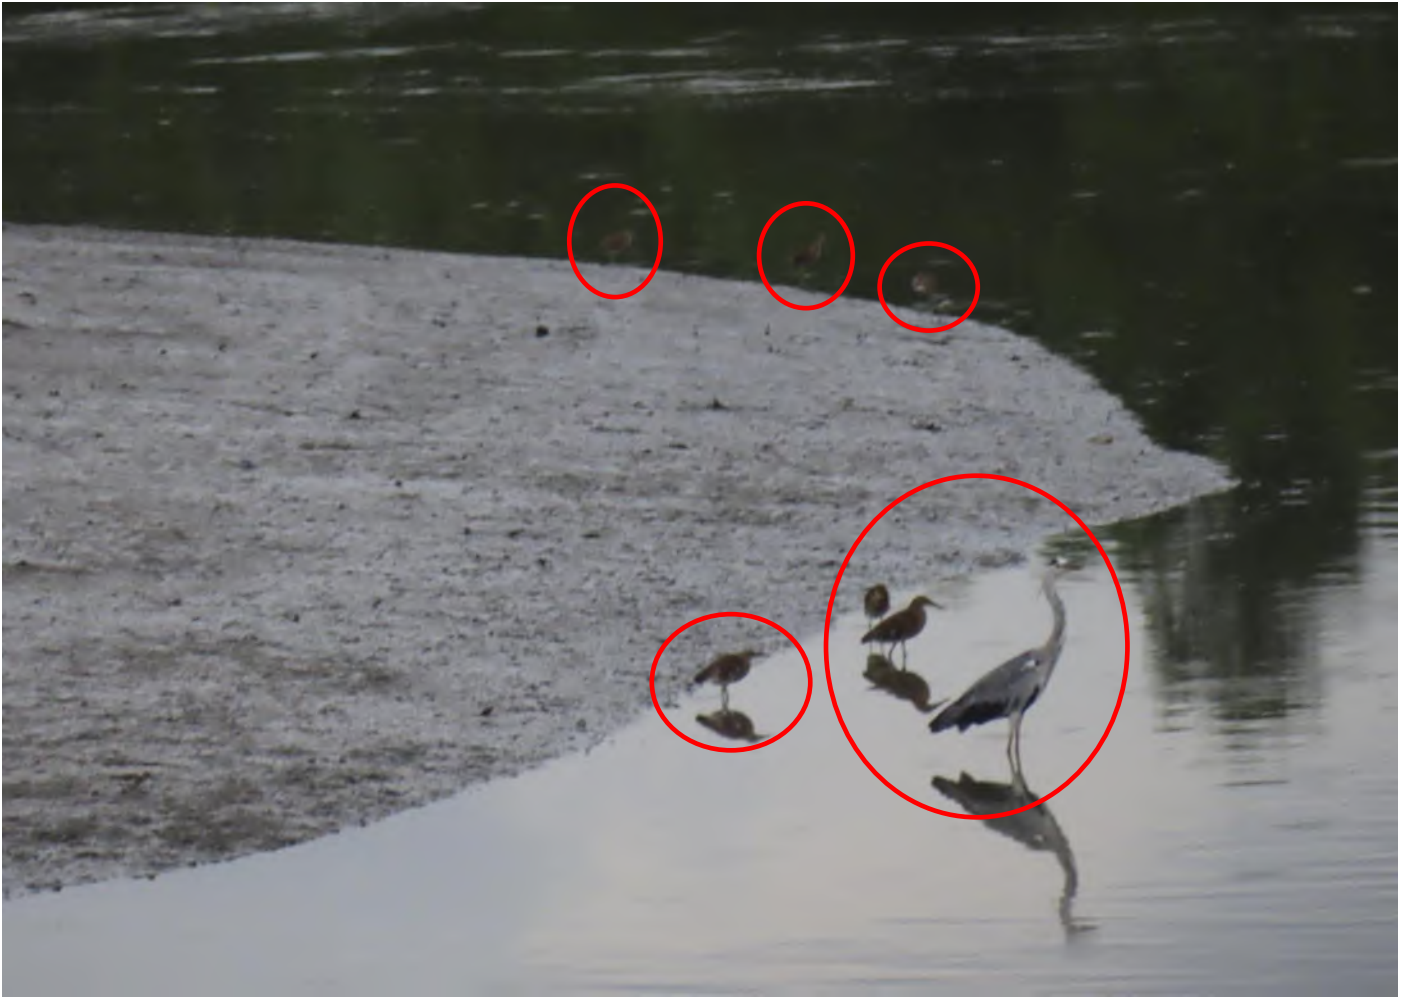
O.2.2 Active Night Roosting Site and Roosting Substrates

Appendix O.2.2a: Active night roost in the mudflat northeast side of the Project boundary (ANR2) observed on 25 August 2025 at around 18:46.

For the final night roost at around 18:52, individuals of Chinese Pond Heron *Ardeola bacchus* (3), Great Egret *Ardea alba* (1) and Grey Heron *Ardea cinerea* (1) were observed at the roosting area ANR1 utilizing the understory to canopy layer of the roosting substrate *Sonneratia apetala* and *S. caseolaris*; while other individuals of Chinese Pond Heron *Ardeola bacchus* (12), Great Egret *Ardea alba* (2), Little Egret *Egretta garzetta* (2) and Grey Heron *Ardea cinerea* (1) were noted at ANR2 that utilized the understory to canopy layer of the aforementioned roosting substrate.

No disturbance (construction related and/or otherwise) to the active night roost areas was observed during the period. Bird droppings were observed within the vicinity of the roosting area located east of the Project boundary.
