# Monthly EM&A Report (May 2023)

**Contract No. SPW 07/2020 Environmental Team for Construction of Yuen Long Effluent Polishing Plant Stage 1**

**Independent Environmental Checker for Construction of Yuen Long Effluent Polishing Plant Stage 1 (2022-2023)**

**EP Condition 3.4 – Monthly EM&A Report for May 2023**

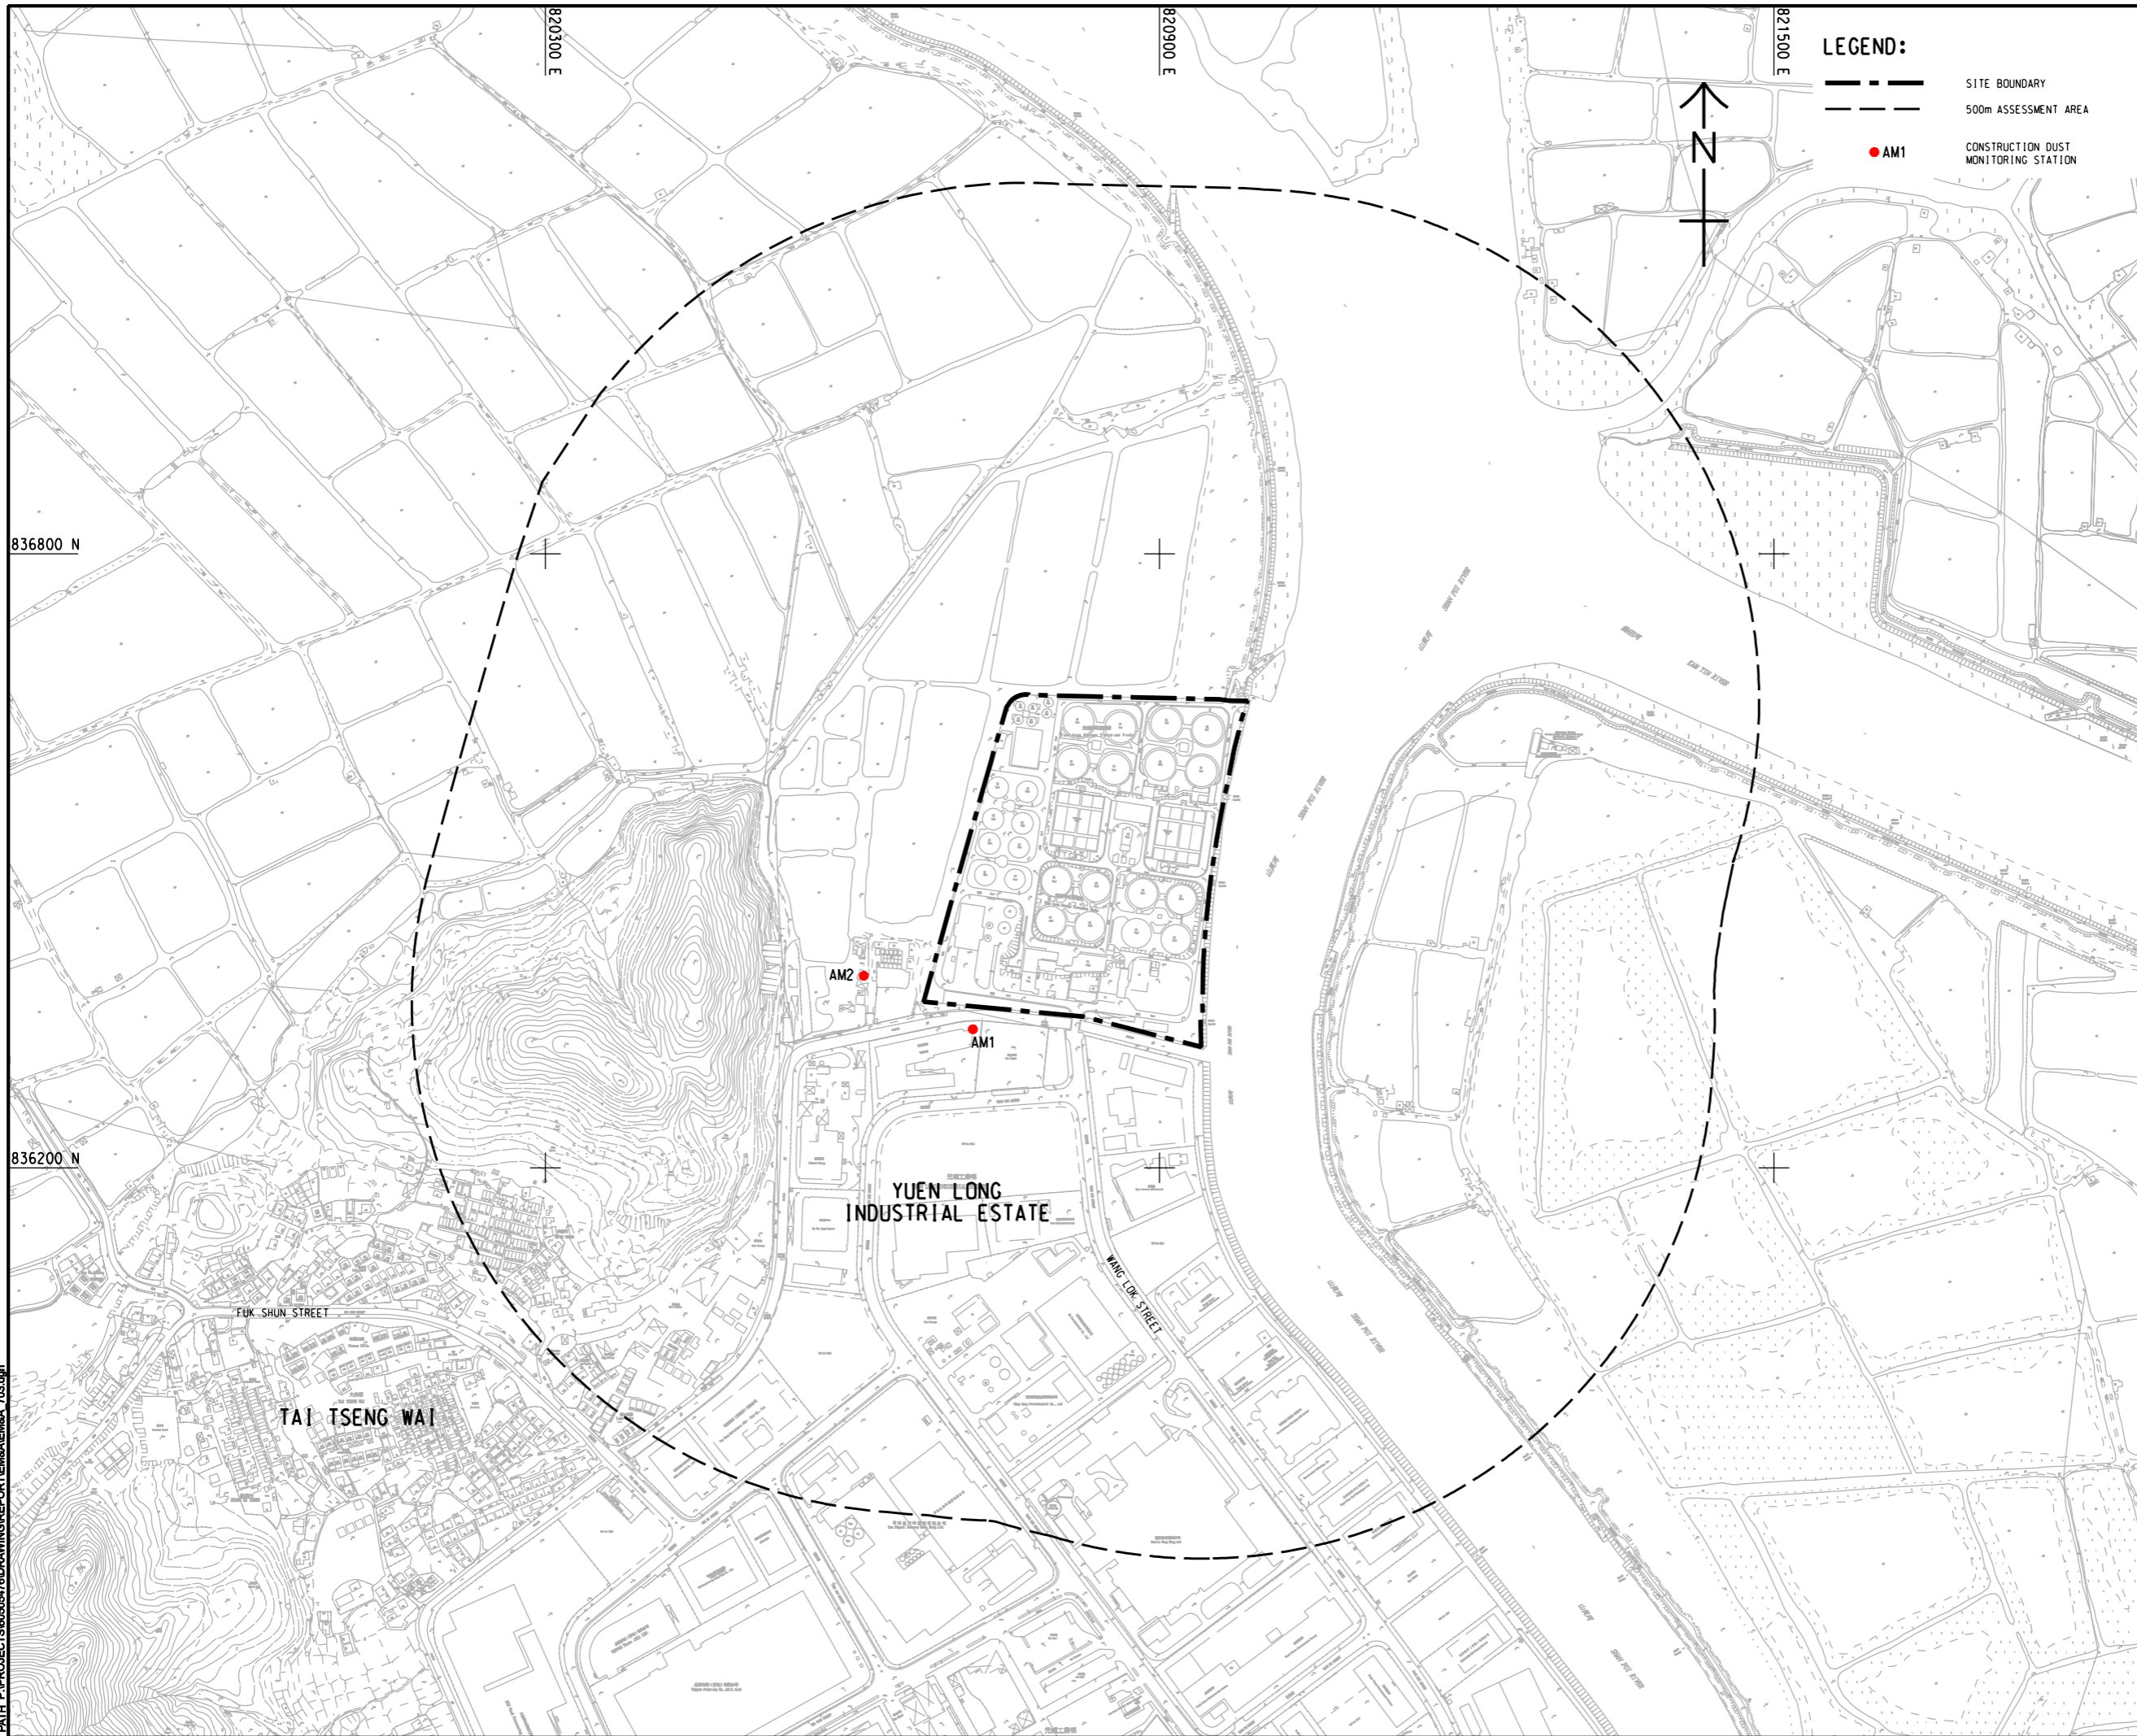
Location of Construction Dust  
Monitoring Stations

- SITE BOUNDARY
- 500m ASSESSMENT AREA
- AM1 CONSTRUCTION DUST MONITORING STATION

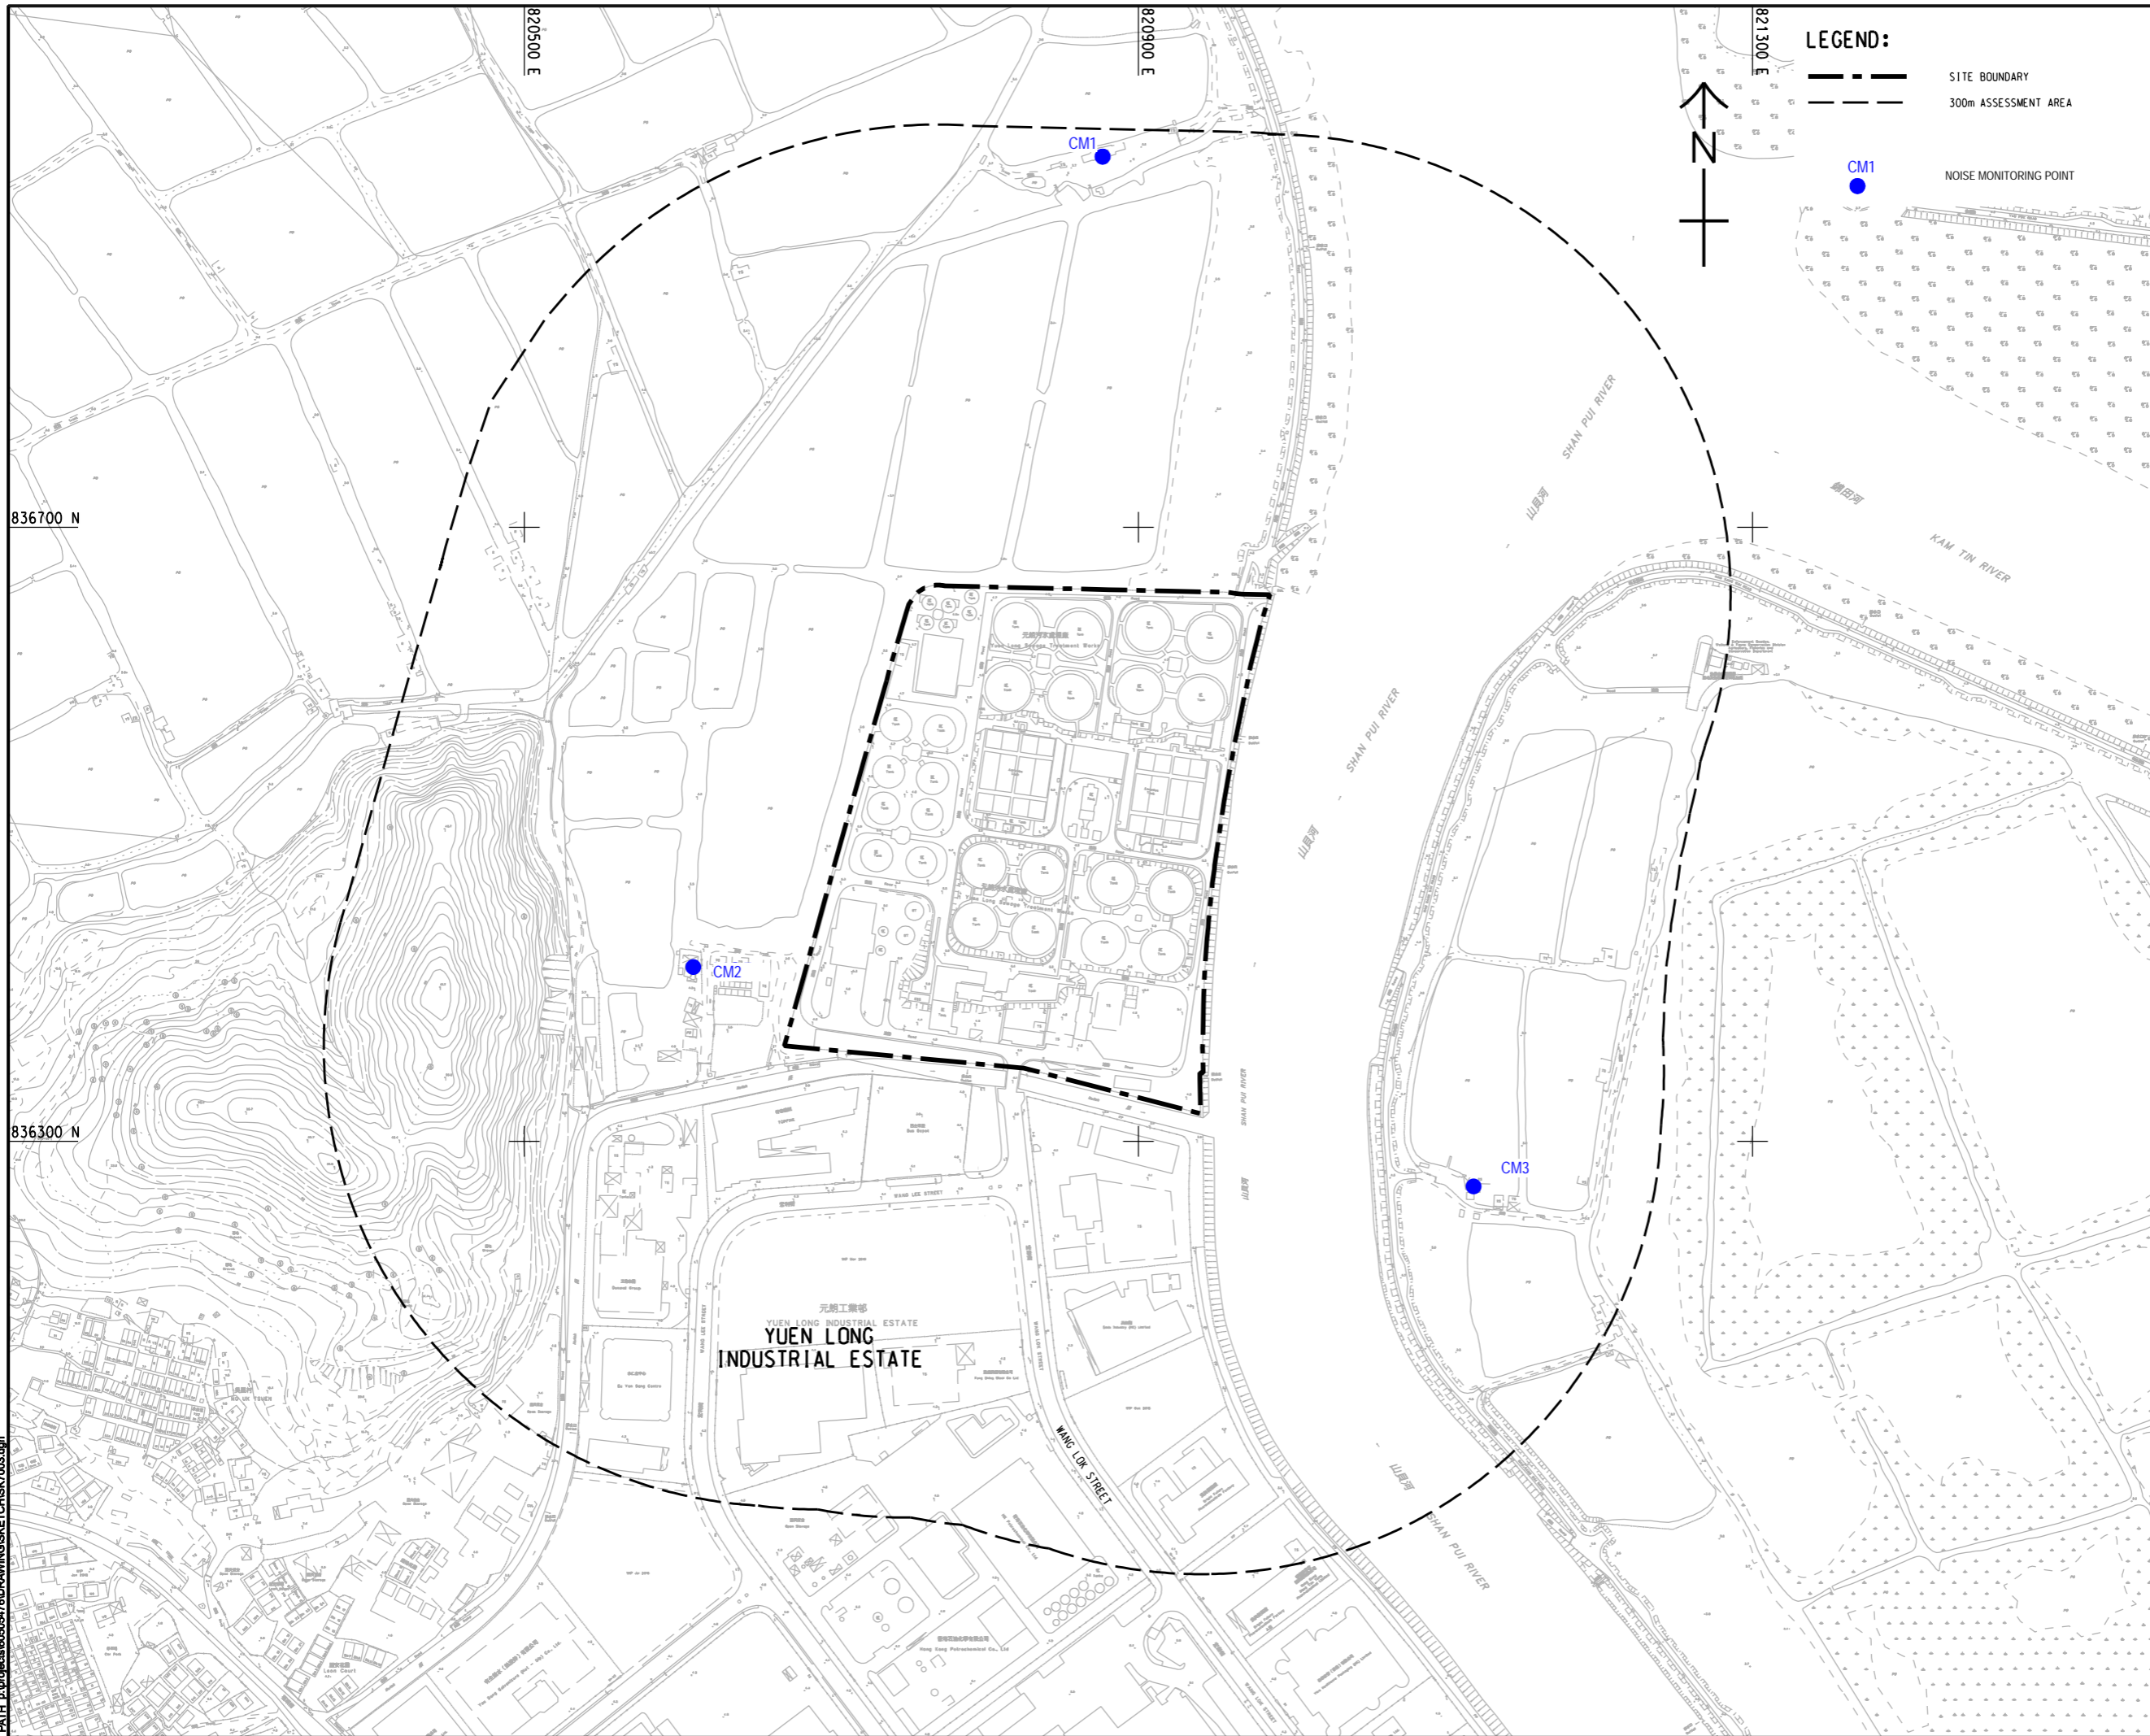
Noise Monitoring Locations

- SITE BOUNDARY
- 300m ASSESSMENT AREA
- NOISE MONITORING POINT

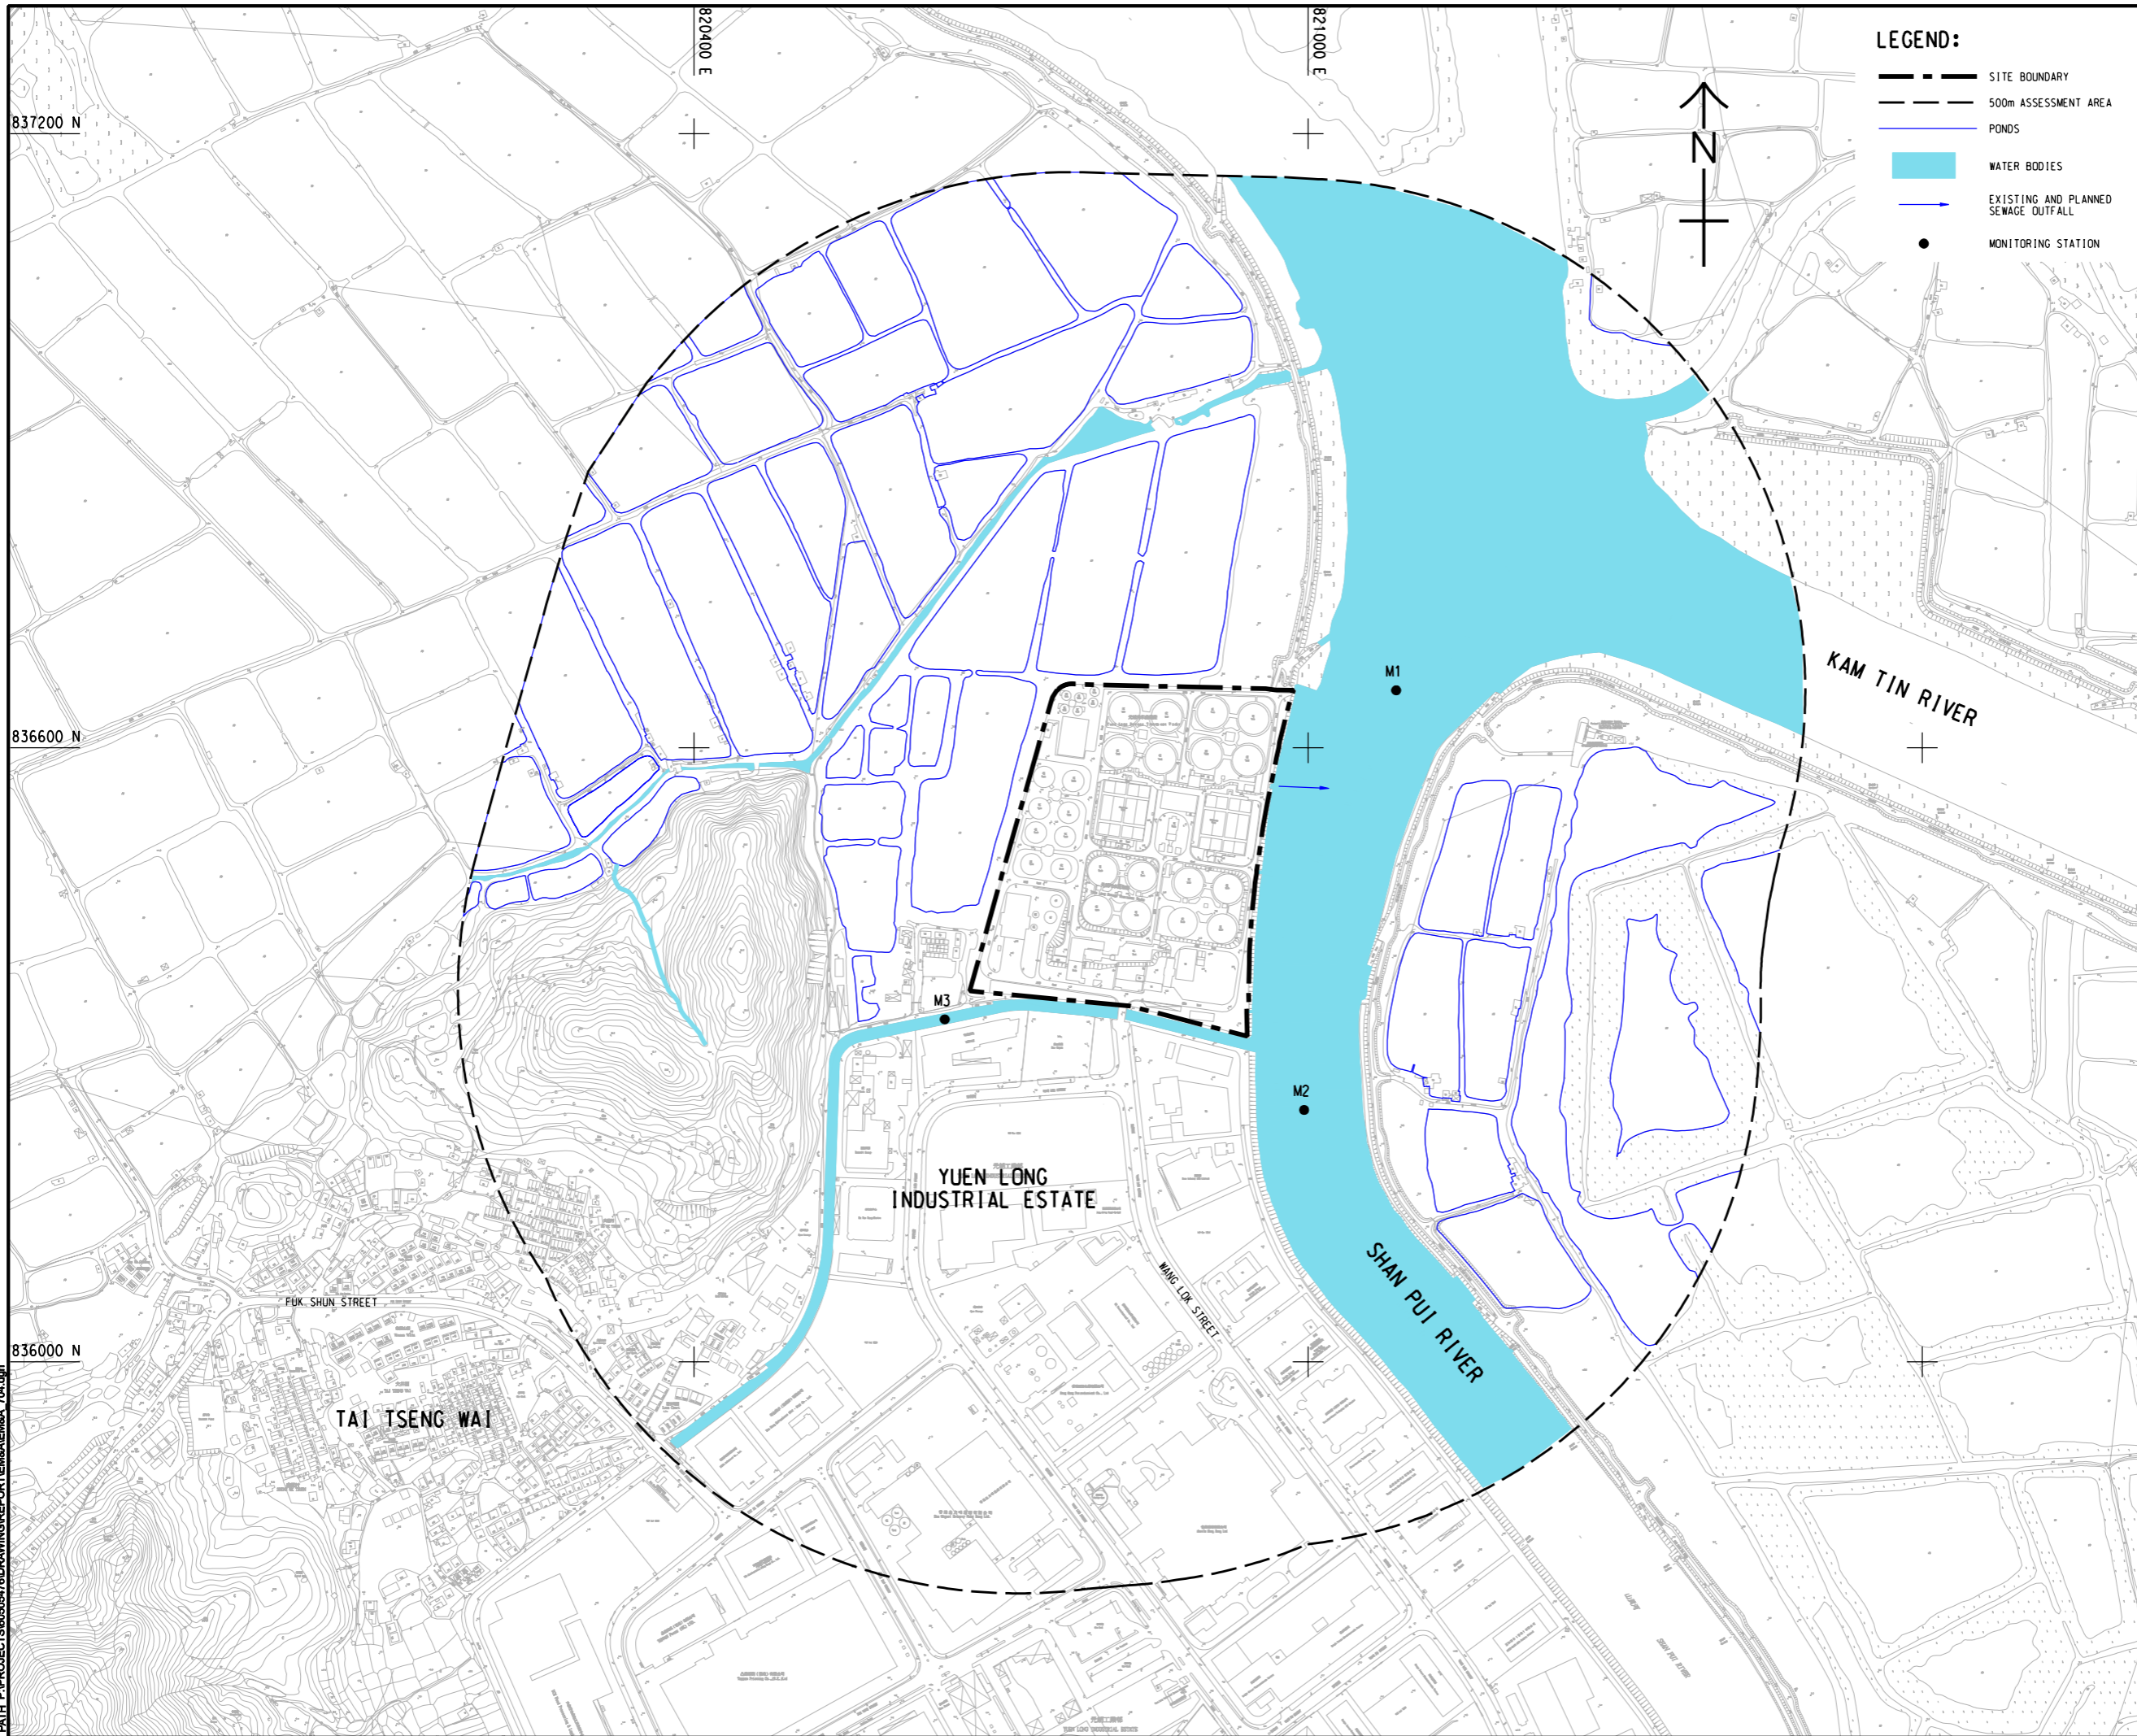
Water Quality Monitoring Locations

- SITE BOUNDARY
- 500m ASSESSMENT AREA
- PONDS
- WATER BODIES
- EXISTING AND PLANNED SEWAGE OUTFALL
- MONITORING STATION

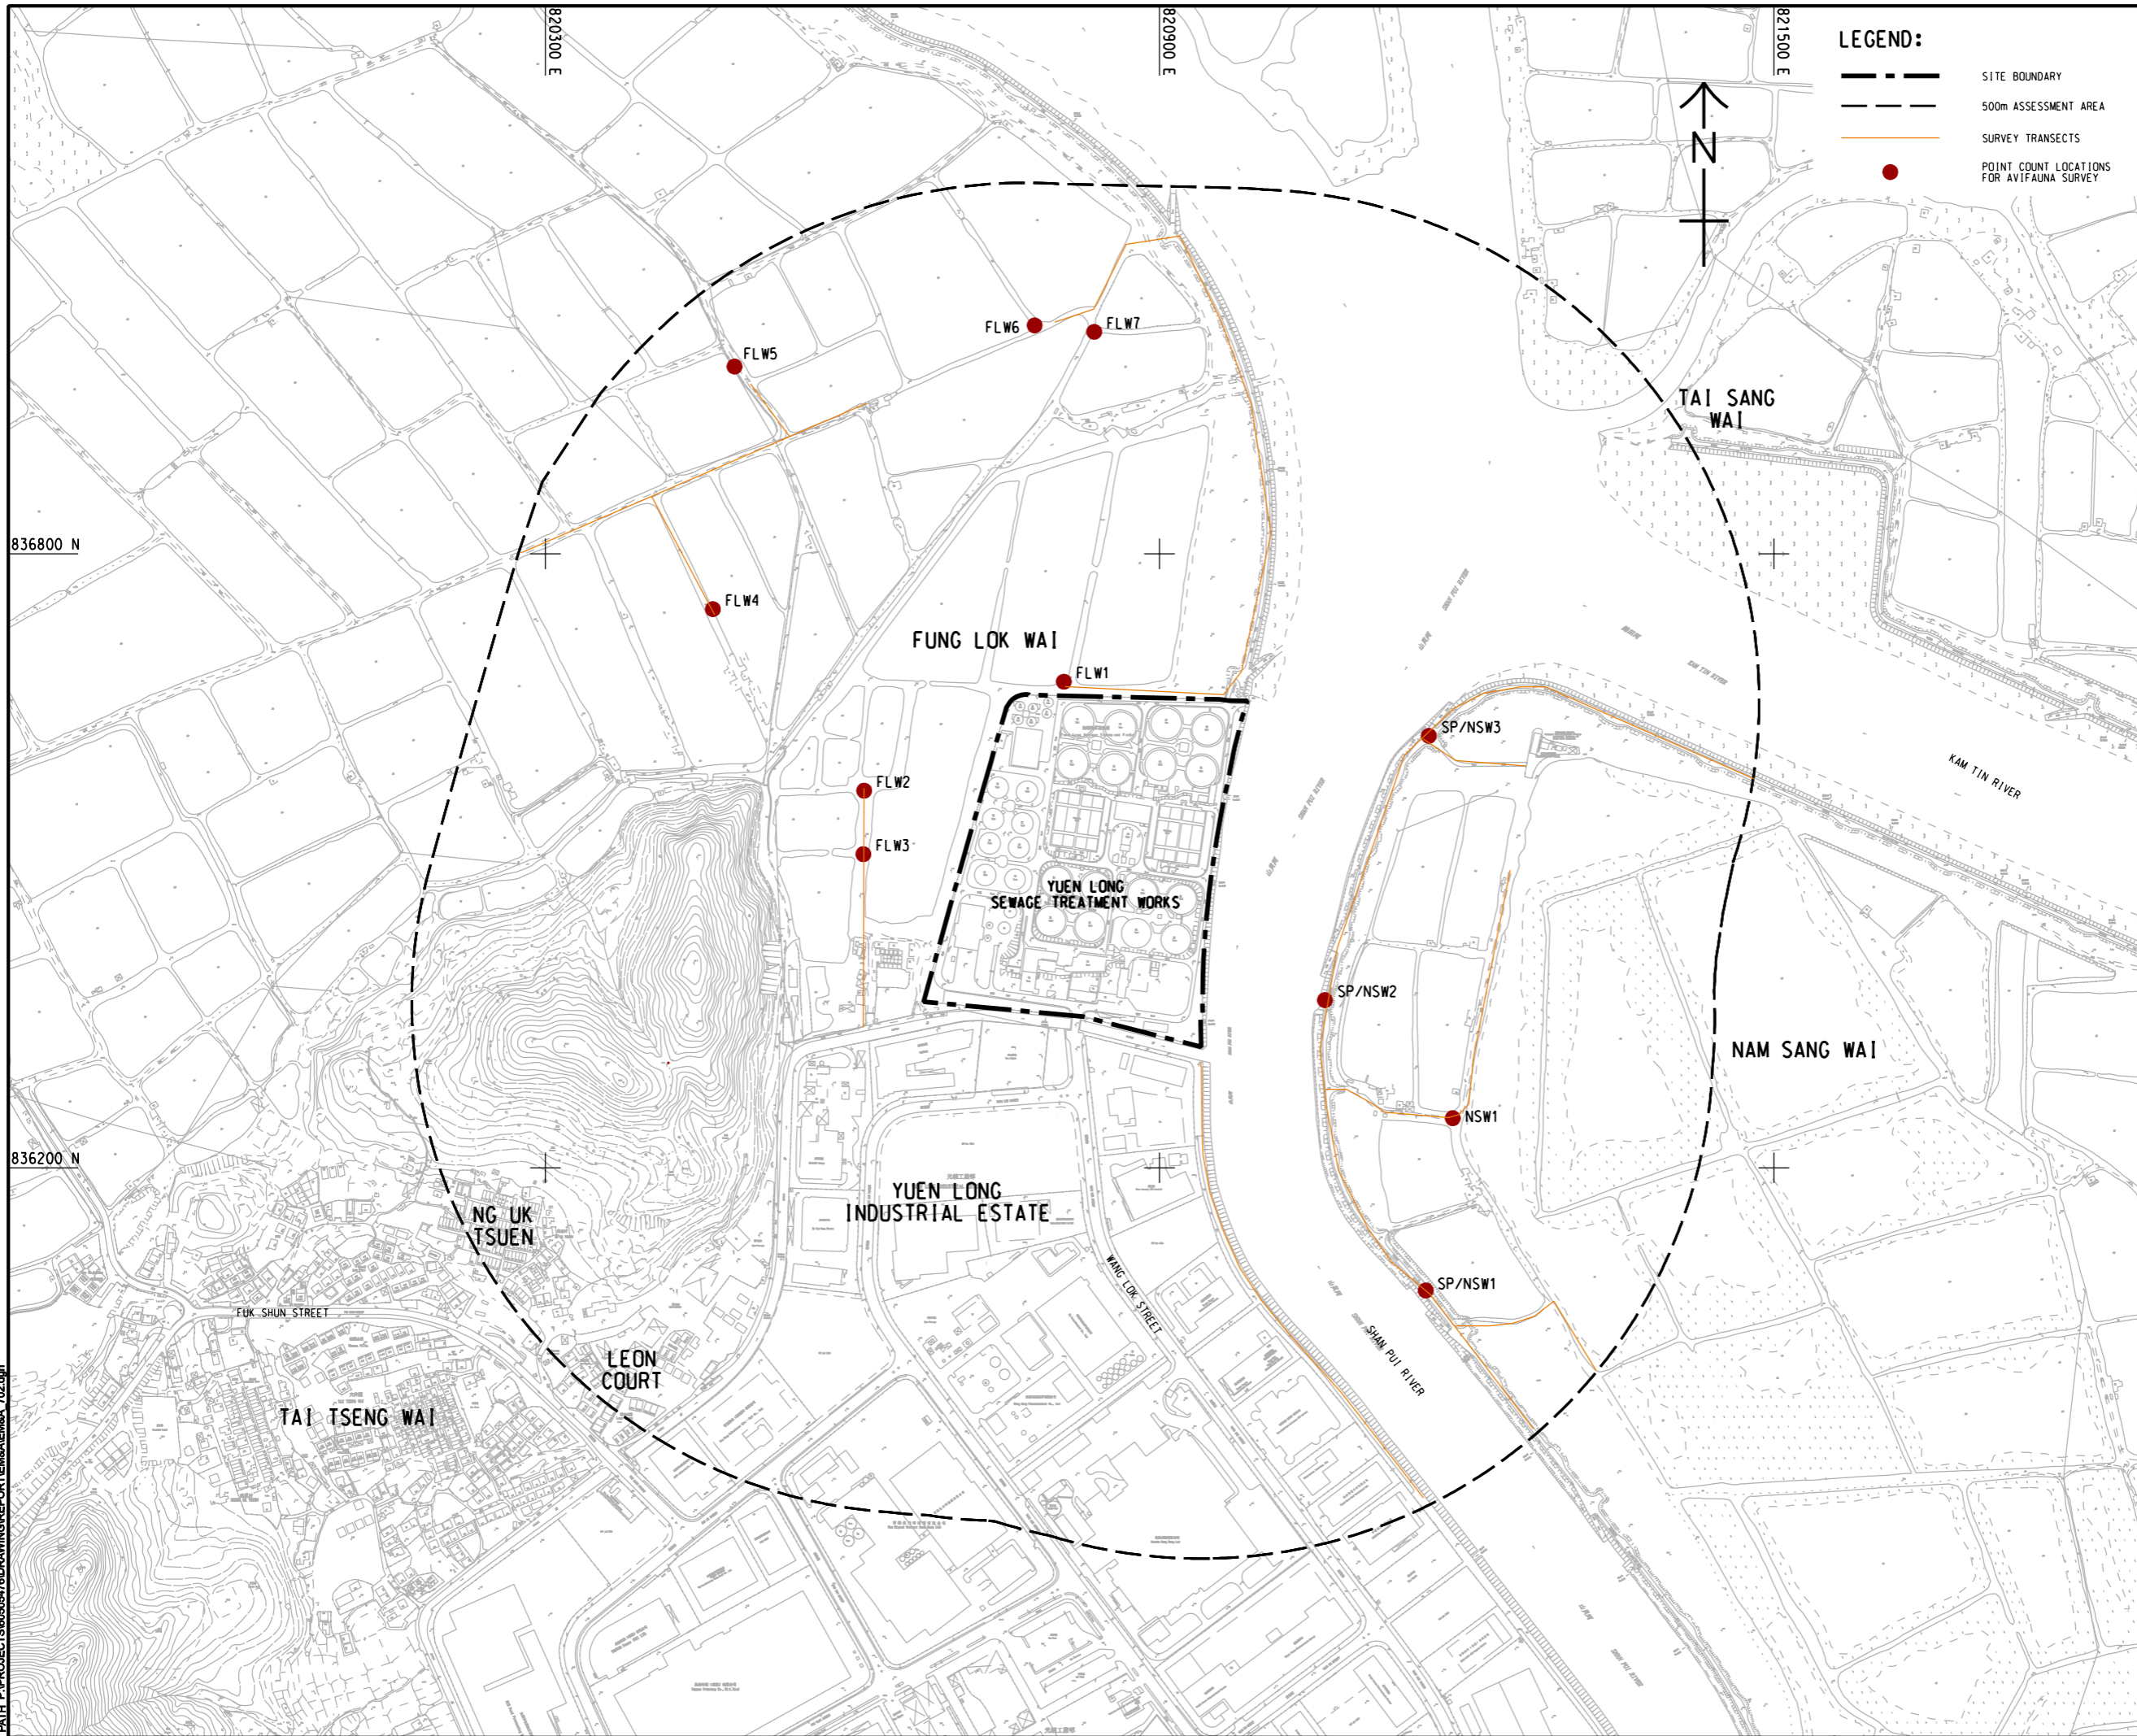
Ecology Monitoring Locations

- SITE BOUNDARY
- 500m ASSESSMENT AREA
- SURVEY TRANSECTS
- POINT COUNT LOCATIONS FOR AVIFAUNA SURVEY

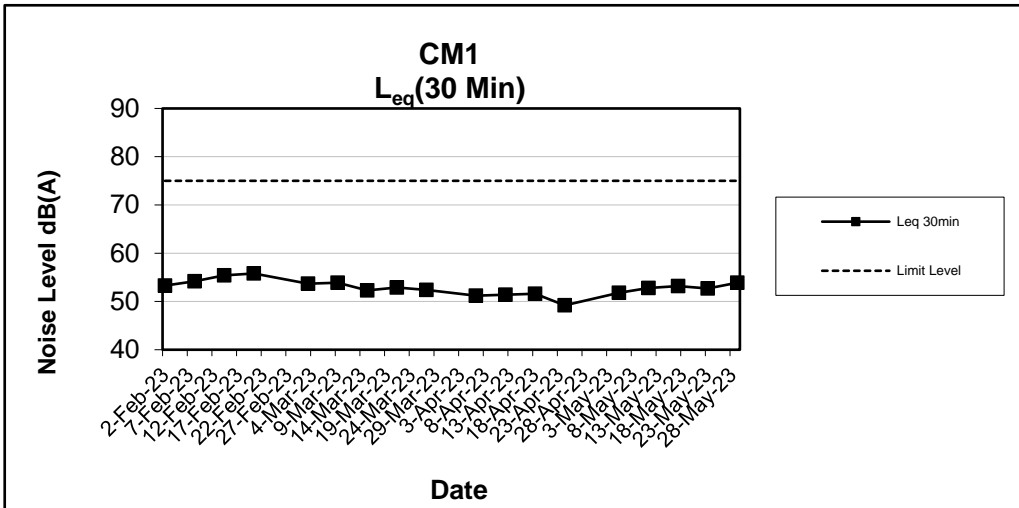
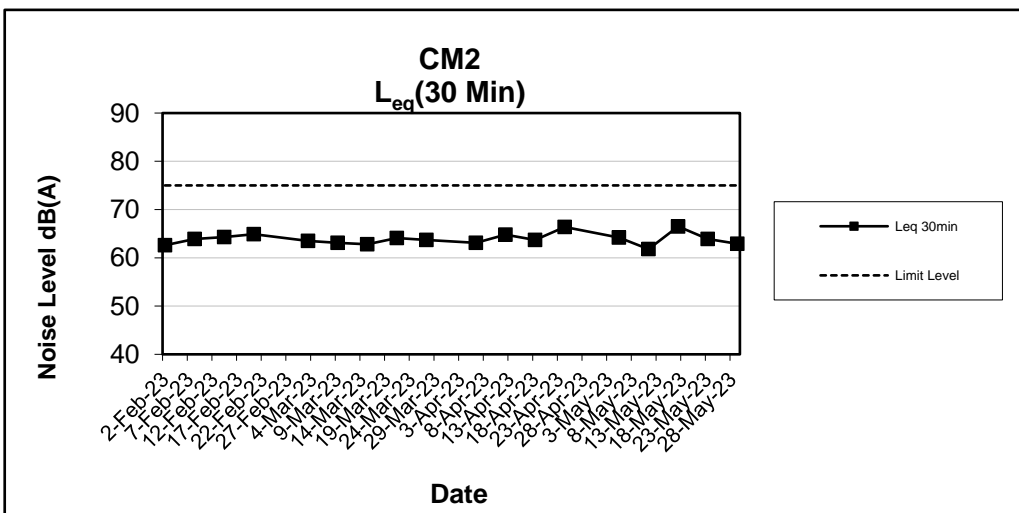
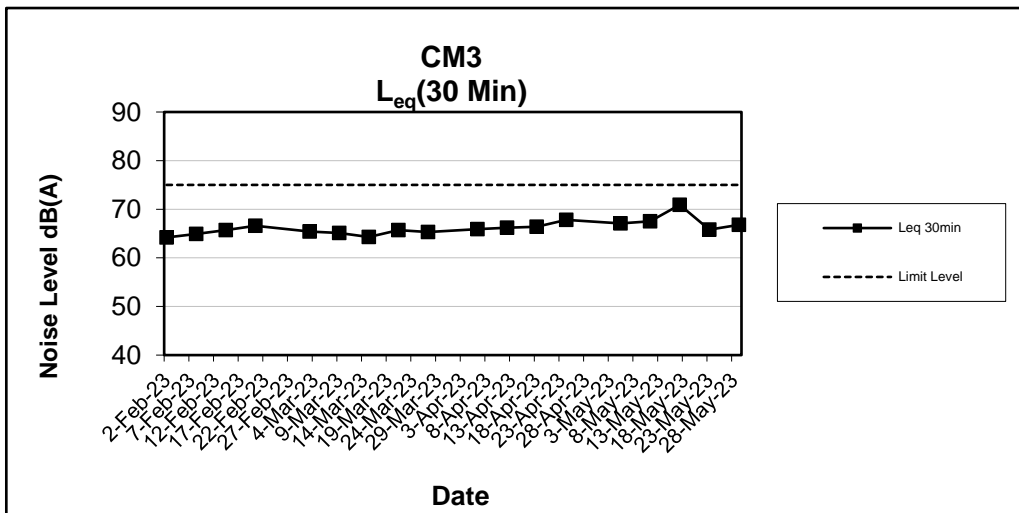
**Noise Monitoring Results**

CM1, CM2 and CM3: Free-field measurement (+3dB(A) correction has been applied).

No raining or wind with speed over 5 m/s was observed during noise monitoring according to the onsite observation.

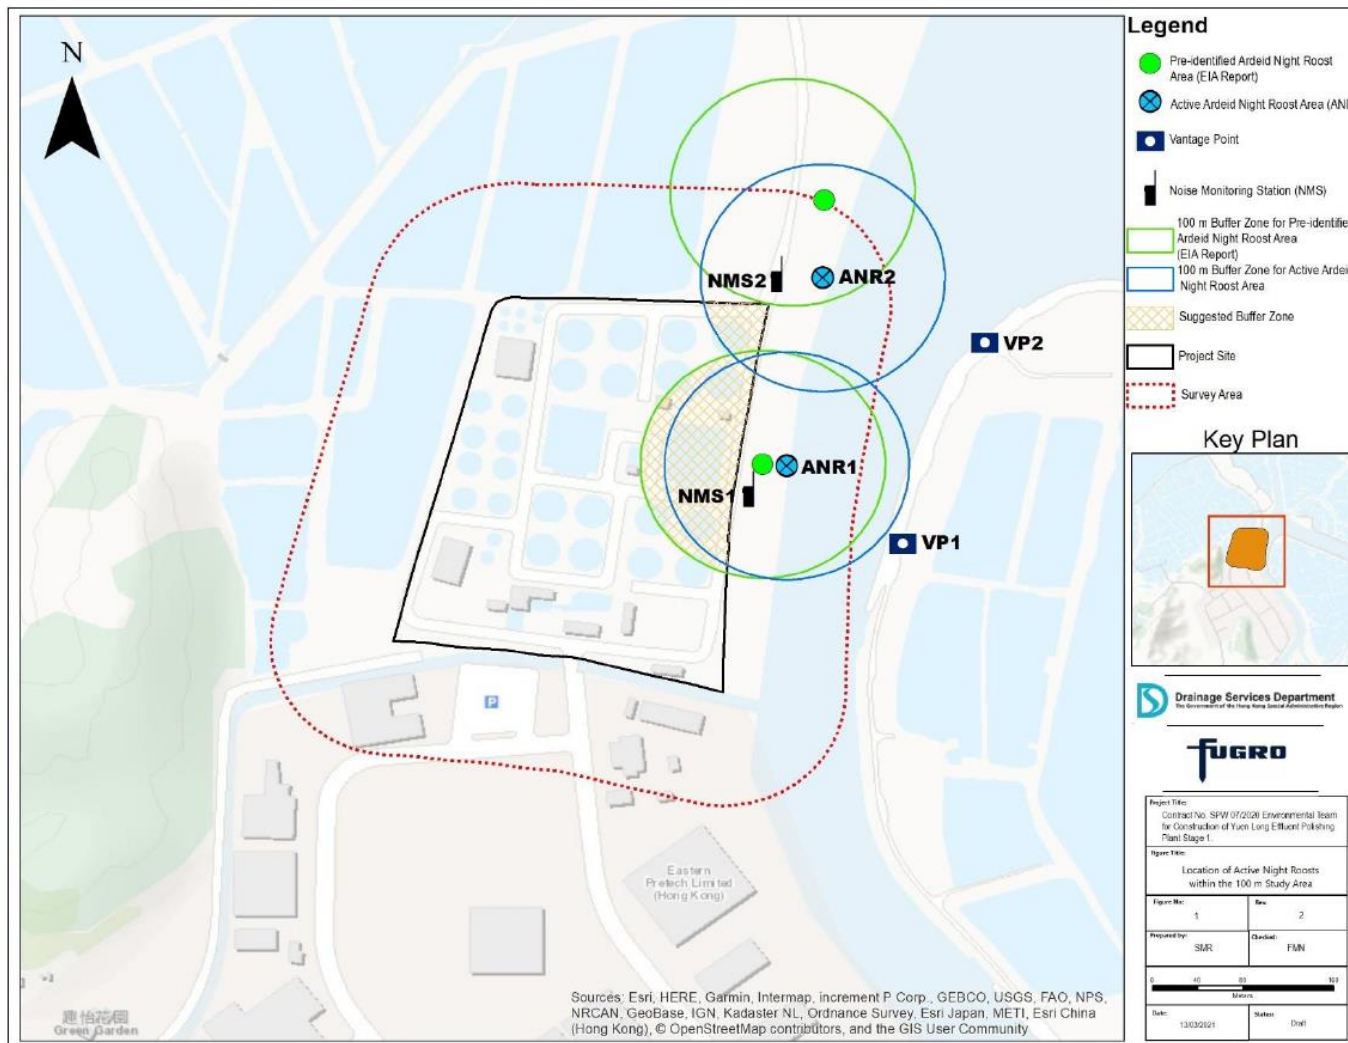
**O.1 Map of the Monitoring Area, Vantage Points for Observation of Active Night Roosts and Noise Monitoring Stations**

Appendix O.1: Monitoring Area, Vantage Points for Observation of Active Night Roosts and Noise Monitoring Stations

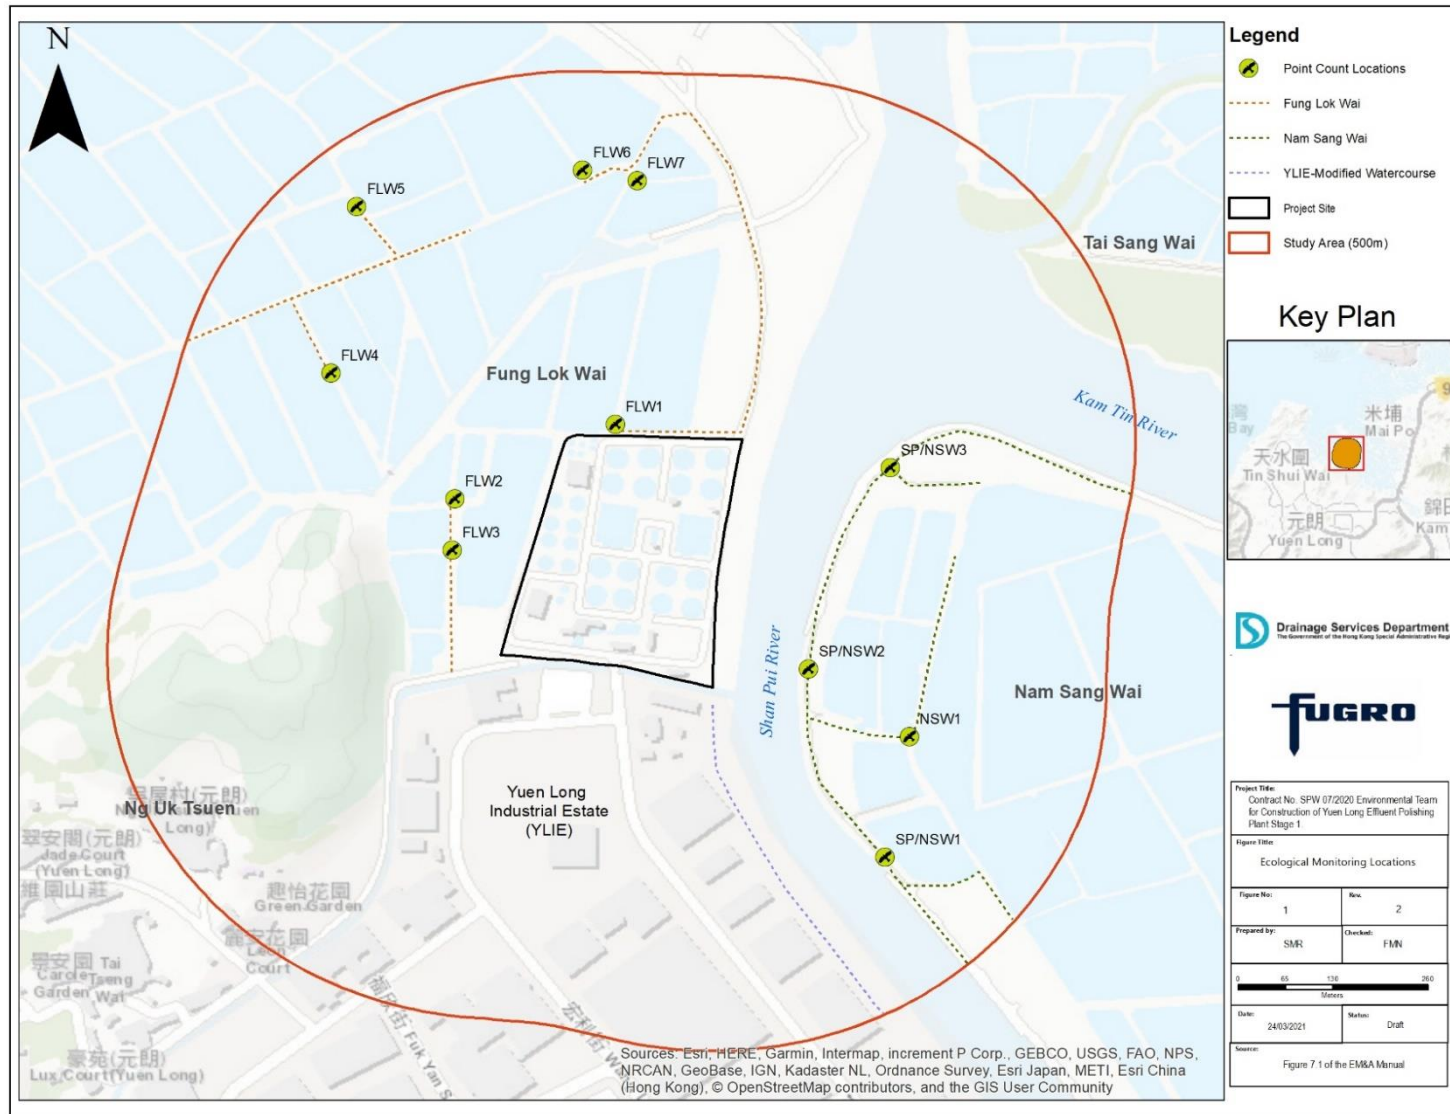
Ecological Bird Monitoring Area with Locations  
of Point Count Sites and Transect Routes

Appendix P: Ecological bird monitoring area with the locations of point count sites and transect routes
