Monthly EM&A Report (April 2023)

0120/20/ED/0589 02

Contract No. SPW 07/2020 Environmental Team for Construction of Yuen Long Effluent Polishing Plant Stage 1

EP Condition 3.4 – Monthly EM&A Report for April 2023

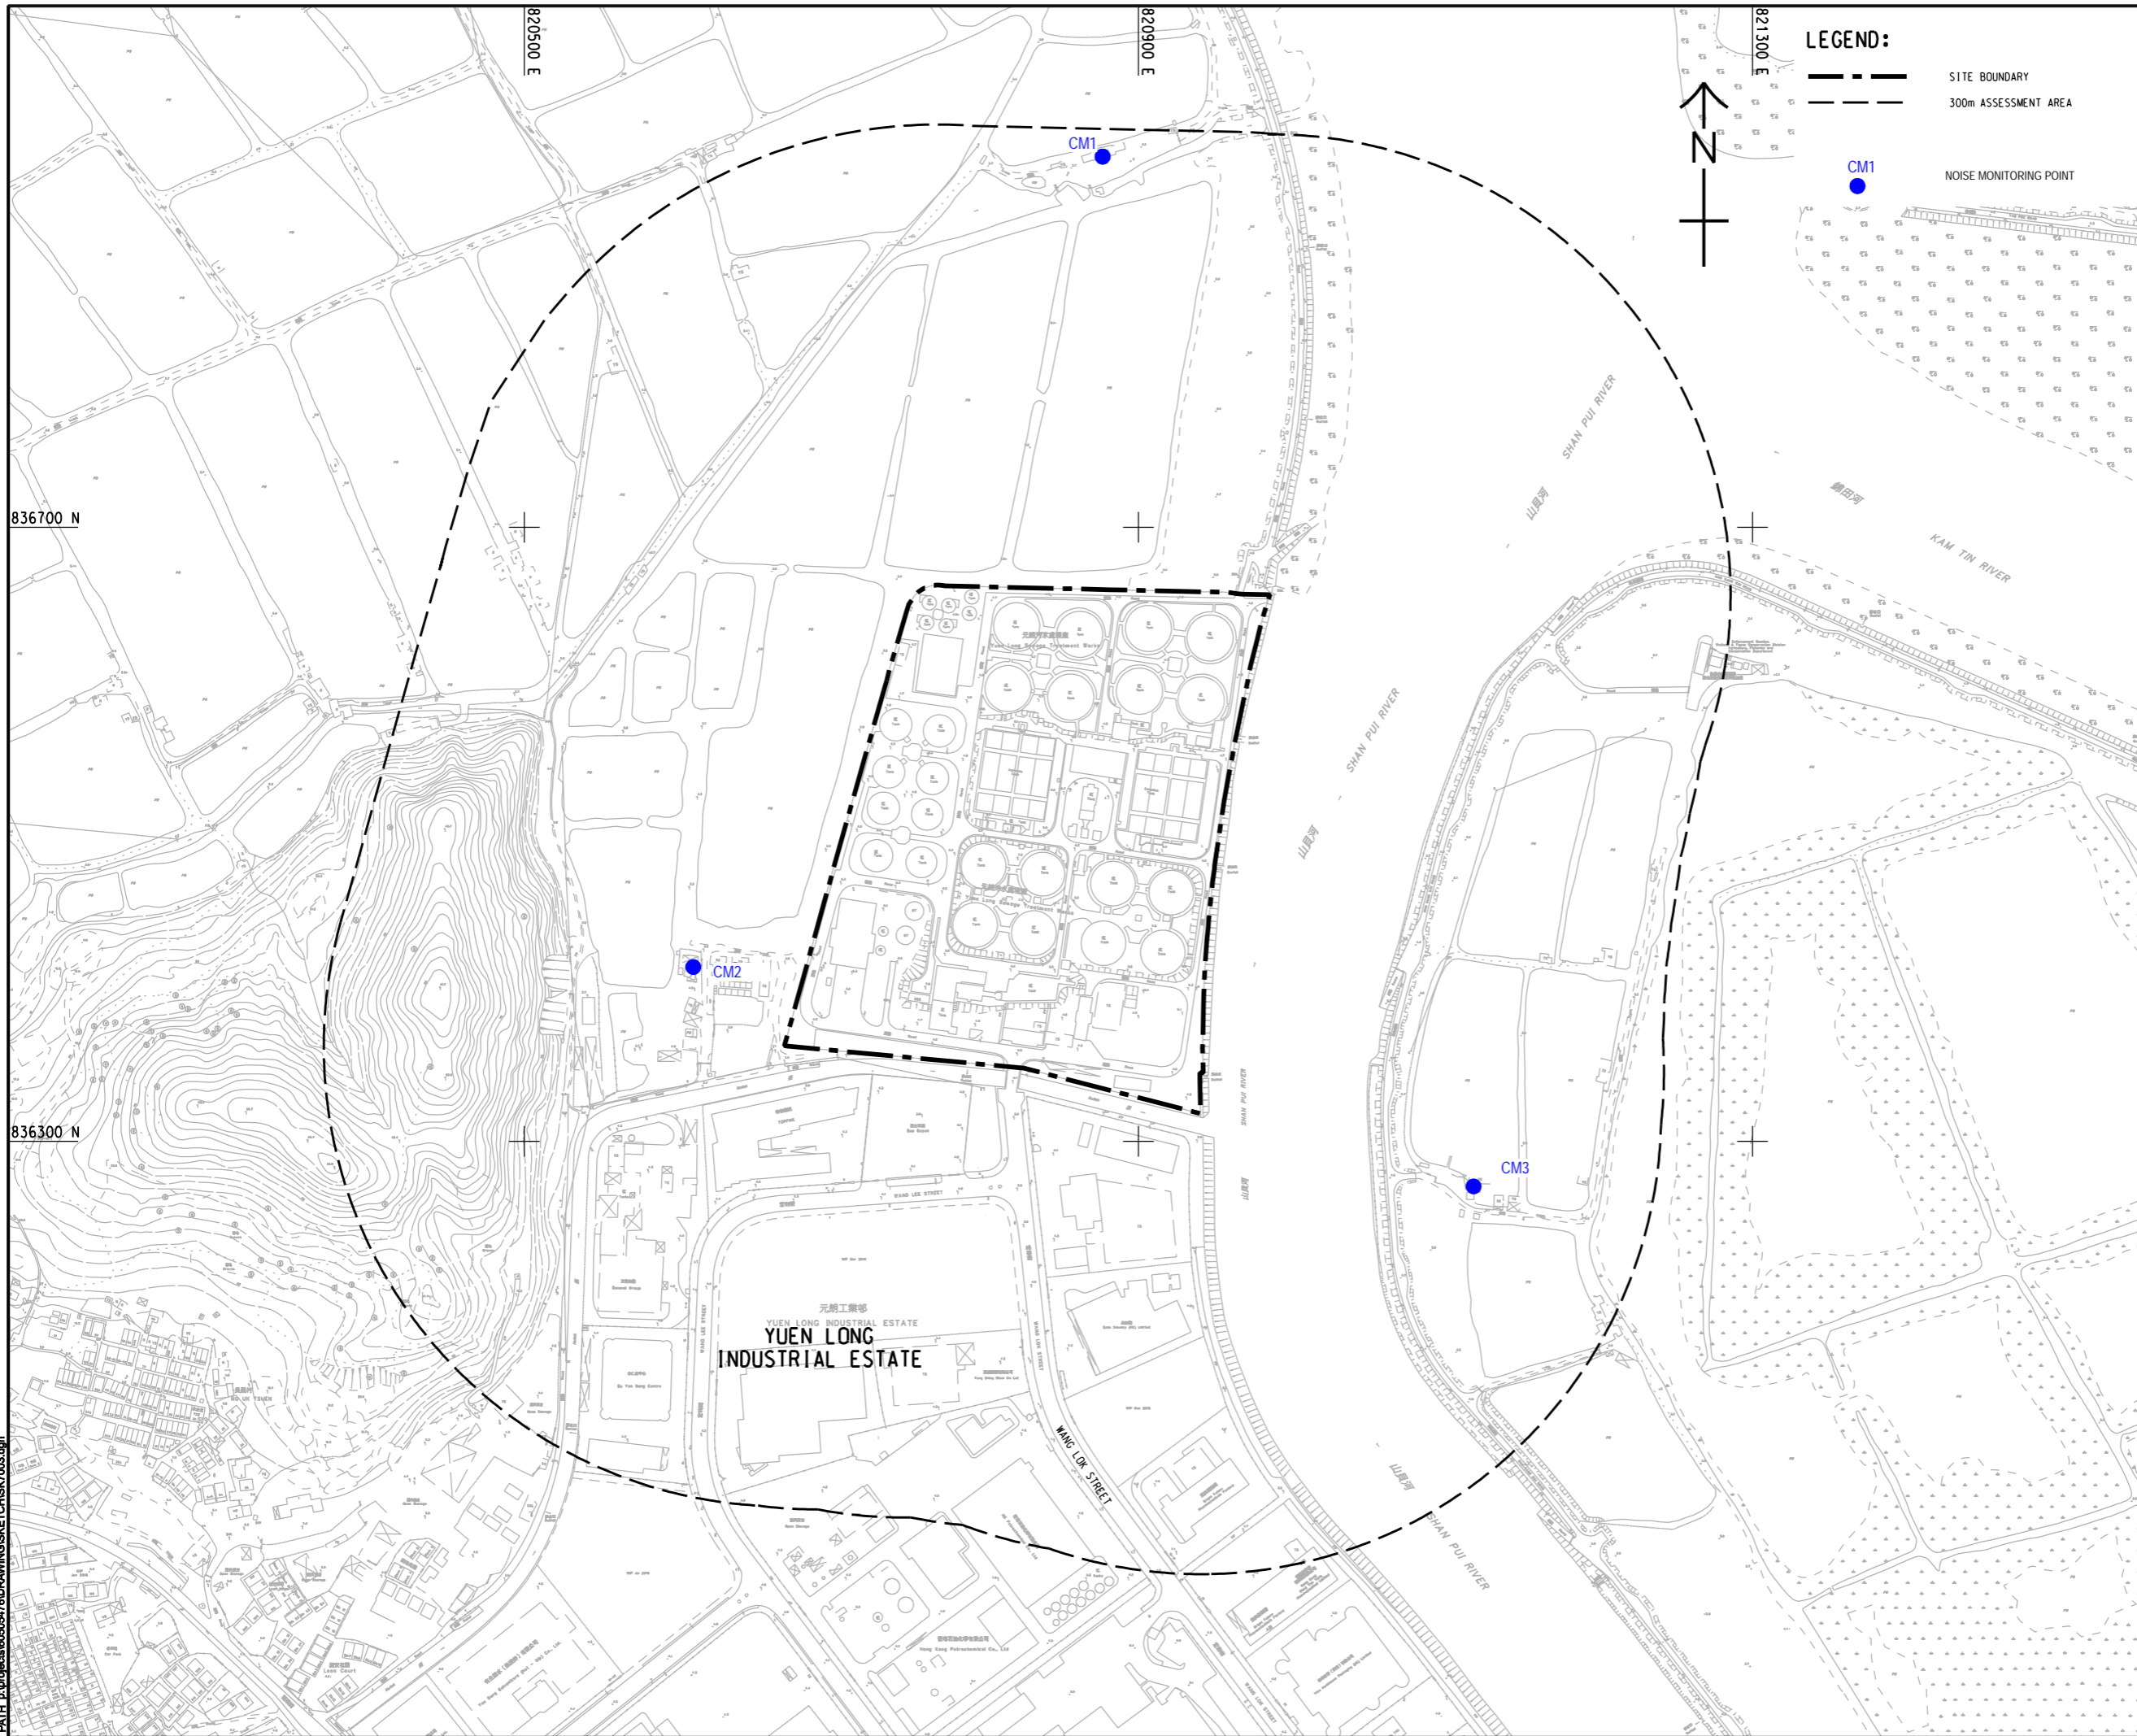
Figure 3

Noise Monitoring Locations

- SITE BOUNDARY
- 300m ASSESSMENT AREA
- NOISE MONITORING POINT

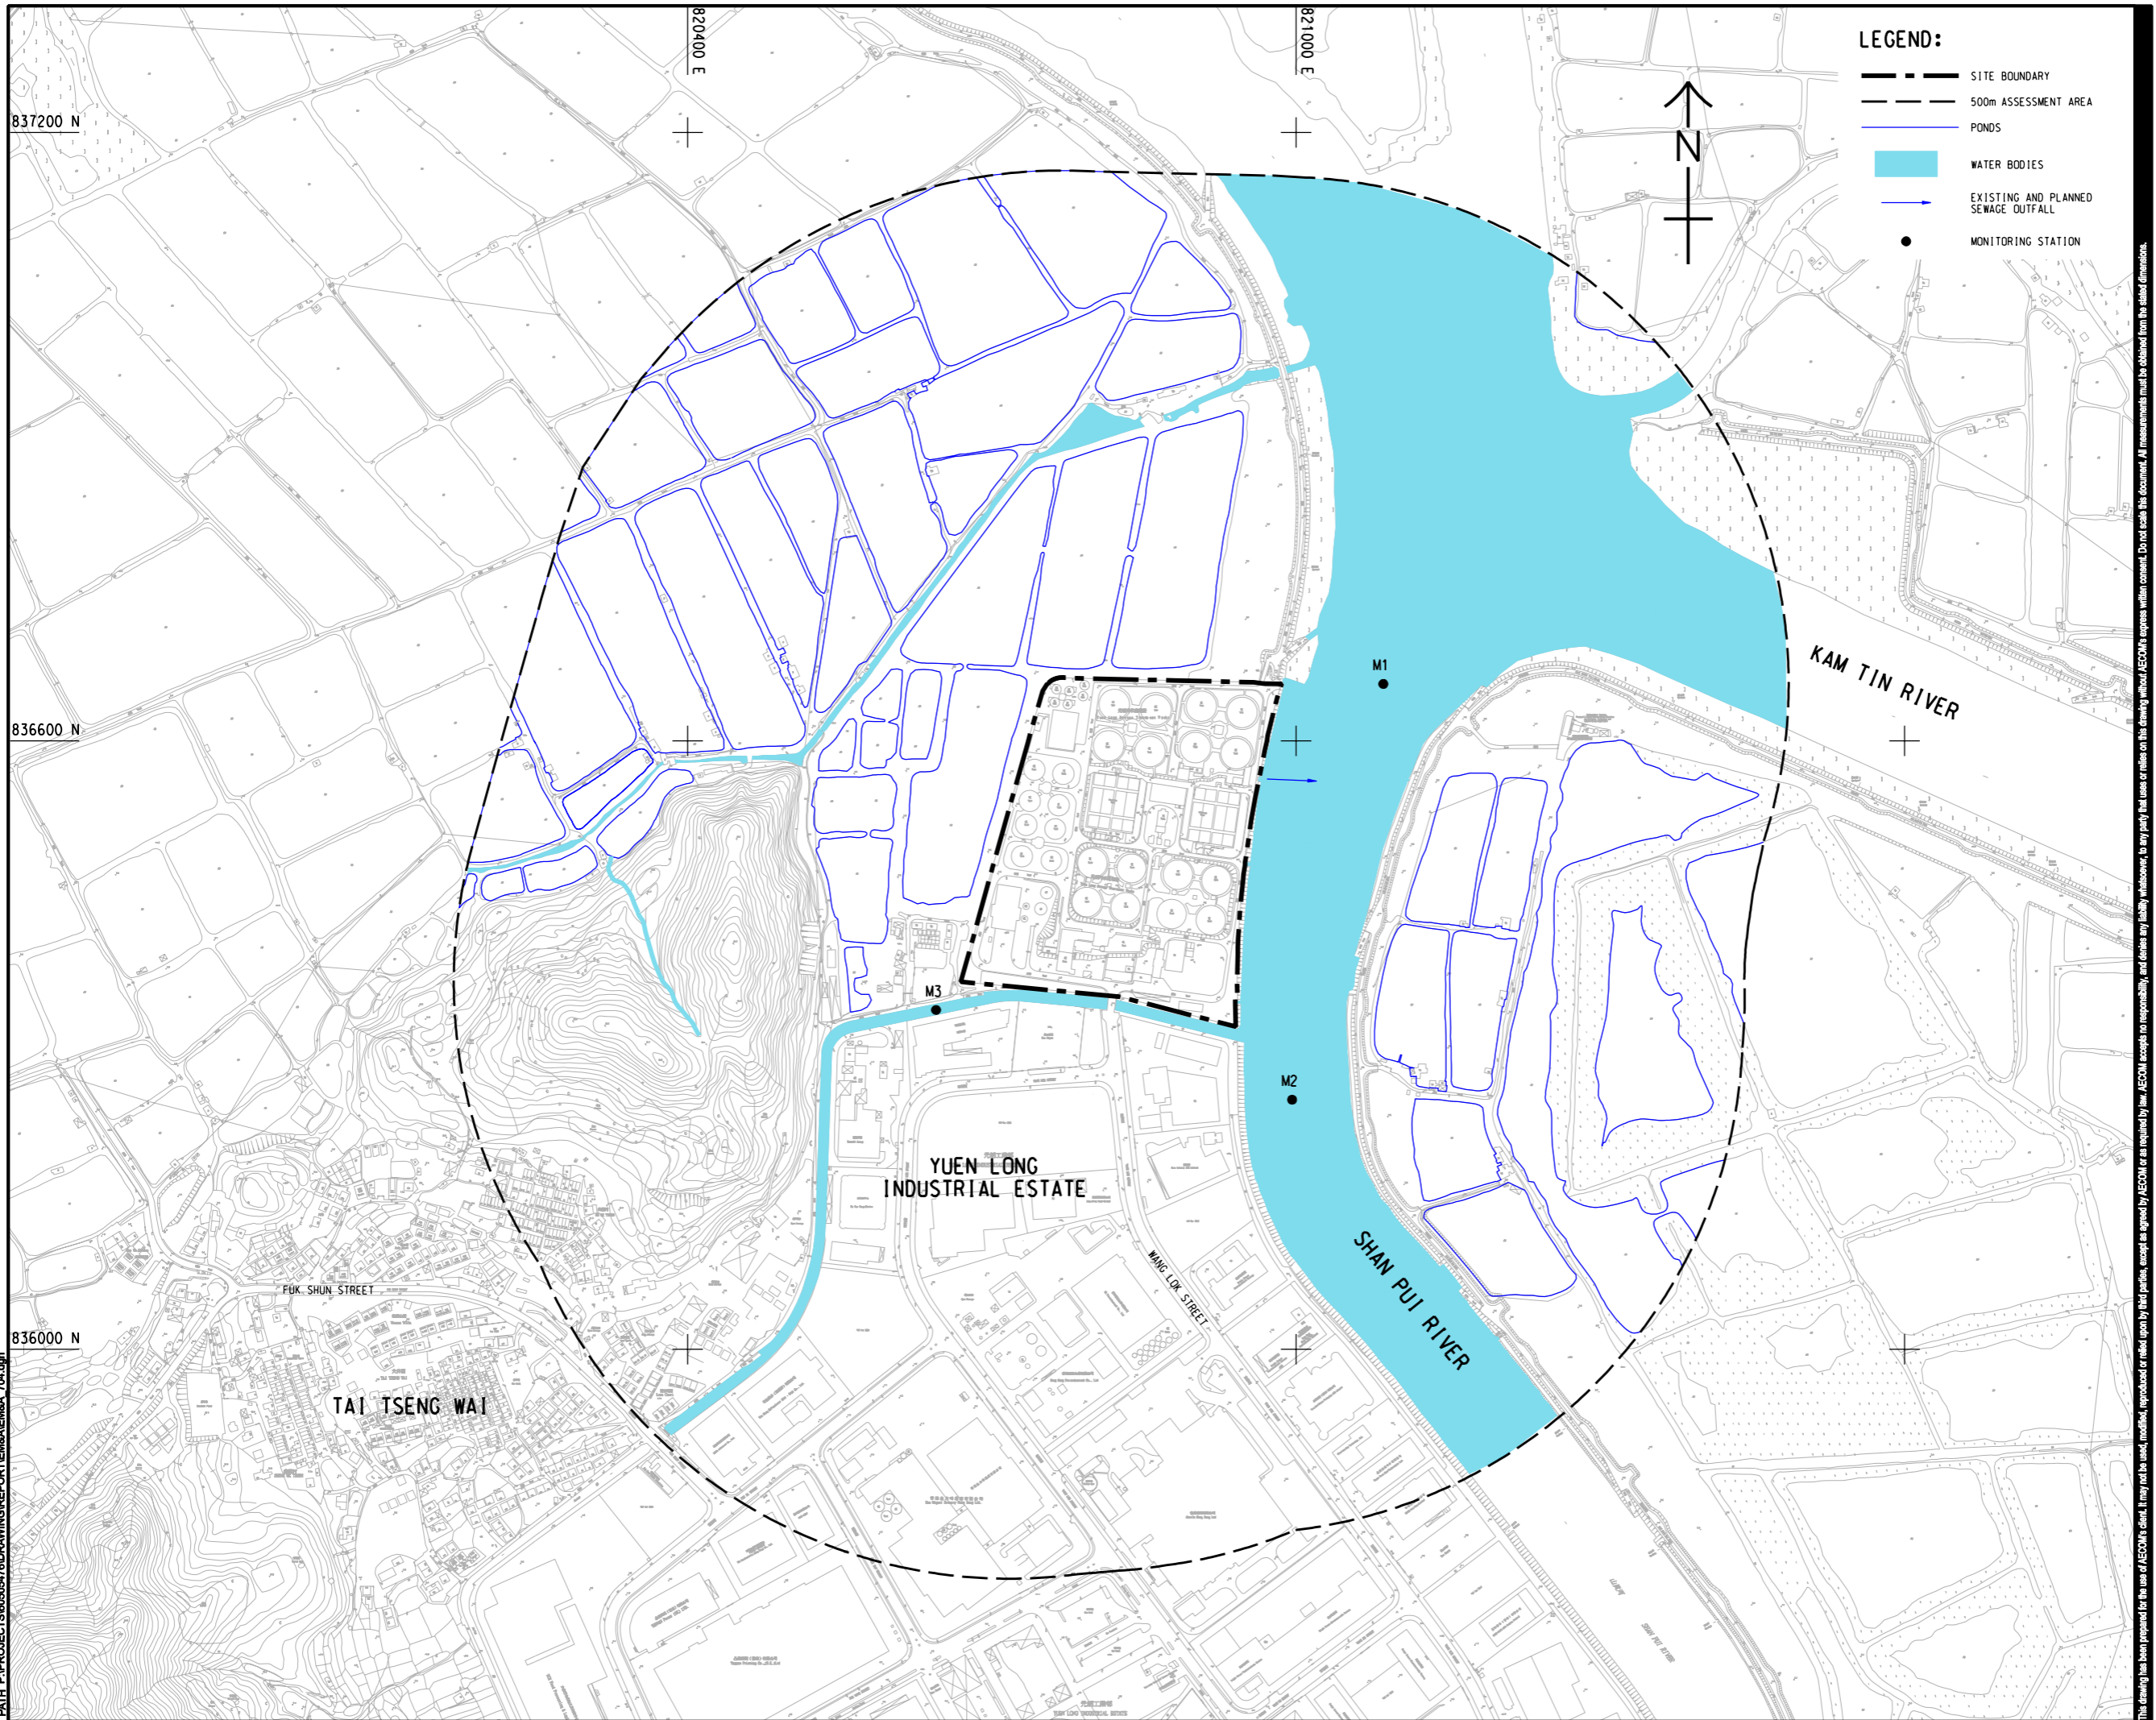
Water Quality Monitoring Locations

- SITE BOUNDARY
- 500m ASSESSMENT AREA
- PONDS
- WATER BODIES
- EXISTING AND PLANNED SEWAGE OUTFALL
- MONITORING STATION

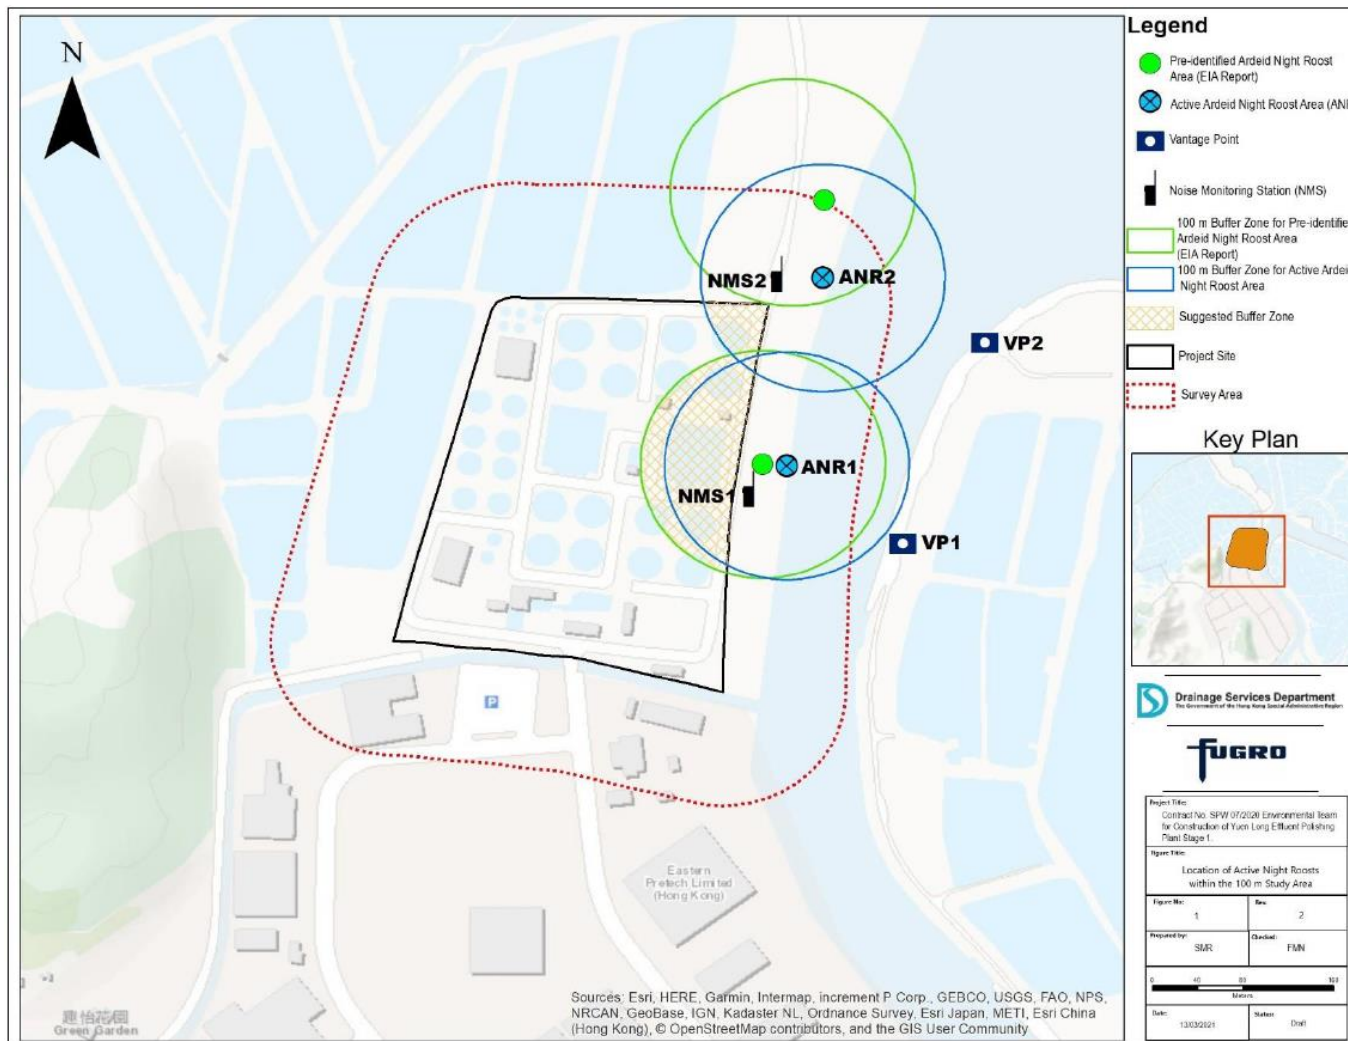
O.1 Map of the Monitoring Area, Vantage Points for Observation of Active Night Roosts and Noise Monitoring Stations

Appendix O.1: Monitoring Area, Vantage Points for Observation of Active Night Roosts and Noise Monitoring Stations

5.1.4 No Action / Limit exceedance was recorded for noise levels at stations (NMS1 and NMS2) in close proximity to the two active ardeid night roosts (ANR1 and ANR2) observed within the Survey Area during the reporting month.

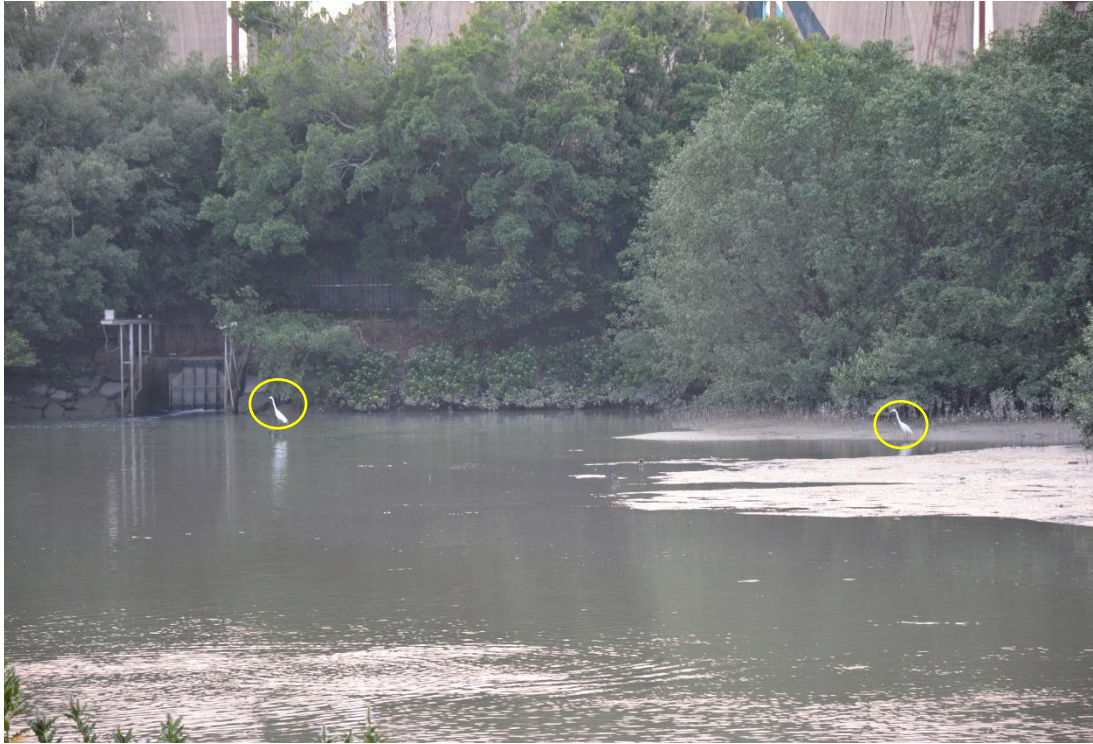
Appendix O.2.1a: Pre-roost aggregate of Great Egret *Ardea alba* northeast of the Project boundary observed on 12 April 2023 around 18:00.

The monitoring activity was conducted on 12 April 2023 and started around 17:42 (one hour before sunset) on a high tide condition. During the pre-roost period (PRP), the period when avian individuals gather first before flying into a night roost, individuals of Great Egret *Ardea alba* (2) and Grey Heron *Ardea cinerea* (1) were noted in the east side (ANR1) of the Project boundary while individuals of Chinese Pond Heron *Ardeola bacchus* (1) and Grey Heron (1) were noted at the northeast side of the Project boundary (**Table 5.2**).

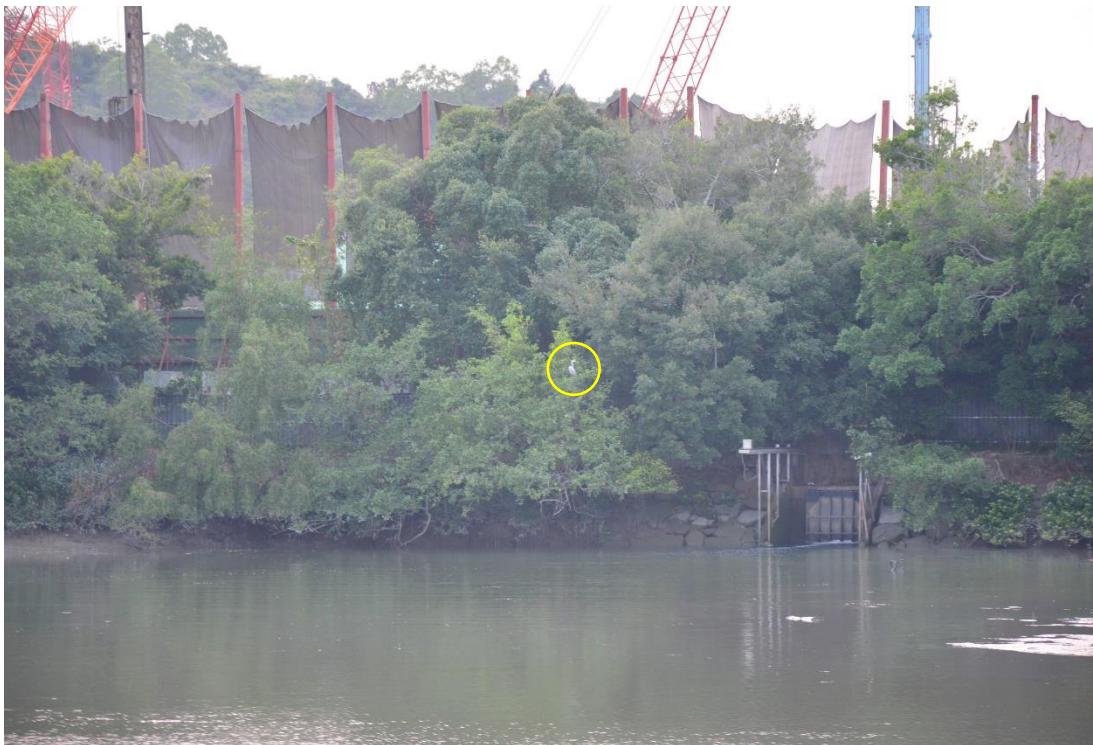
Appendix O.2.1b: Pre-roost aggregate of Grey Heron *Ardea cinerea* northeast of the Project boundary observed on 12 April 2023 around 18:00.

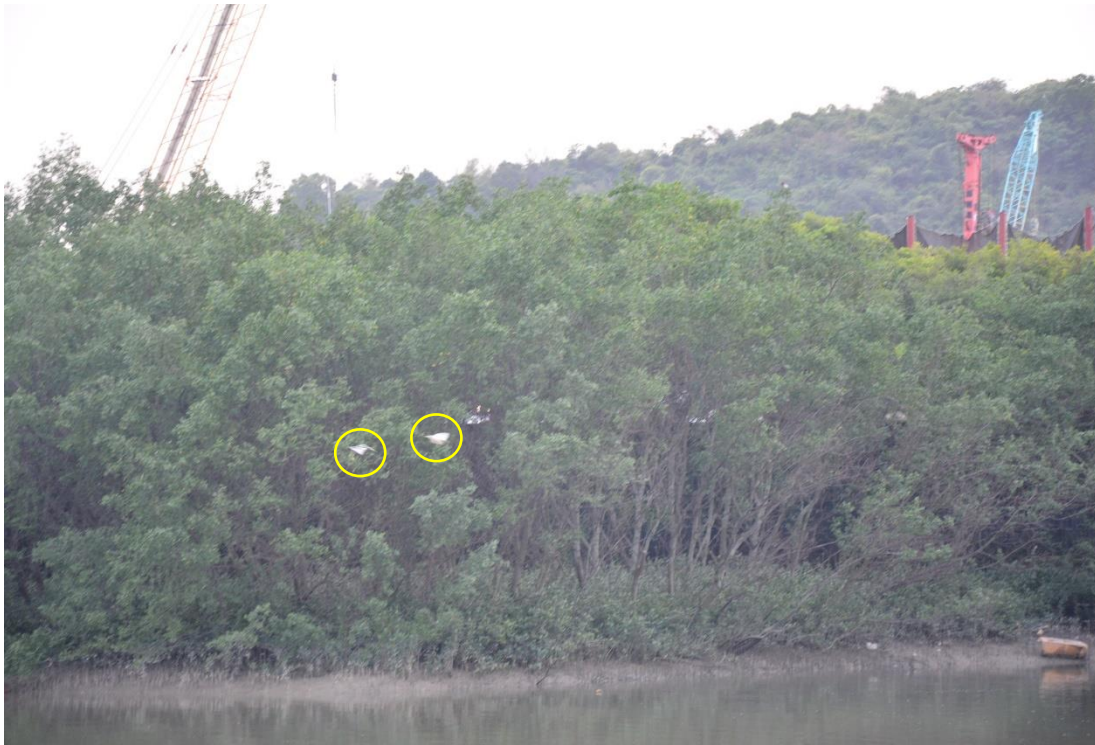
Appendix O.2.2a: Active night roost on *Sonneratia apetala* and *S. caseolaris* mangrove roosting substrate located northeast of the Project boundary observed on 12 April 2023 around 18:27.

For the final night roost at around 18:27, individuals of Grey Heron (1) and Chinese Pond Heron (2) were observed at the roosting area ANR1 utilizing the understory to canopy layer of the roosting substrate *Sonneratia apetala* and *S. caseolaris*; while Chinese Pond Heron (9), Grey Heron (3), Little Egret *Egretta garzetta* (7) and Great Egret (6) were noted at ANR2 that utilized the understory to canopy layer of the aforementioned roosting substrate.

No disturbance (construction related and/or otherwise) to the active night roost areas was observed during the period. Bird droppings were observed within the vicinity of the roosting area located east of the Project boundary.

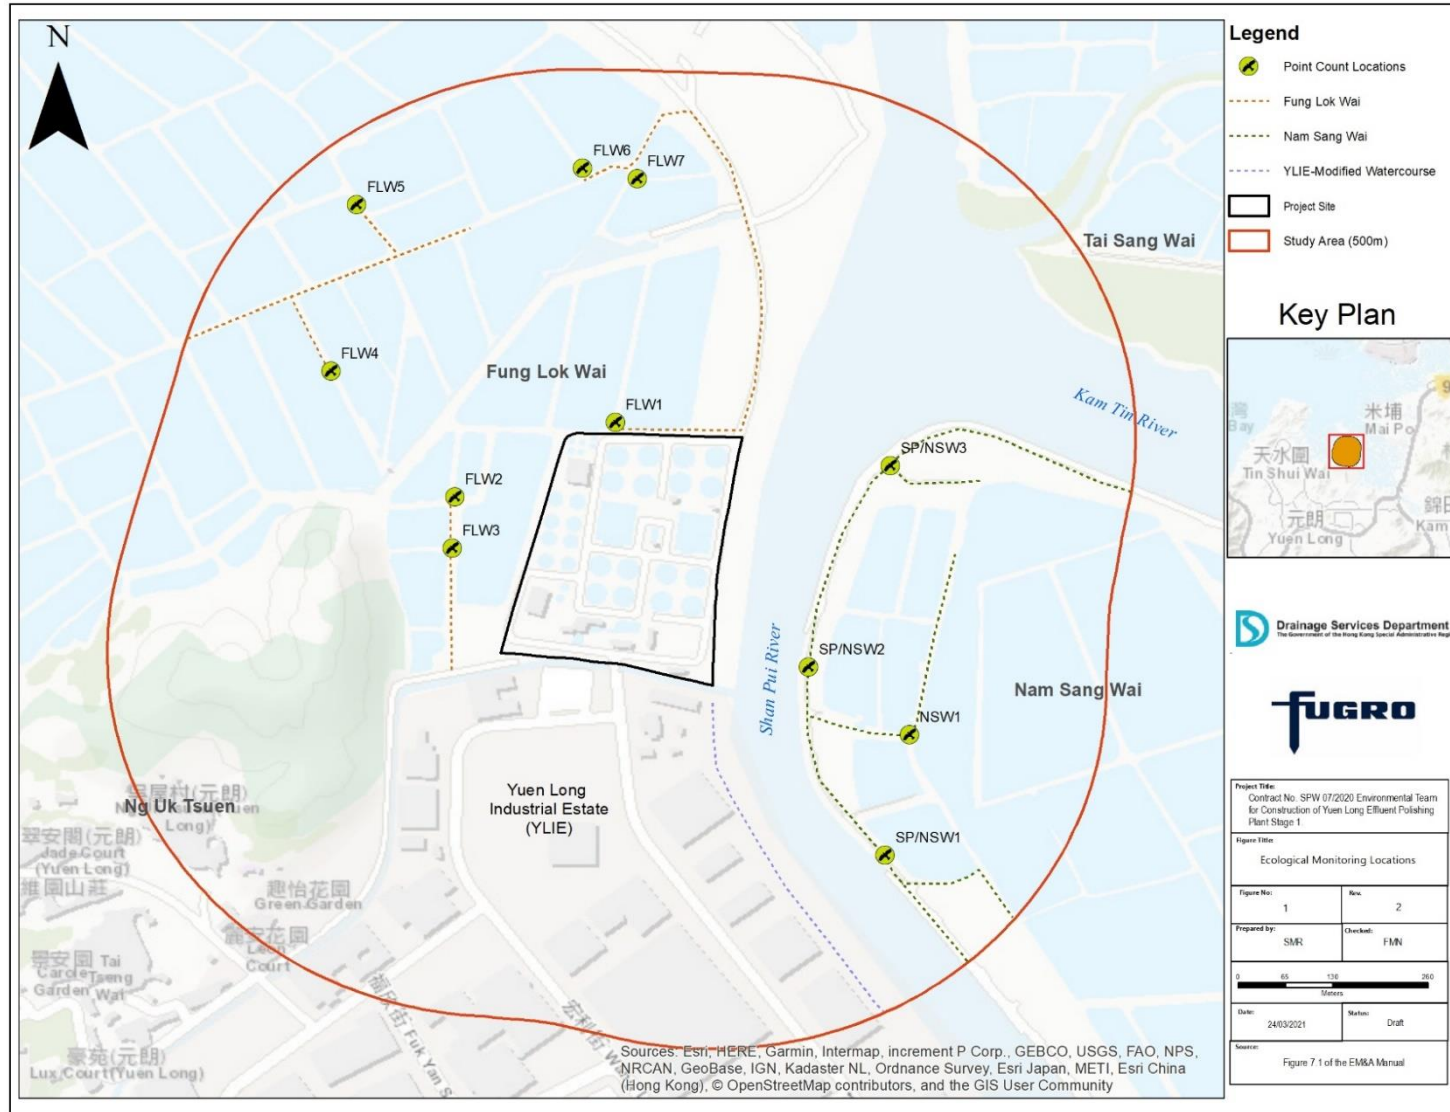
Ecological Bird Monitoring Area with Locations
of Point Count Sites and Transect Routes

Appendix P: Ecological bird monitoring area with the locations of point count sites and transect routes
