# Monthly EM&A Report (May 2022)

0120/20/ED/0483 02

**Contract No. SPW 07/2020 Environmental Team for Construction of Yuen Long Effluent Polishing Plant Stage 1**

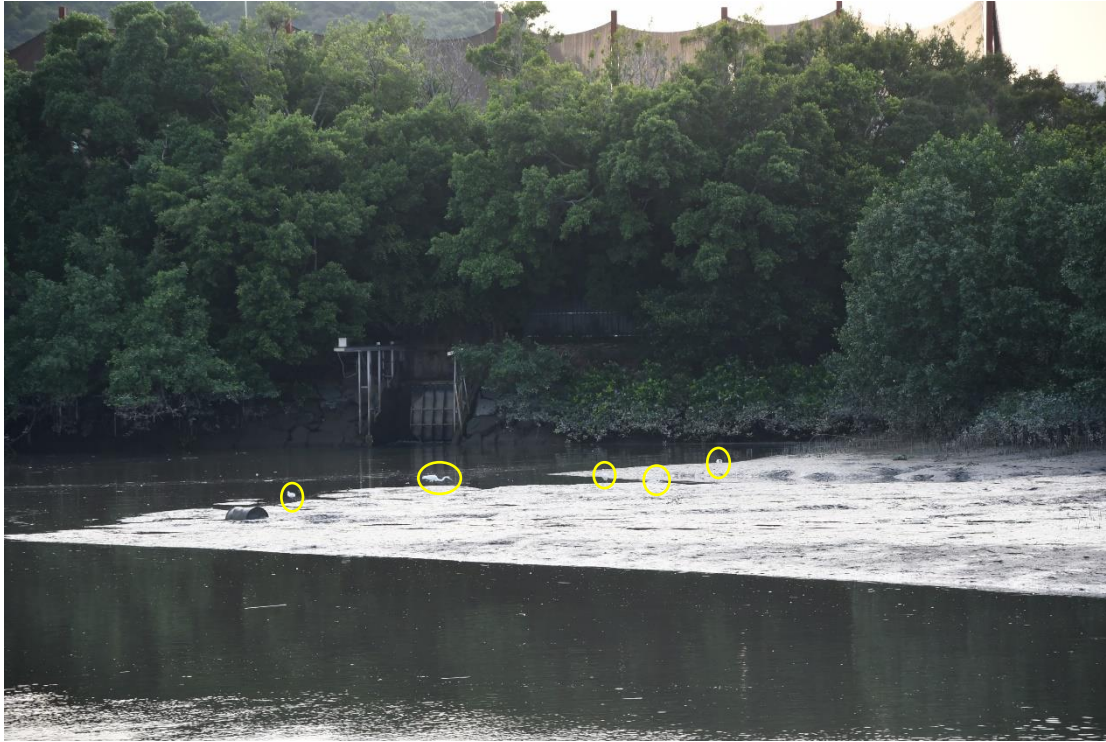
Appendix O.2.1a: Pre-roost aggregate of Chinese Pond Heron *Ardeola bacchus*, Great Egret *Ardea alba*, and Intermediate Egret *Egretta intermedia* in the mudflat area east of the Project boundary observed on 19 May 2022 around 18:25

The monitoring activity was conducted on 19 May 2022 and started around 17:58 (one hour before sunset) on a low tide condition. During the pre-roost period (PRP), the period when avian individuals gather first before flying into a night roost, Chinese Pond Heron *Ardeola bacchus* (3 individuals), Great Egret *Ardea alba* (2 individuals) and Intermediate Egret *Egretta intermedia* (3 individuals) were observed in pre-roost aggregate (PRA) around 18:25 at the mudflat east side (ANR1) of the Project boundary while Great Egret (2 individuals) and Little Egret *Egretta garzetta* (7 individuals) were concurrently noted at the mudflat northeast side (ANR2) of the Project boundary during the period (**Table 5.2**).

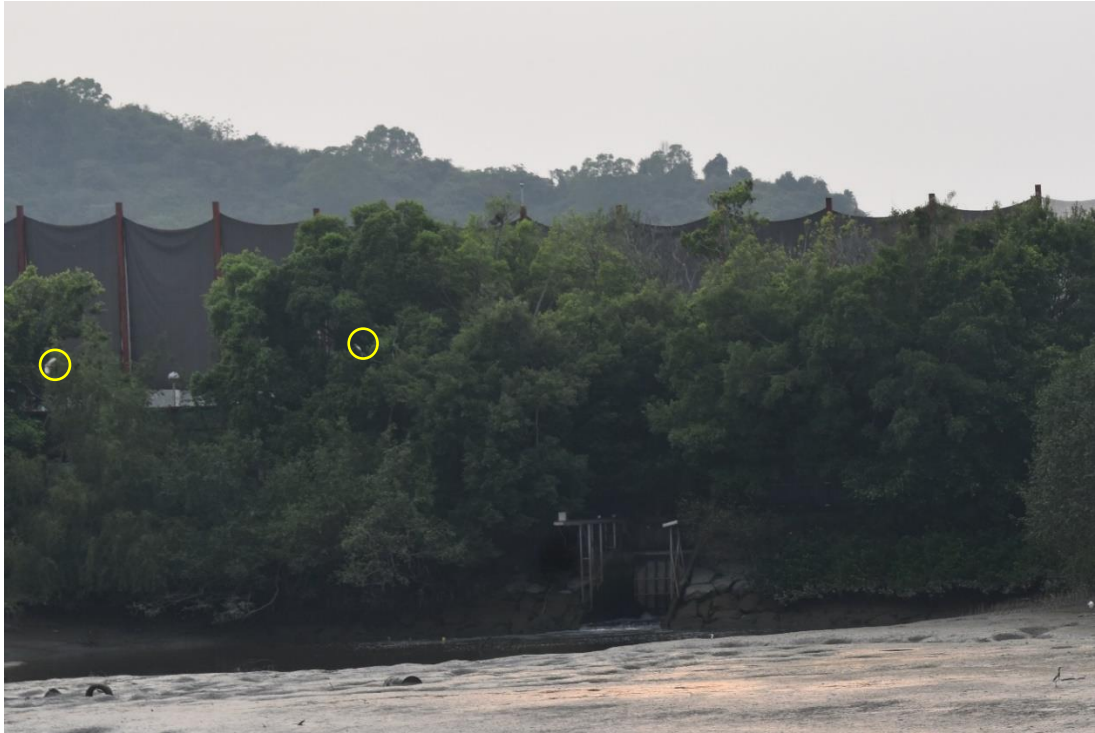
Appendix O.2.2a: Active night roost on *Sonneratia apetala* and *S. caseolaris* mangrove roosting substrate located east of the Project boundary observed on 19 May 2022 around 19:01

For the final night roost at around 19:01, Chinese Pond Heron (3 individuals) were observed at the roosting area ANR1 utilizing the inside portions of the understory to canopy layers of the roosting substrate *Sonneratia apetala* and *S. caseolaris*; while individuals of Intermediate Egret (6 individuals), Little Egret (3 individuals), and Chinese Pond Heron (5 individuals) were noted at ANR2 and utilized the canopy layer of the aforementioned roosting substrate.

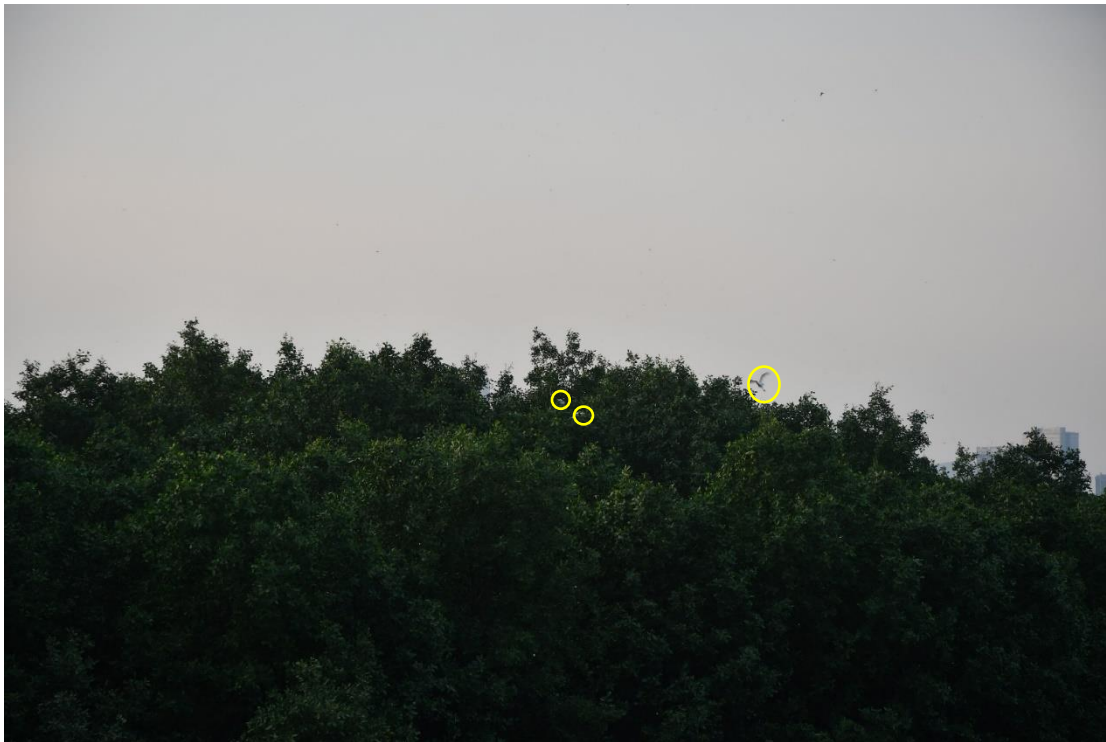
Appendix O.2.2b: Active night roost on *Sonneratia apetala* and *S. caseolaris* mangrove roosting substrate located northeast of the Project boundary observed on 19 May 2022 around 19:01
